Example Report

192 Issues Identified

SUMMARY - TOP ISSUES LEADING TO POOR PERFORMANCE

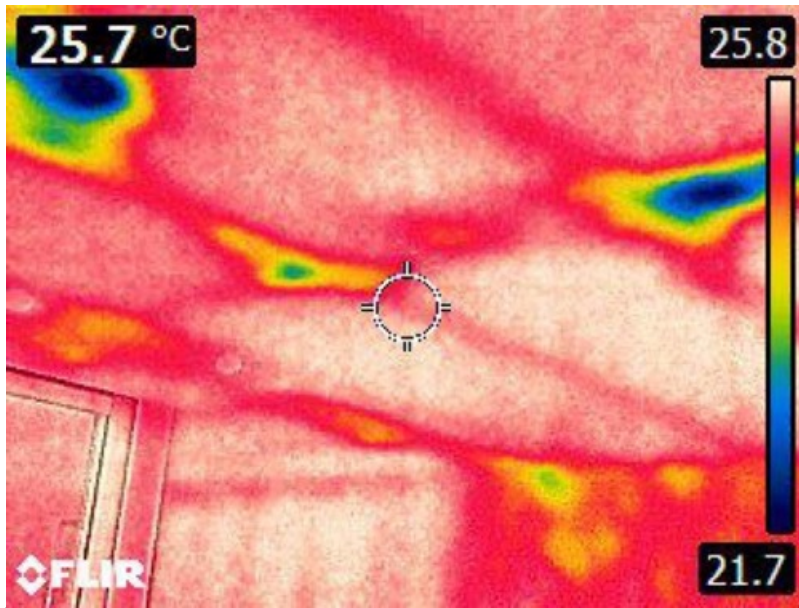
Relay insulation within the Loftspace, between and across ceiling joists in a perpendicular fashion to mitigate cold bridging

Adequately insulate over the cavity closers and into the eaves to mitigate cold bridging throughout the Loftspace

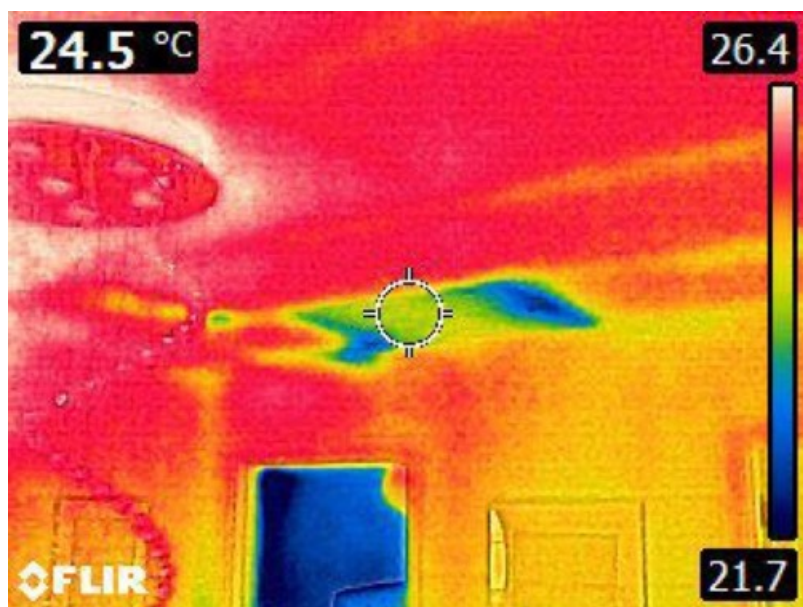
Minor cold bridging around the loft hatch

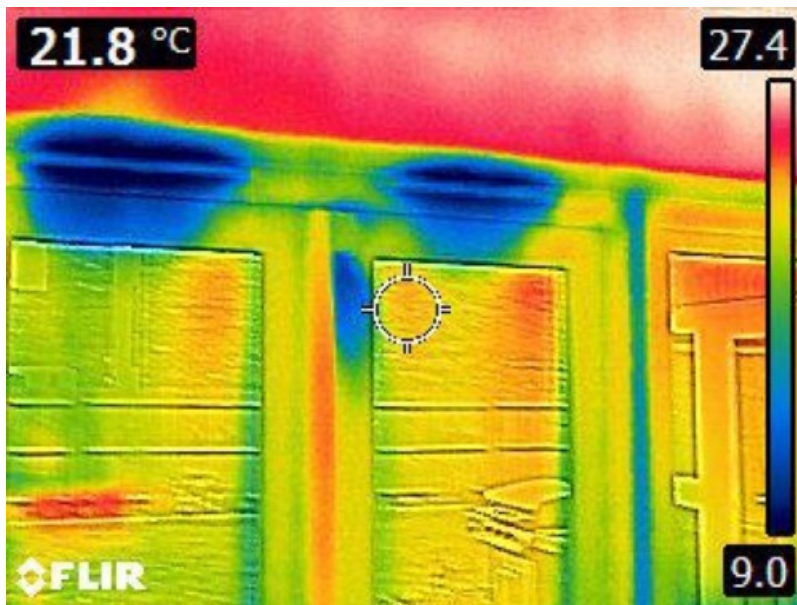
Cold bridging noted between the doors

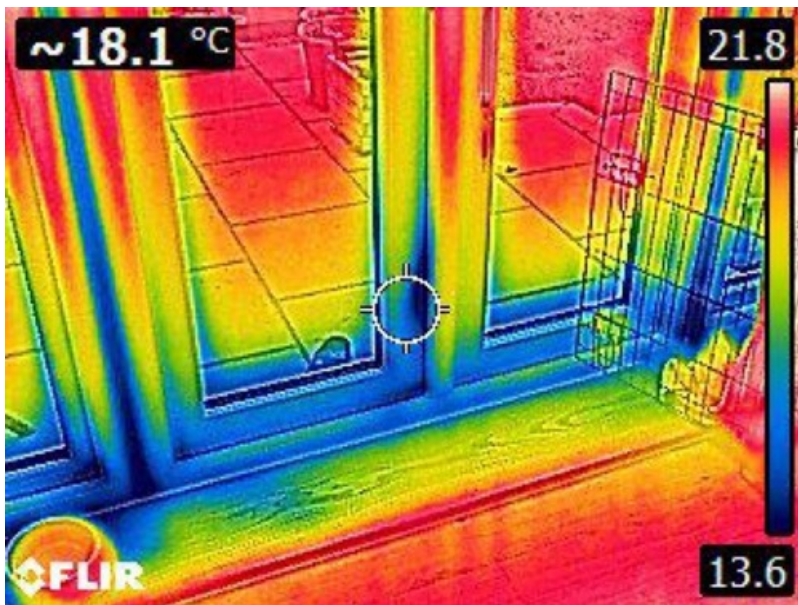
Cold bridging noted between the doors

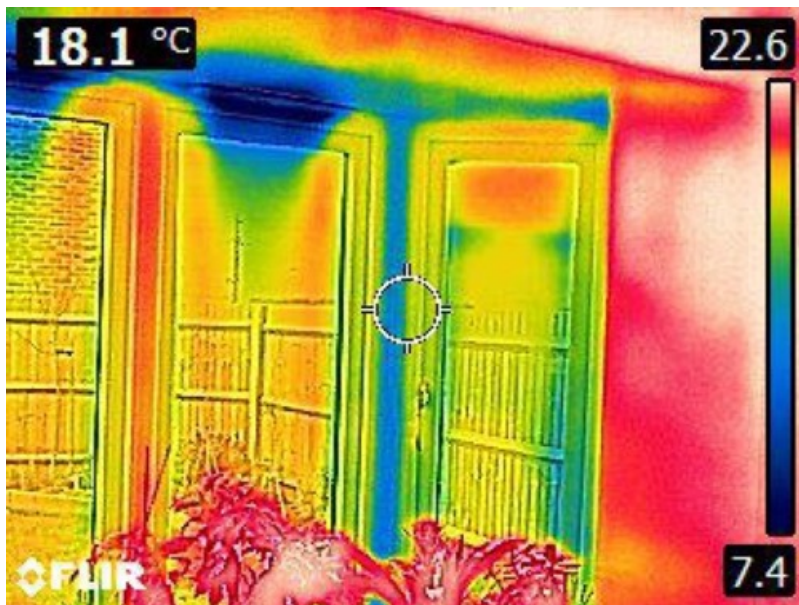
Cold bridging noted down the covered structural members of the opening, where assumed not suitably foam/ insulated

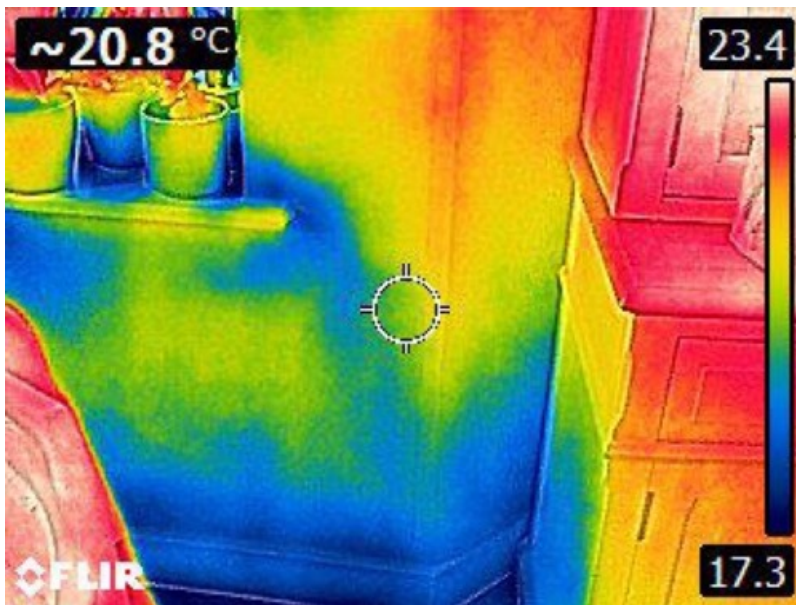
Cold bridging noted around the opening
and external floor lines

Detailed later in the report, ensure all floor
to wall junctions are suitably sealed/
foamed along to mitigate cold bridging and
draught ingress behind the dot and dab dry
lining

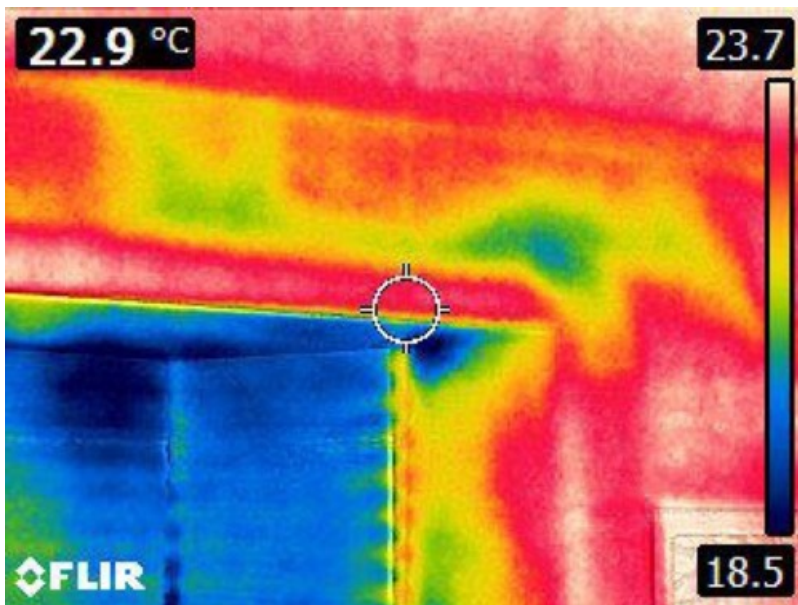
Cold bridging noted around the bay ceiling and opening reveals

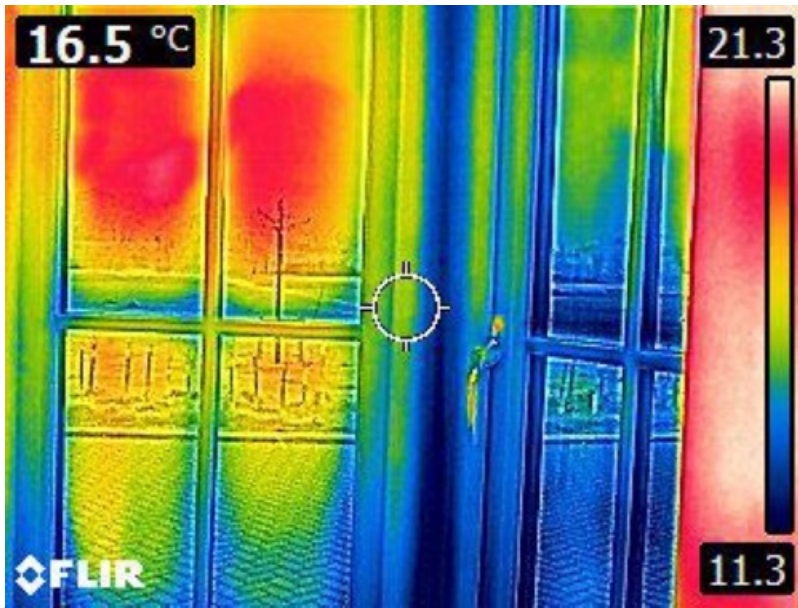
Cold bridging noted down the covered structural members of the opening, where assumed not suitably foam/ insulated

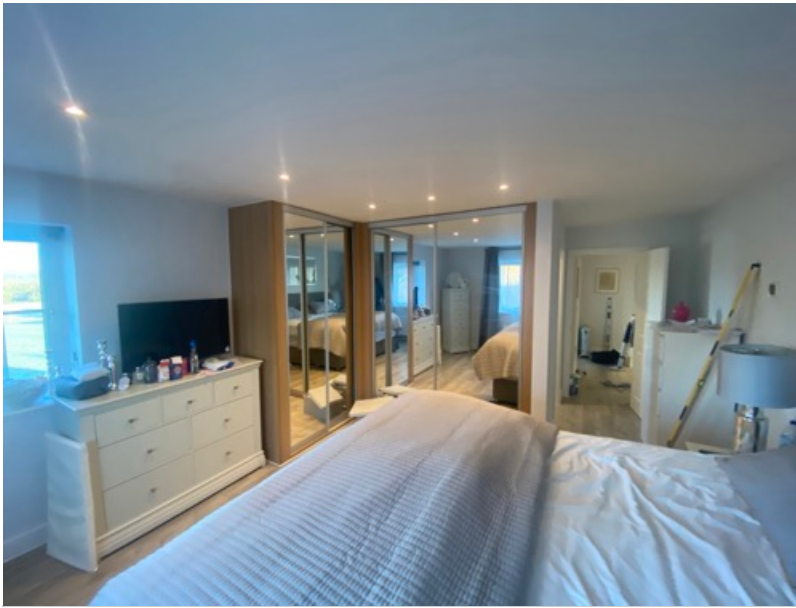
Shrinkages noted

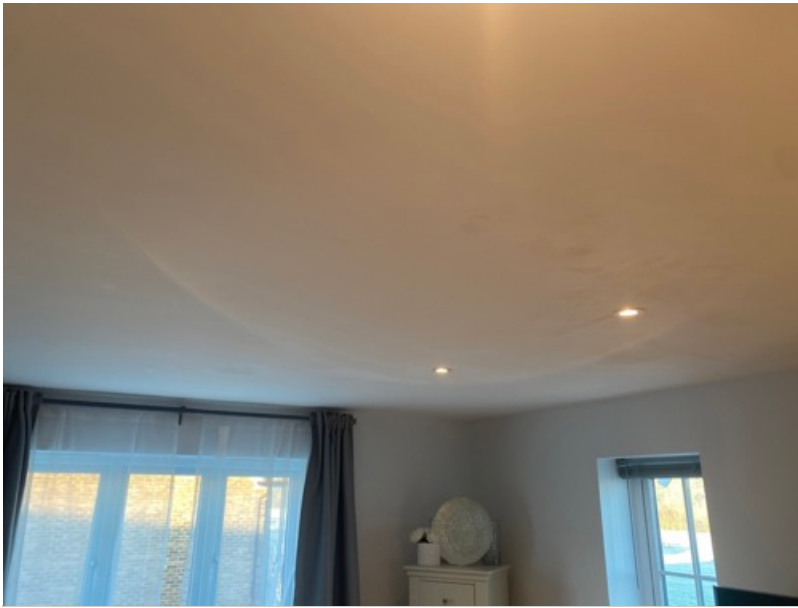
Shrinkages noted around ceiling line in wardrobe

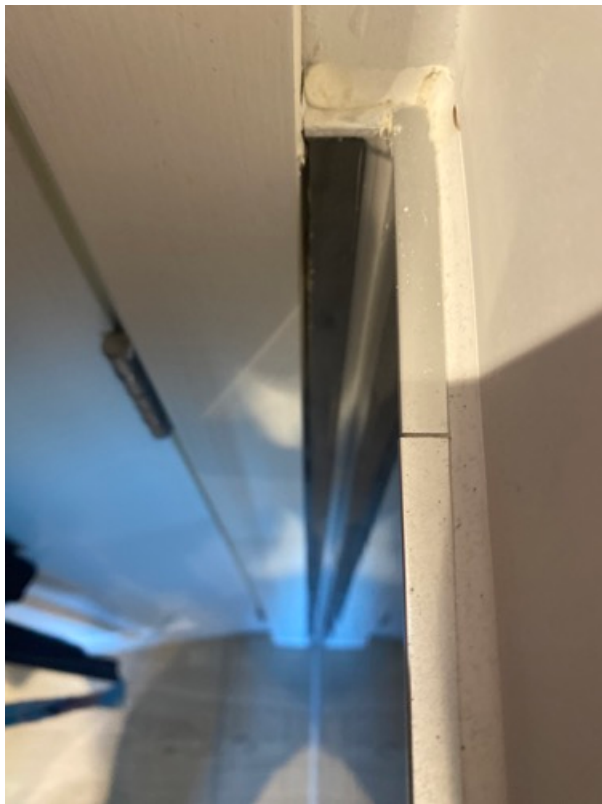
Nail pops

Shrinkages noted

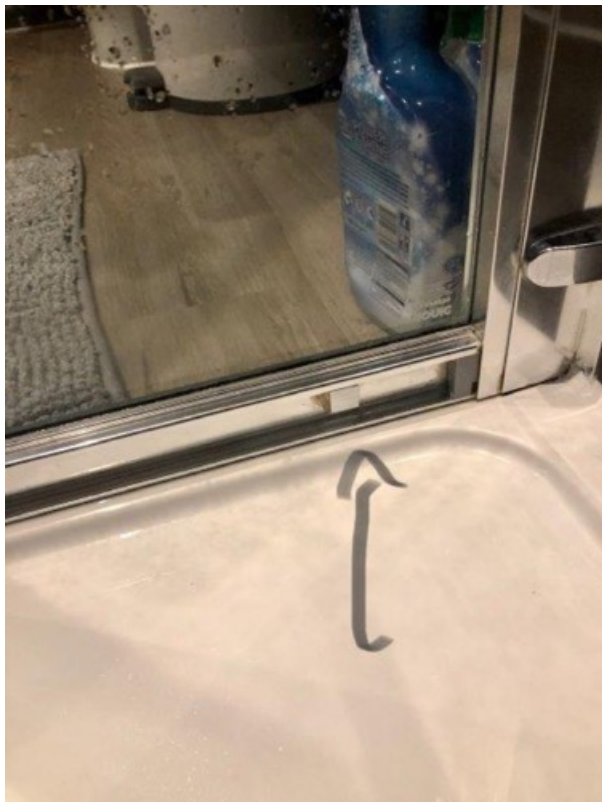
Shrinkages noted

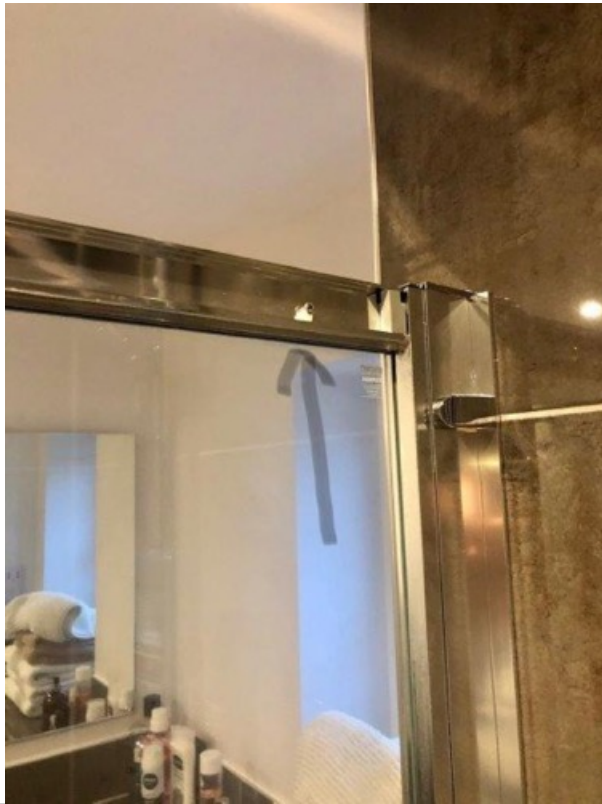
Stopper damaged

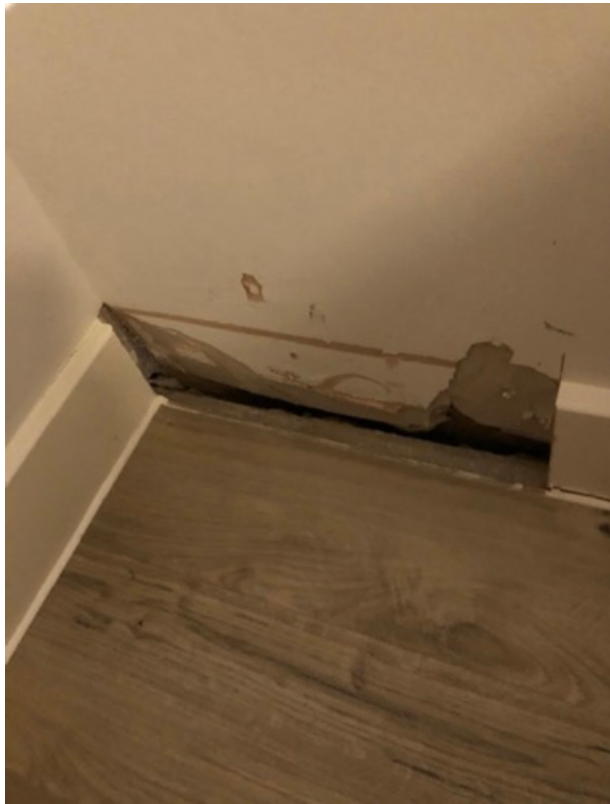
Gaps noted between flooring and external

walls, allowing air to freely flow between floors and behind dot and dabbed dry lining

- seal the gaps at the bottom of the walls. This could be done by removing the skirting boards and fully foaming the gap between the bottom of the plaster board and the wall.
- seal the gaps at the top of all the ground walls and those at the top of the first floor walls too

- On removing an upstairs skirting it will become immediately apparent that there are problems, draughts will be easy to feel and see, gaps can be observed sometimes right into the cavity, and fingers can be pushed into the gap between the plasterboard and the blockwork. Seal any gaps.
- Once the first floor skirting and a floor board have been removed there will now be relatively easy access to the top of the ground floor wall/ceiling junction, and it is a good opportunity to seal this and foam can be used this time.
- seal along skirting boards on the ground floor

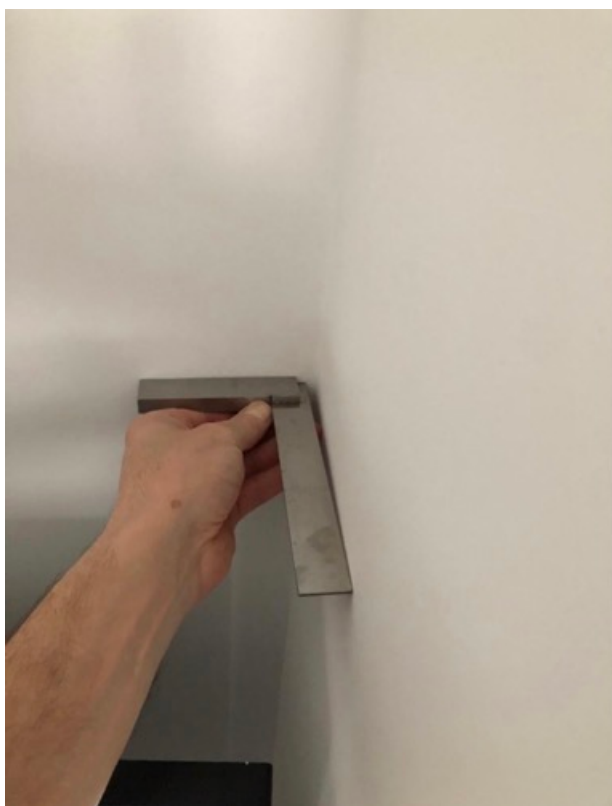
Returns not square

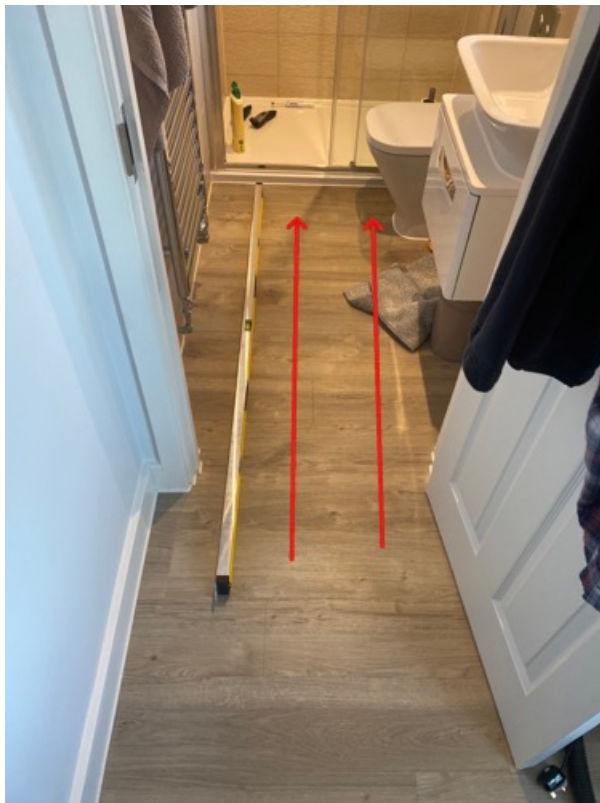
Change in floor level across the room spans

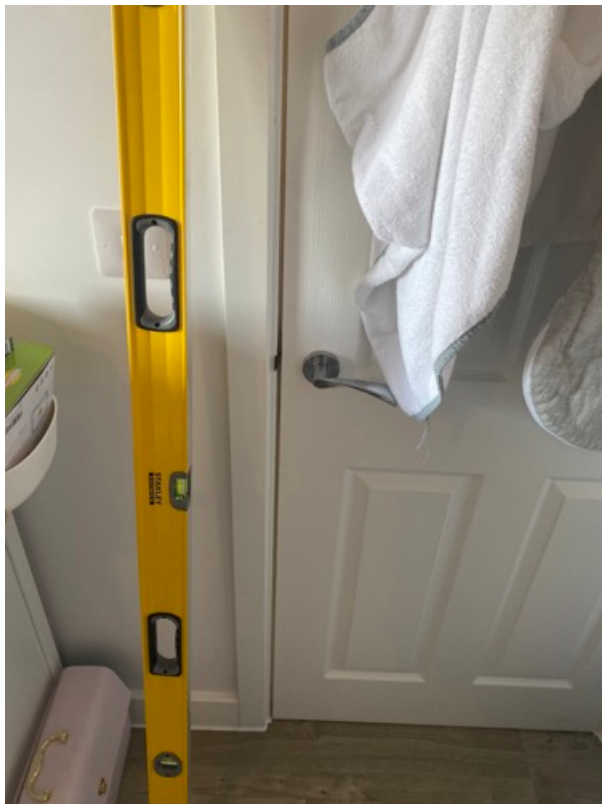
Frame damaged

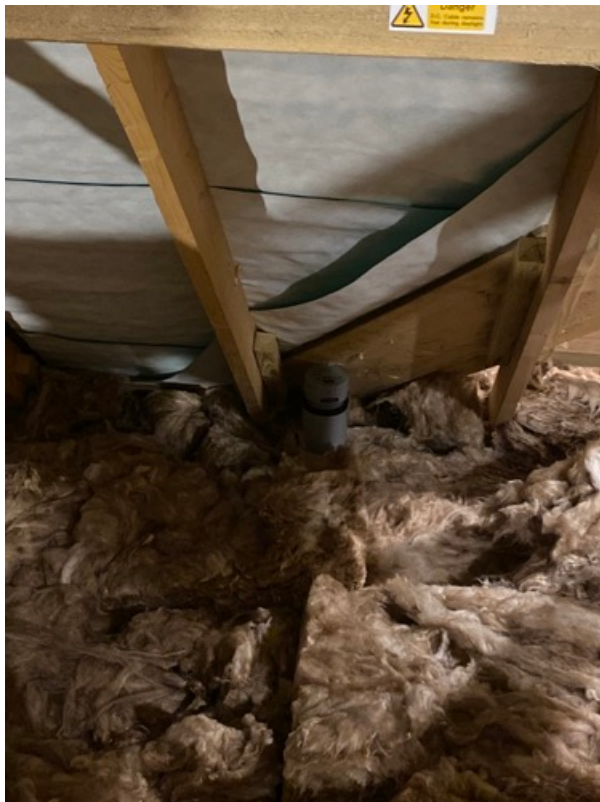
Shrinkages noted

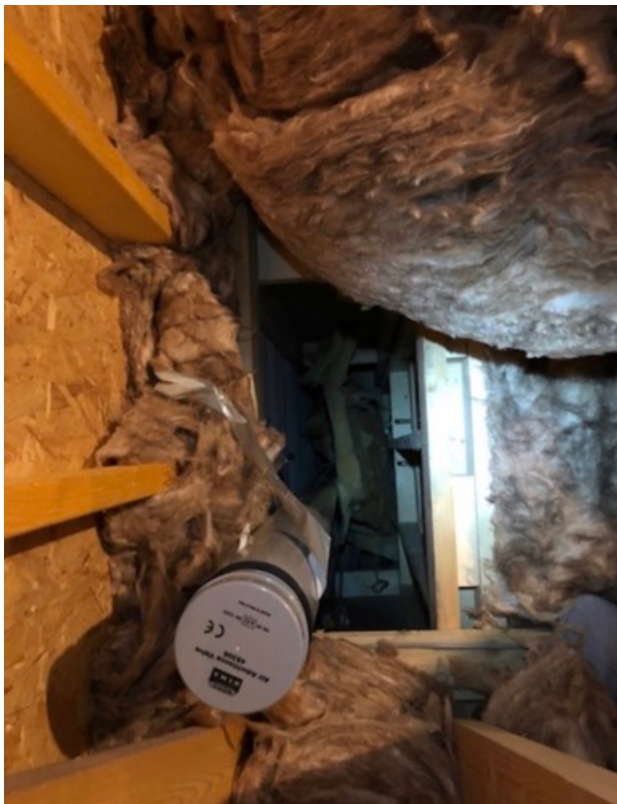
Example, boxing in not insulated over

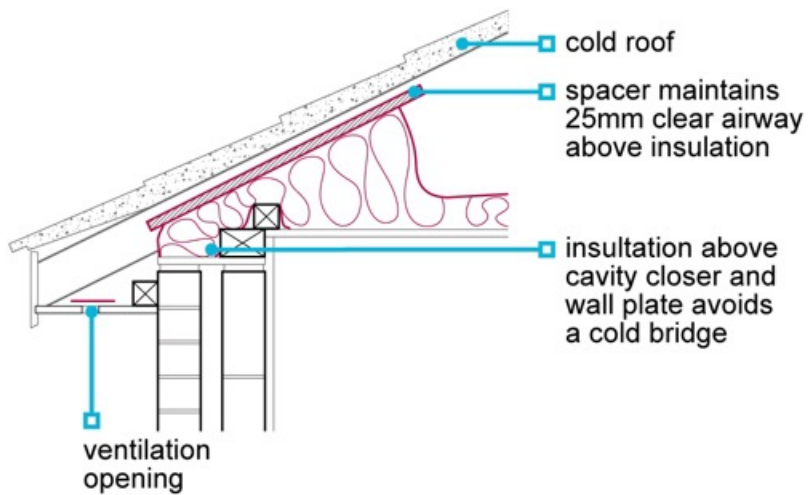
Ensure eaves ventilators in place. Some visible, others missing. Ensure a 25mm ventilation gap down to the eaves to ensure a constant flow of air and ventilation throughout, to mitigate condensation build up

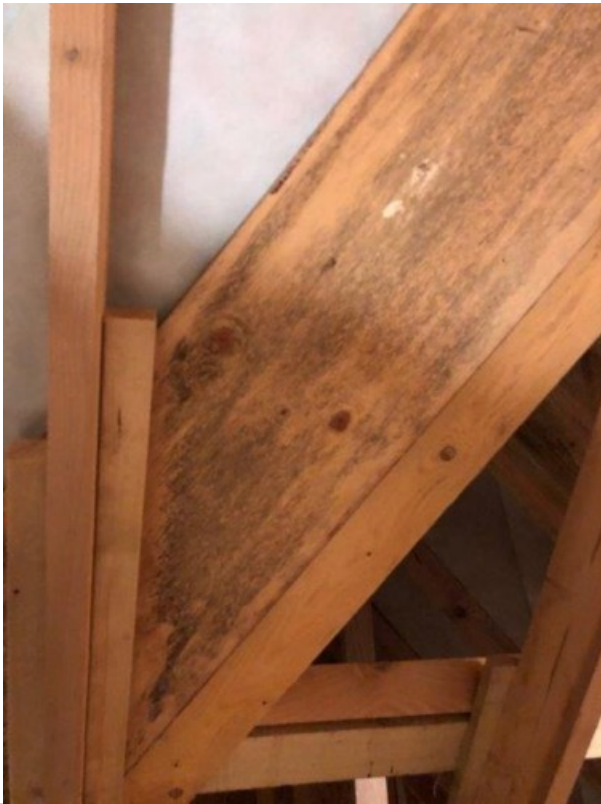
Condensation throughout, where eaves inadequately insulated. No visible gaps externally to allow for sufficient airflow, as later noted within this report

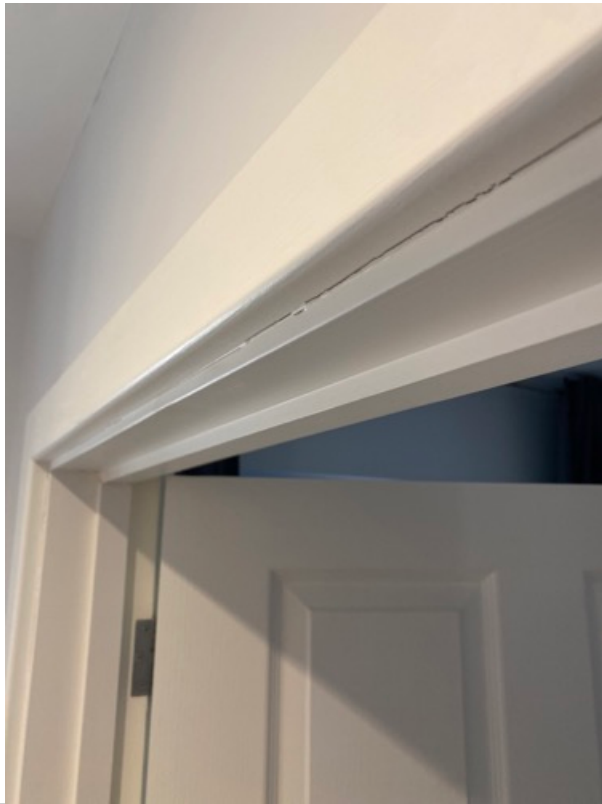
Timbers throughout have been
inadequately prepped prior to decorating

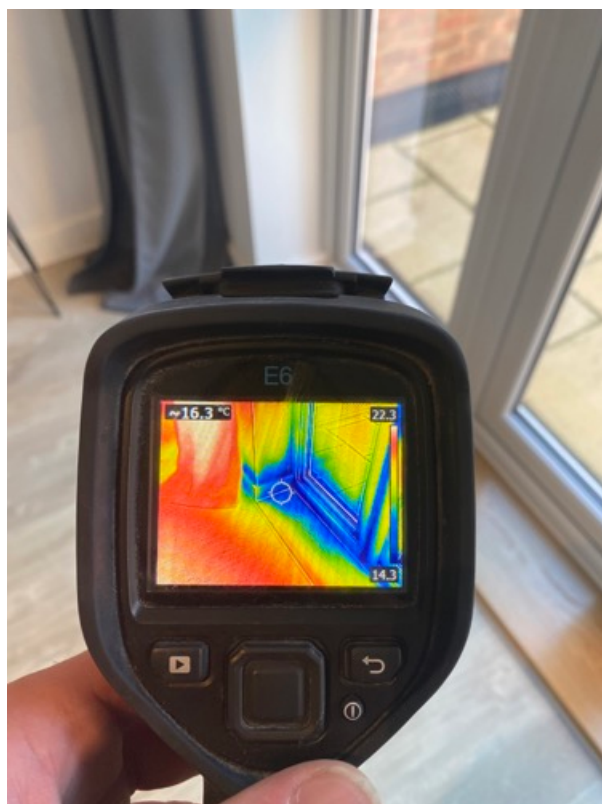
Cold bridging noted down the covered structural members of the opening, where assumed not suitably foam/ insulated - both sides

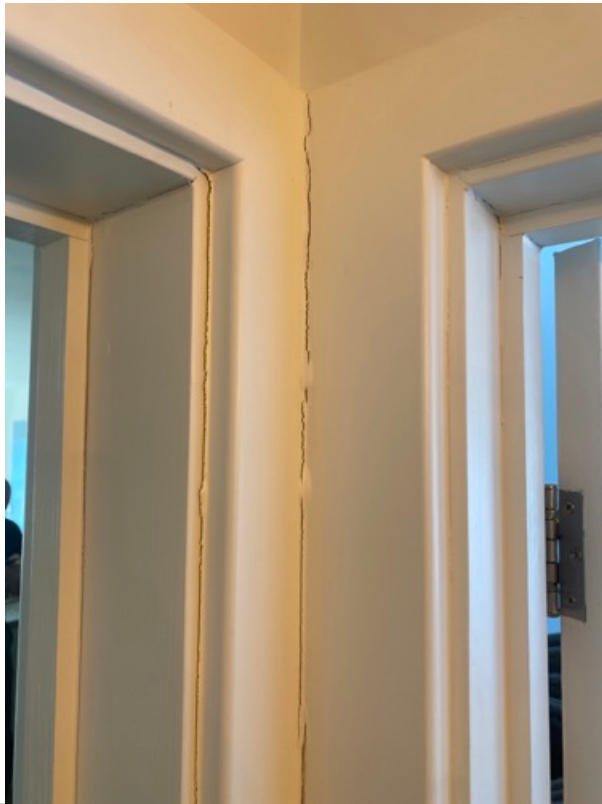
Timbers not suitably prepped prior to decoration

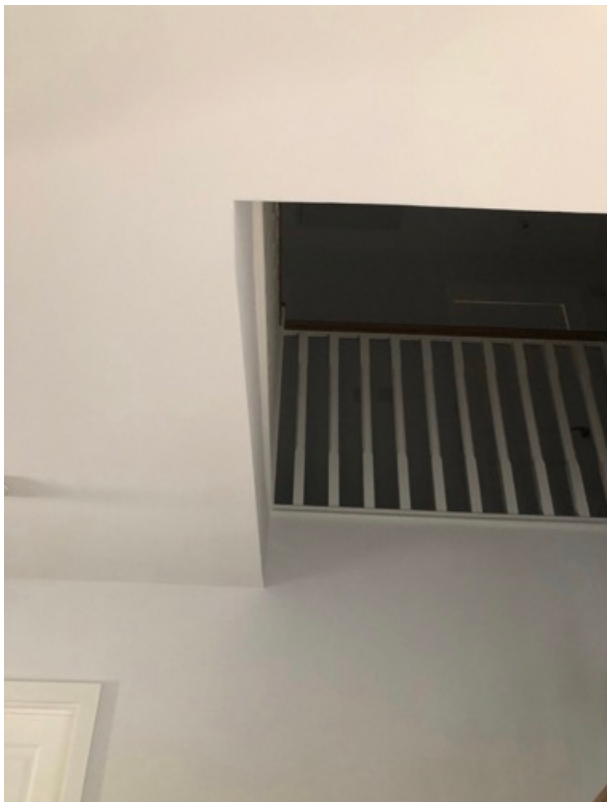
Paint patchwork

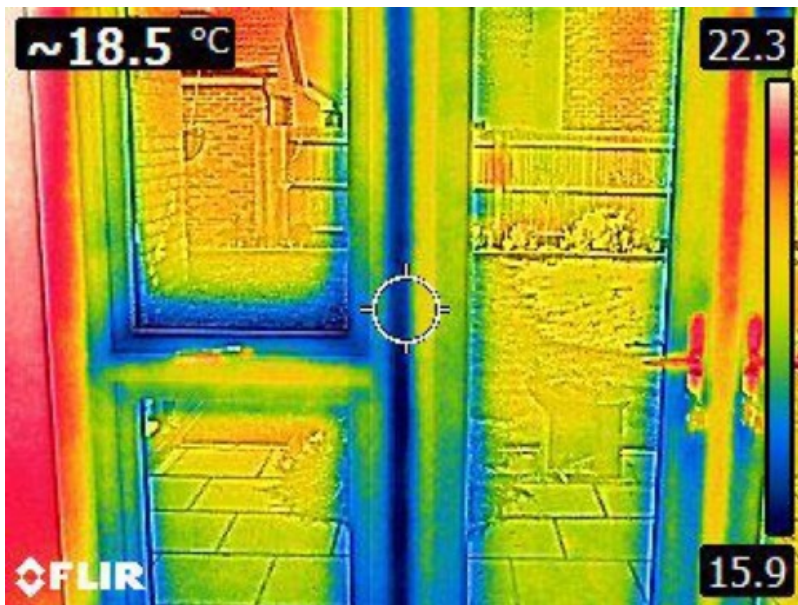
Cold bridging noted down the covered structural members of the opening, where assumed not suitably foam/ insulated

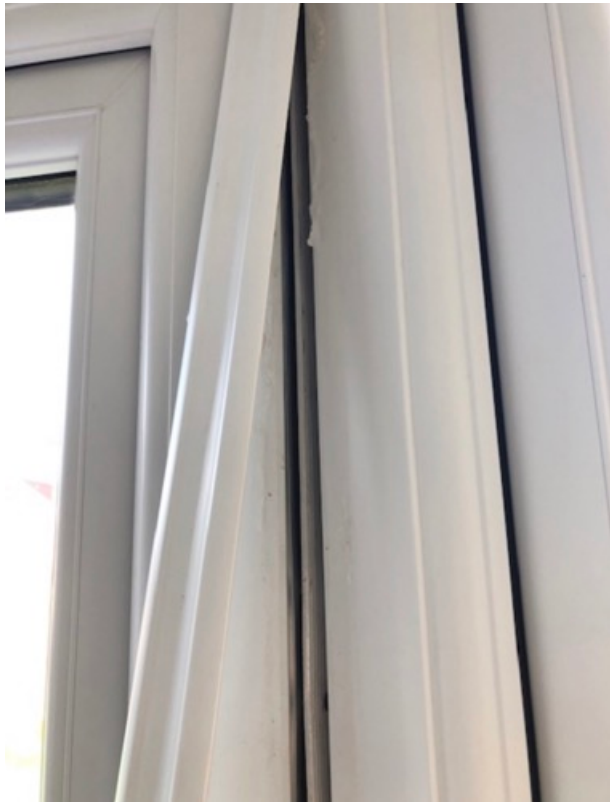
No visible insulation or suitable foaming around the windows structural members

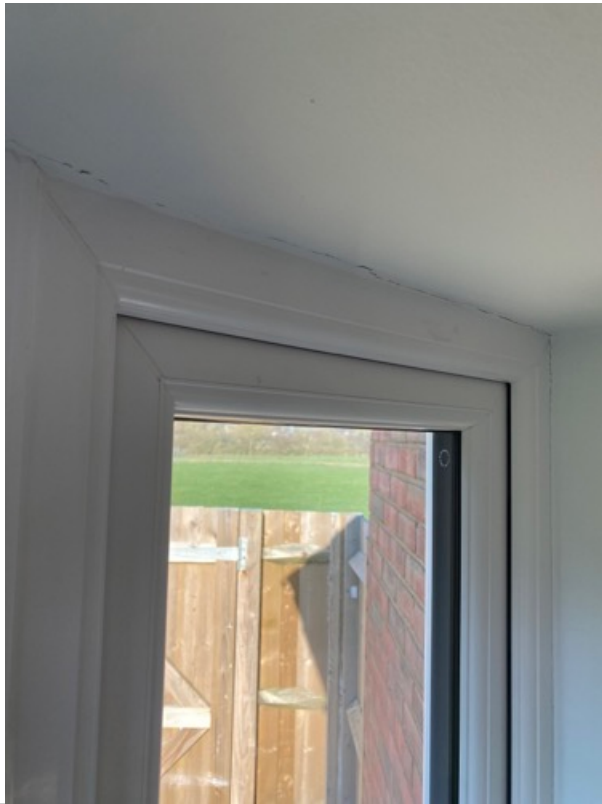
Generally / clips not secure

Clip missing

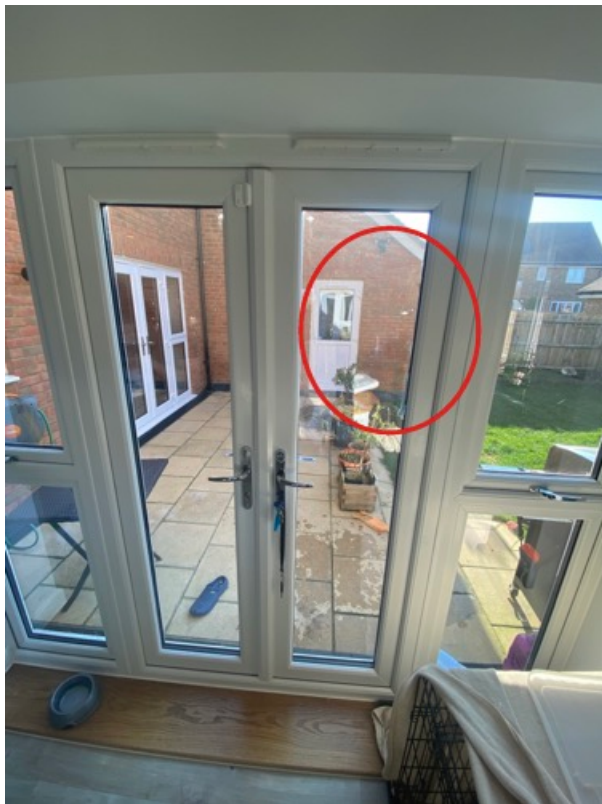
Make good shrinkages around openings

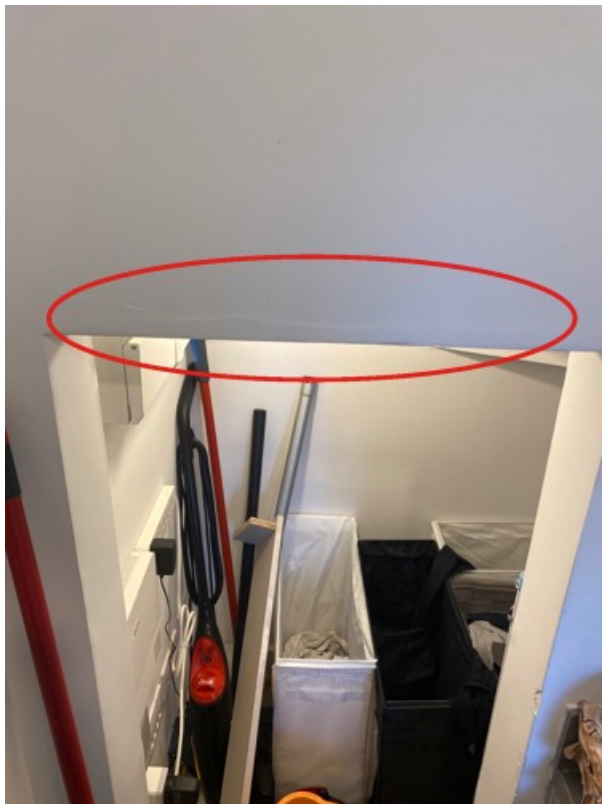
Shrinkages noted

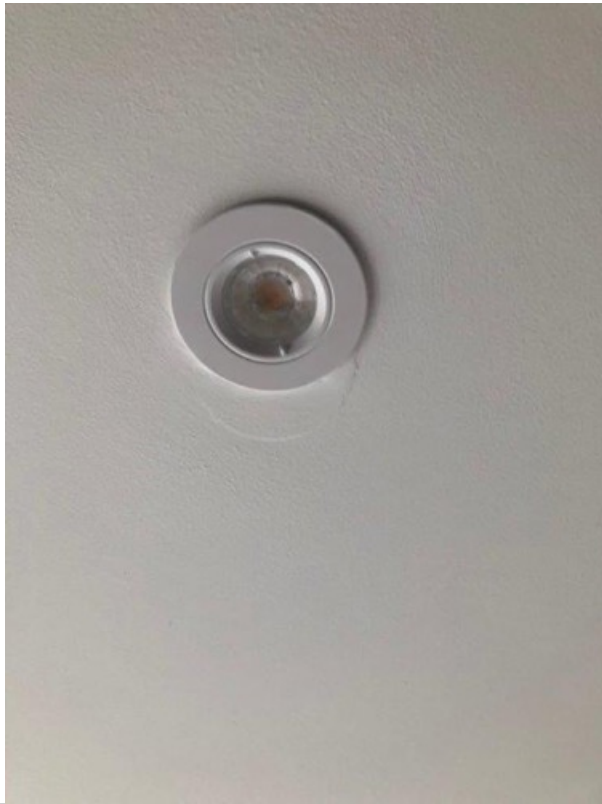
Previously repaired

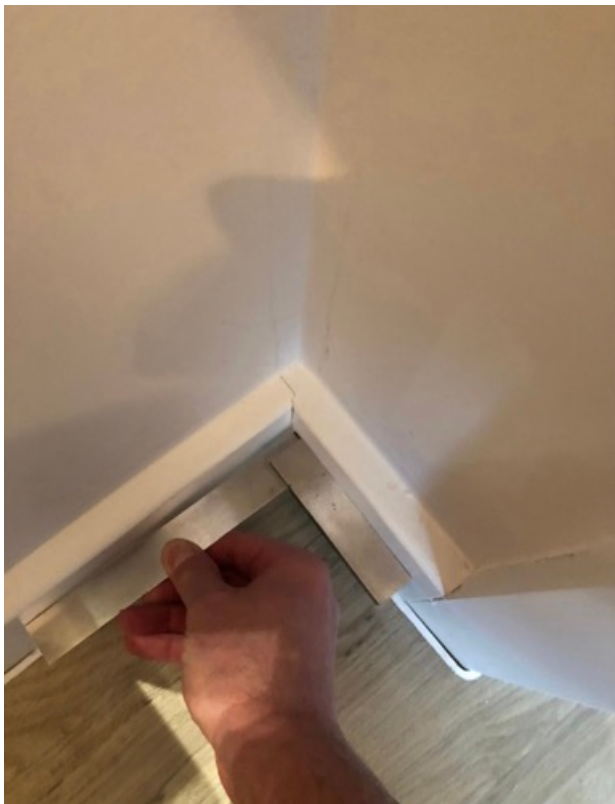
Previously repaired

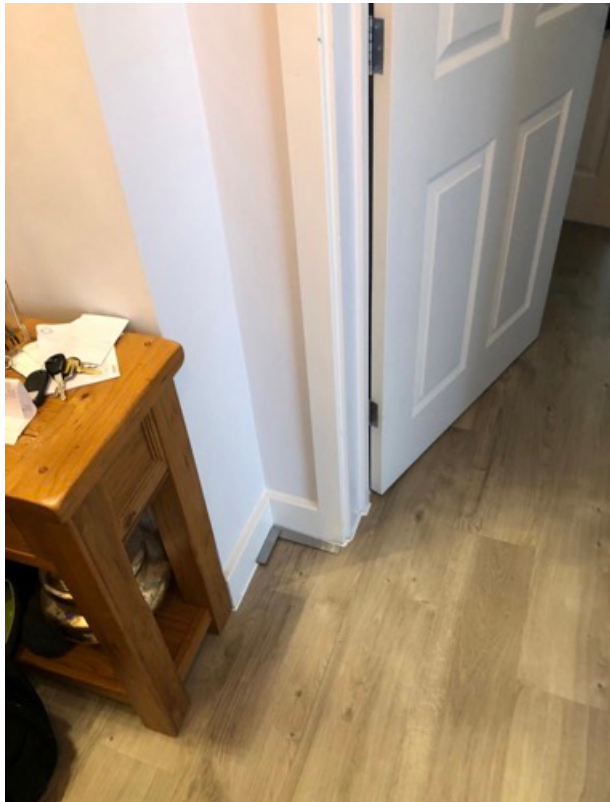
Return not square

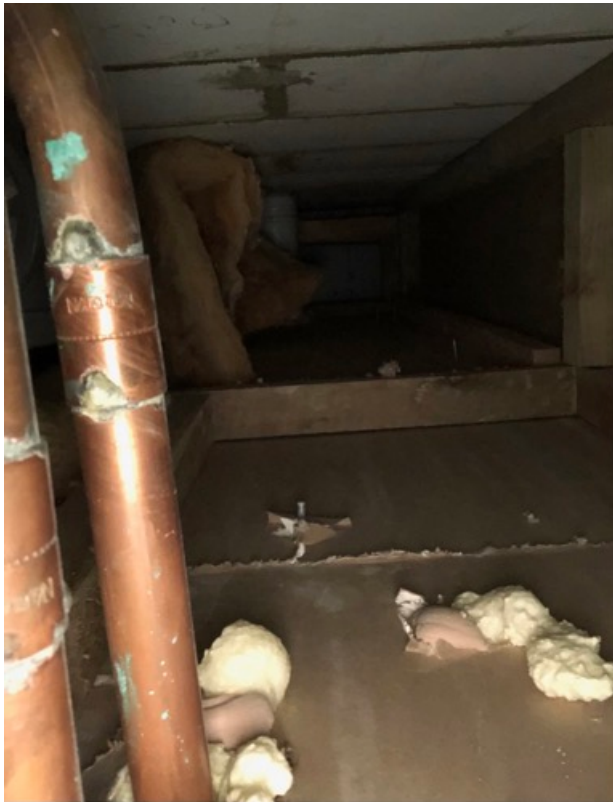
Seal around plumbing runs and external floorlines behind the washing machine to mitigate cold bridging

Complete dry lining

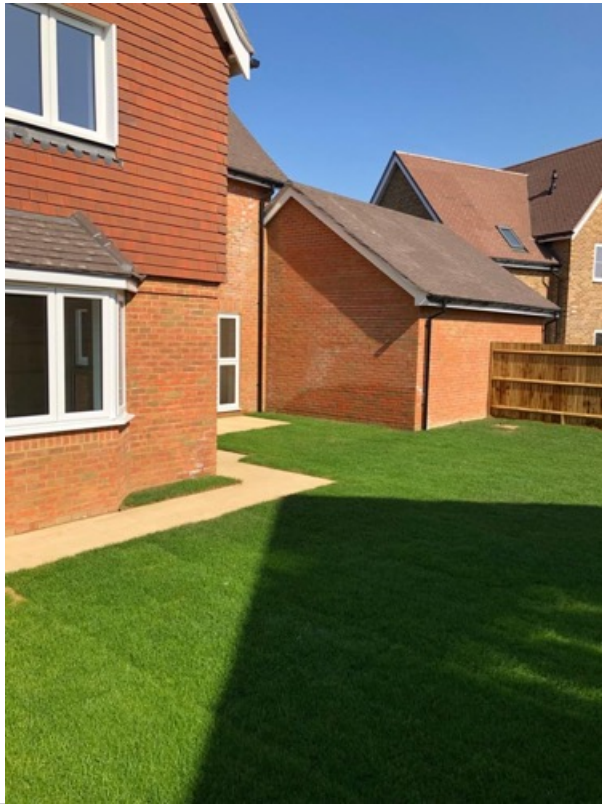
Garage external walls saturated, ensure any DPC hasn't been damaged, or guttering

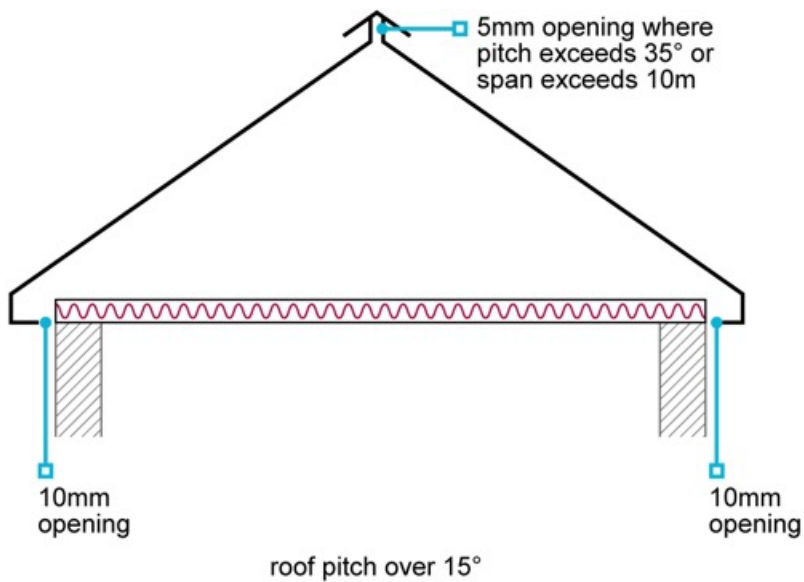
No clear ventilation points to the eaves, noted around the property. Air circulation in the Loftspace limited which has resulted in excessive moisture and condensation build up internally

- where the roof pitch is 15° or more, ventilation equivalent to a 10mm slot running the full length of the eaves should be provided
- where the ceiling follows the slope of a roof, regardless of pitch, or where a cold roof has a pitch less than 15°, ventilation equivalent to a 25mm slot running the full length of the eaves should be provided (a nominal clearance of 50mm should be maintained between the insulation and the roof underlay)
- for mono-pitched roofs, cross ventilation should be in accordance with BS 5250 and have ventilation equivalent of a continuous high-level 5mm slot, in addition to eaves ventilation.

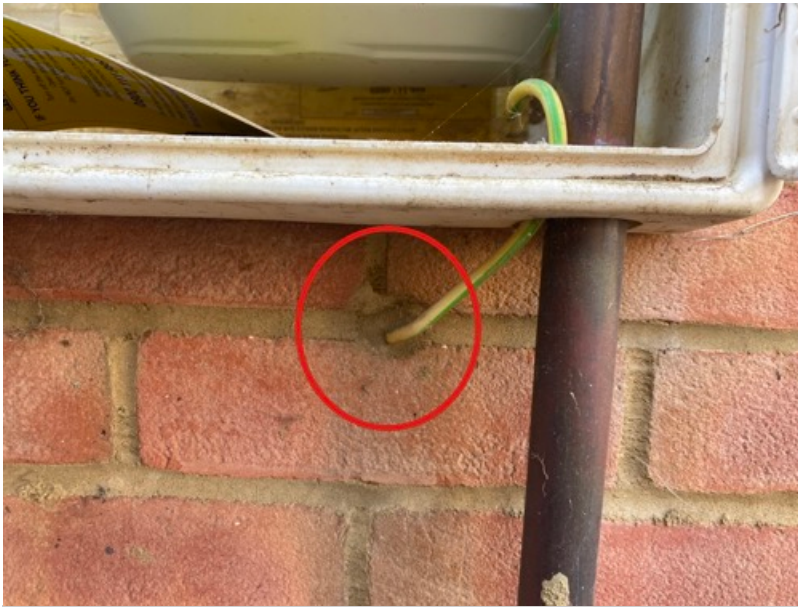
Brick loose

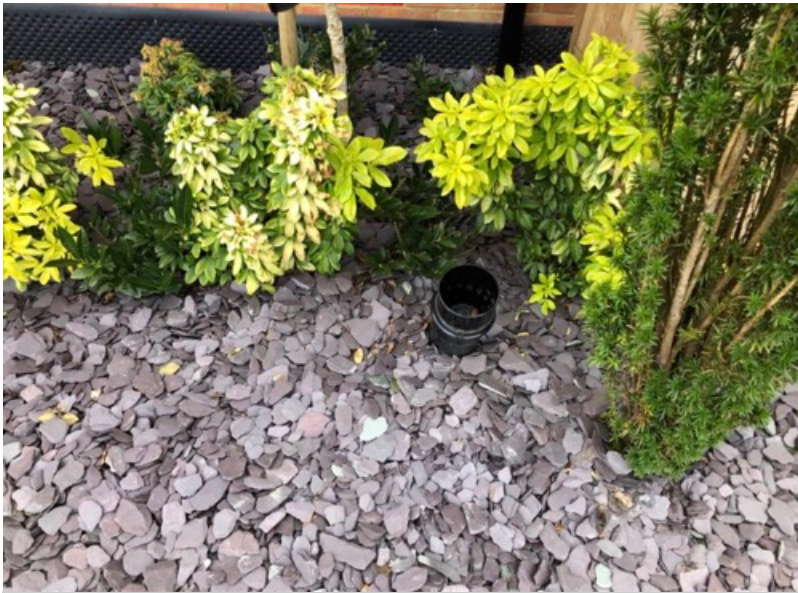
Wall saturated, ensure DPC in tact

When garden was done, treated water found under the house - to avoid potential damage, drainage pipes were installed with access, to drain treated water - NHBC claim 20 / 21705
