# Example Thermal Survey

## Overview

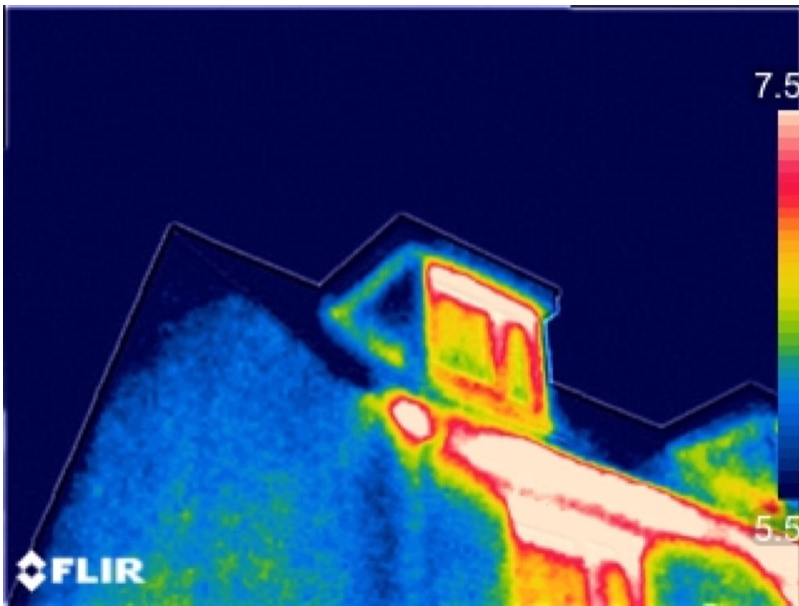
Exterior front

Heat from the windows is warming the soffit.

This could suggest the insulation is missing above the windows. Given the insulation fill is poor in other areas, recommend the insulation above the upper windows is investigated

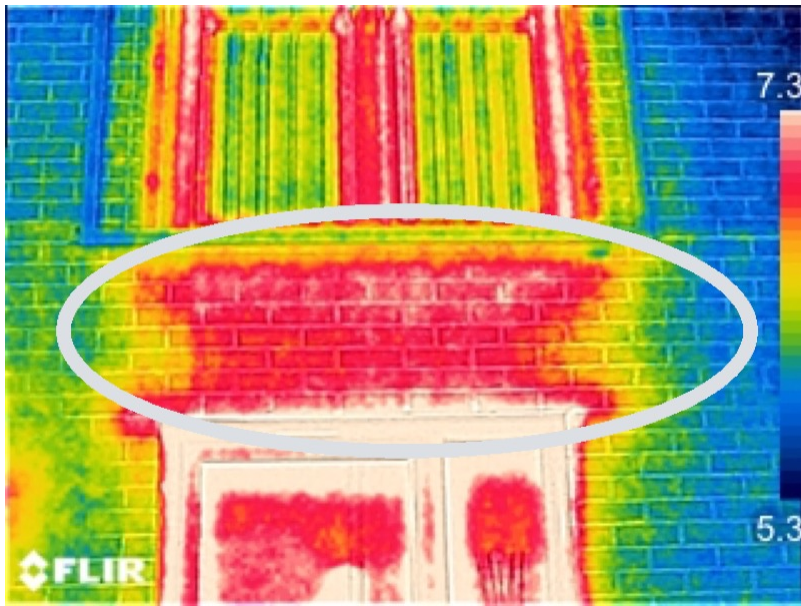
### Exterior front

There is a large heat anomaly on the wall between the Study and Master Bedroom window.

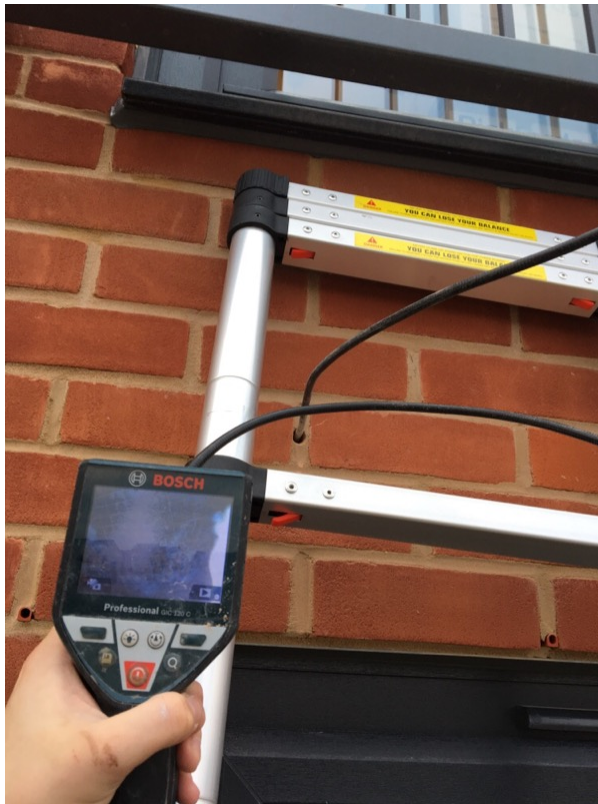
### Exterior front

Borescope check above the Study window showed insulation was missing.

Since the insulation is missing here it is recommended the developer does a full investigation in to the quality of the blown fibre insulation installation

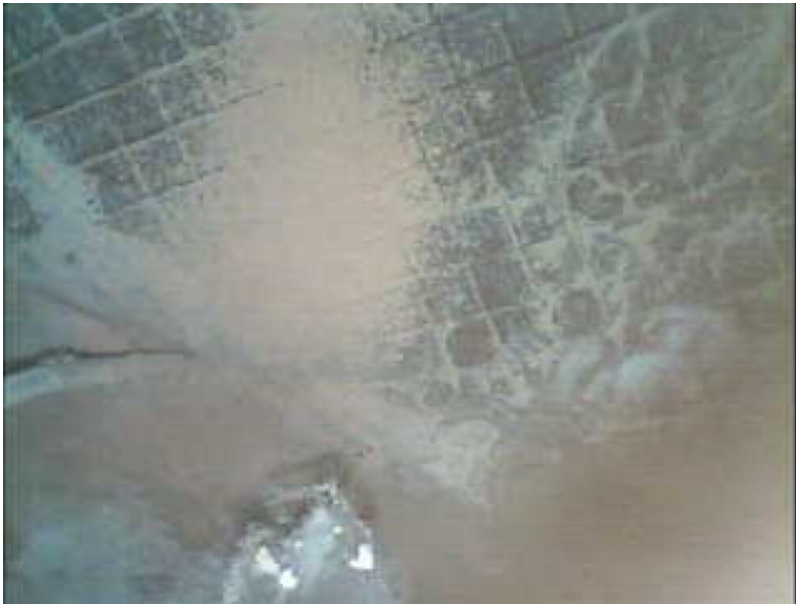
### Exterior front

As above, detail. Insulation is missing above the study window, below the Juliet balcony

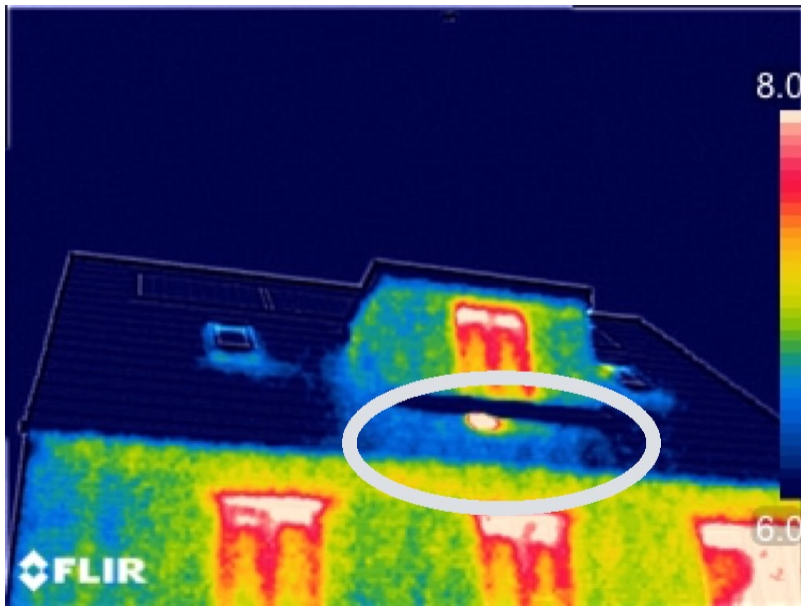
### Exterior back

Excess heat loss below the rear dormer. Corresponds with the internal photo which suggest the loft insulation is poor is missing here

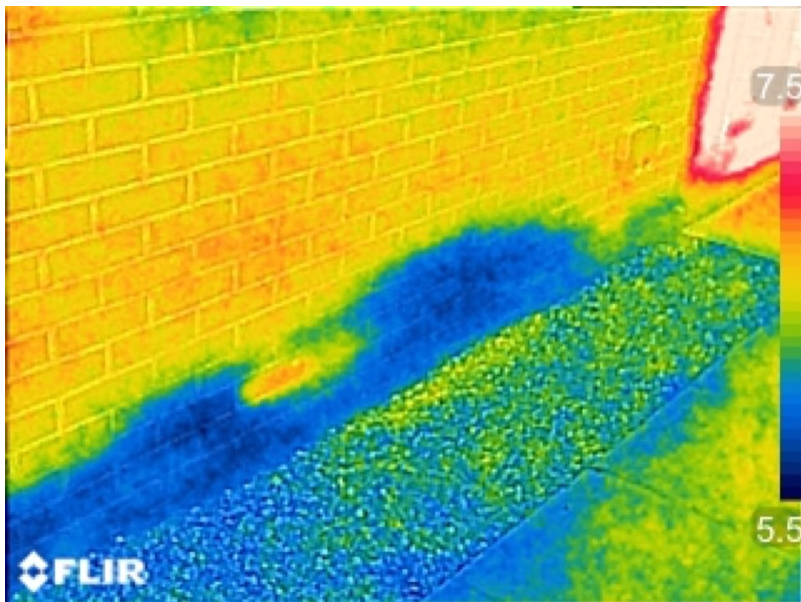
### Exterior back

Moisture on the rear elevation goes above the damp proof membrane, could suggest the damp proof membrane is not continuous here or compromised

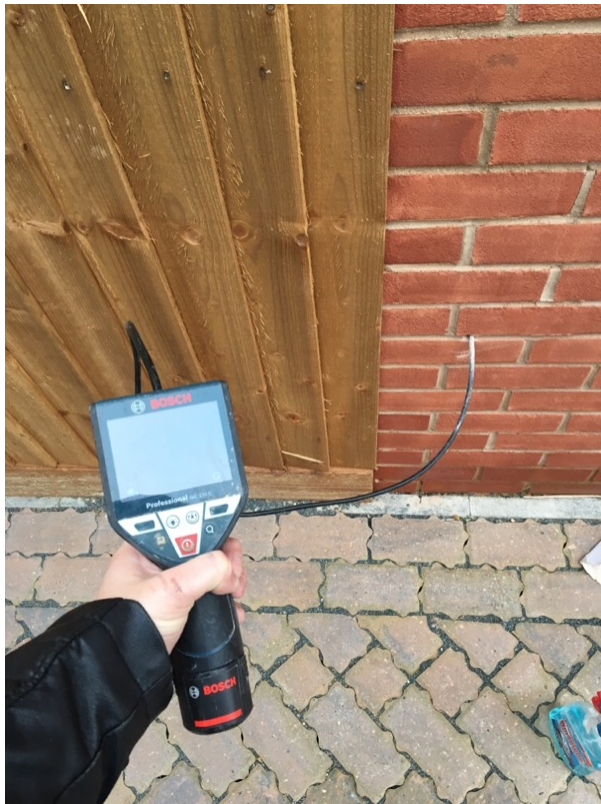
Exterior left

Poor Insulation fill at the rear left corner

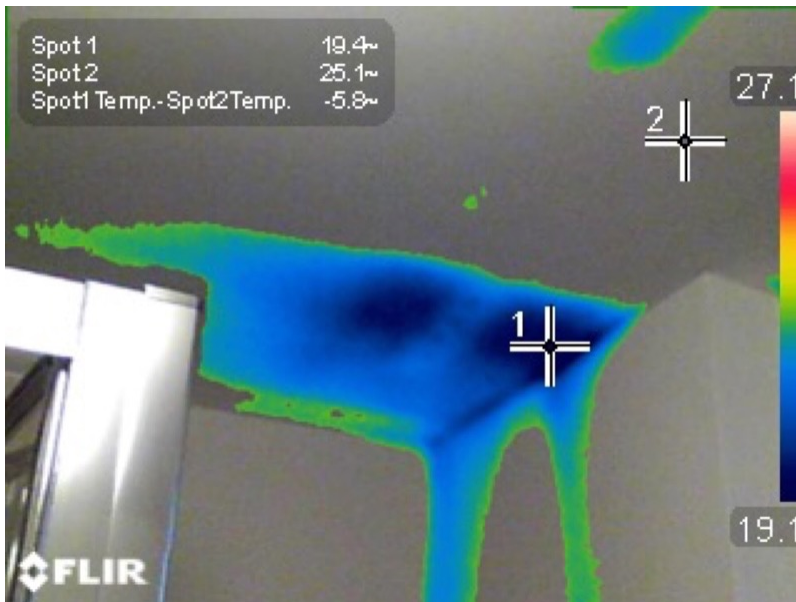
### Top floor bathroom

There are significant heat loss anomalies on the ceiling in the shower room. Some patches are 6 degrees colder than others. There is likely missing insulation or air circulation below the insulation in these areas

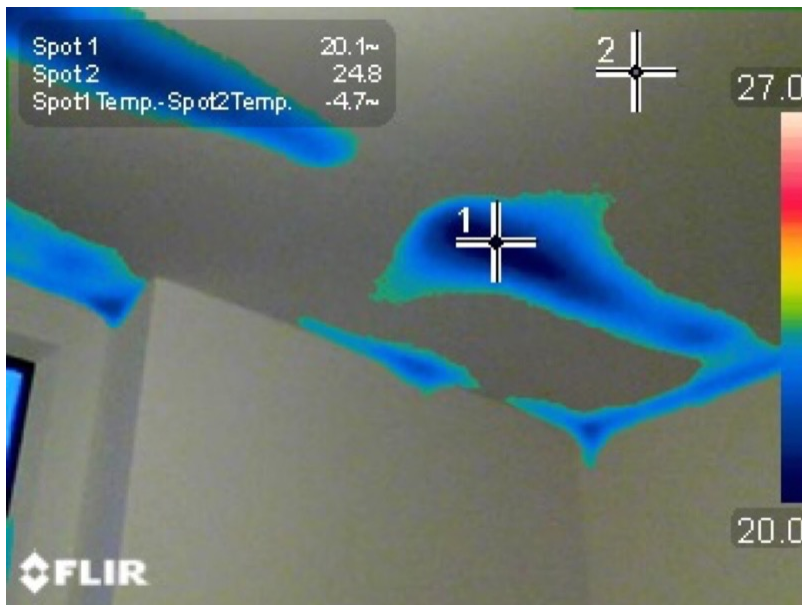
### Top floor bathroom

As above example

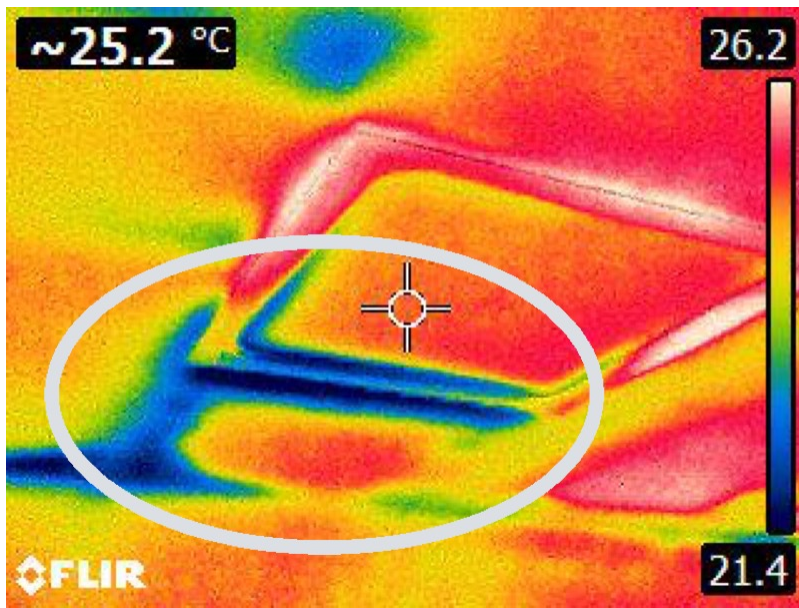
### Bedroom 5

Excess heat loss around the loft hatch. The loft hatch needs replacing with a fire rated loft hatch

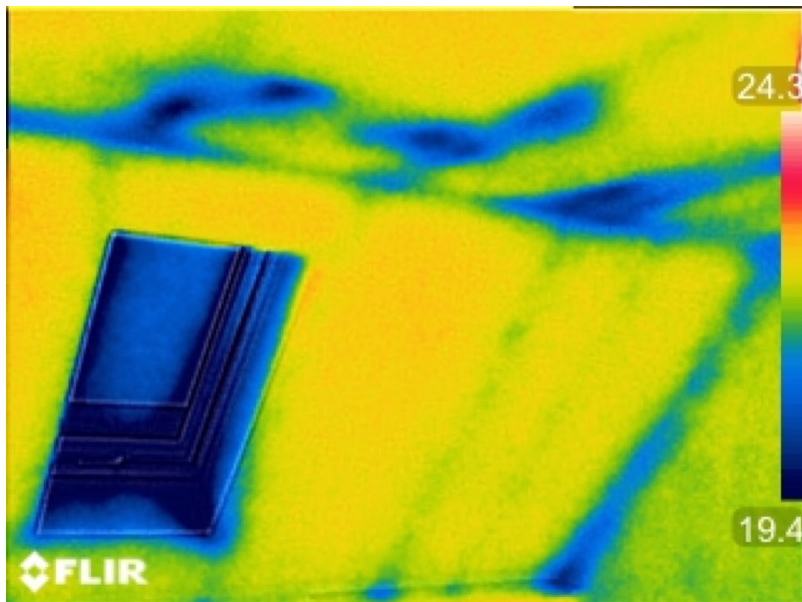
#### Bedroom 4

As above

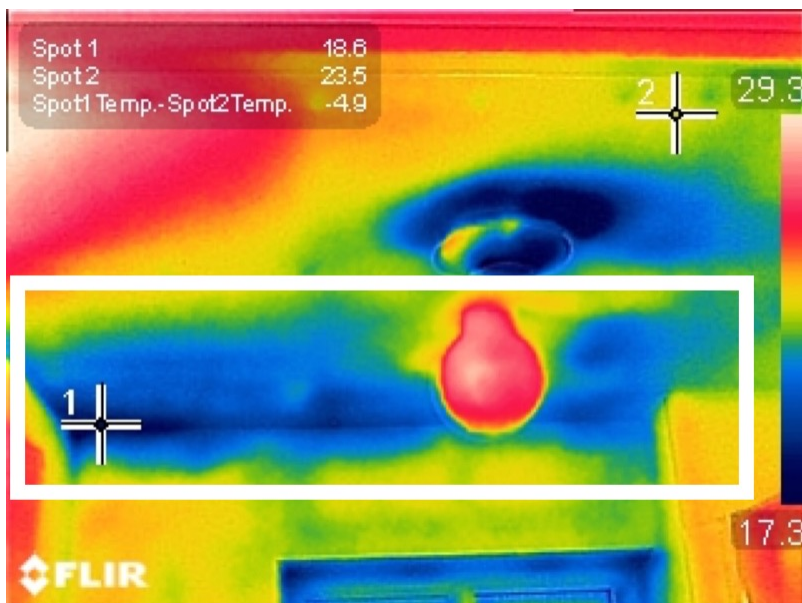
### Bathroom

The insulation appears to be poor  
above the bathroom in the area near  
the eaves. Area is inaccessible as it is  
behind the shower room dormer

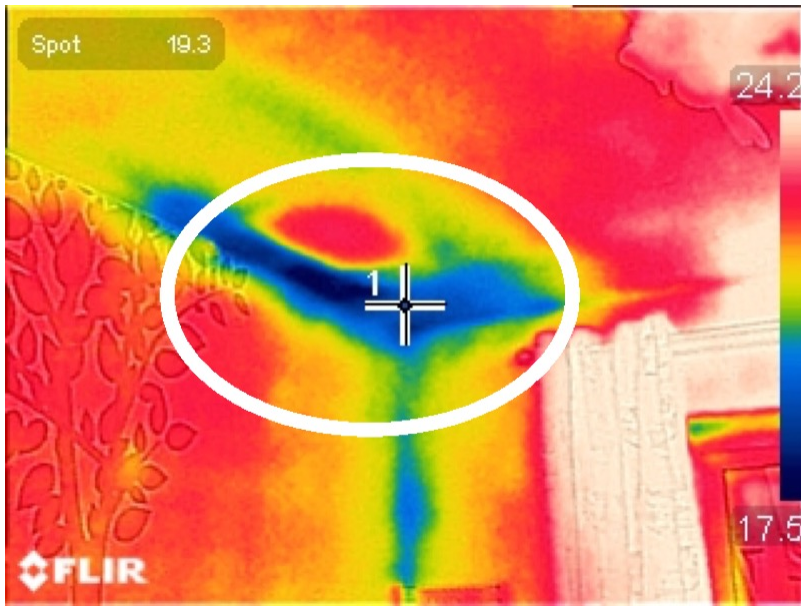
### Bedroom 2

Excess heat loss above bedroom 2 suggests poor insulation behind the stud wall in the corner left of the velux in bedroom 5

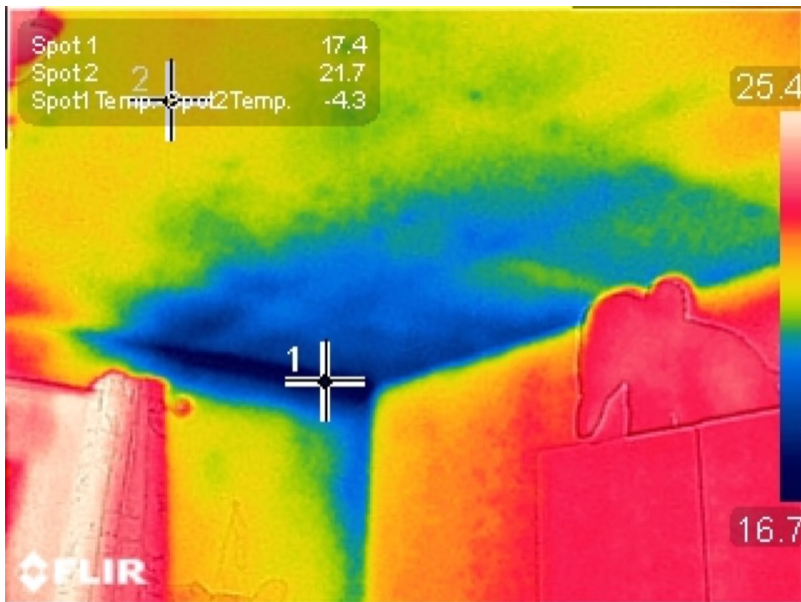
### Bedroom 2

The ceiling above bedroom 2 supports that the insulation is missing or very poor at the eaves void behind the shower room dormer

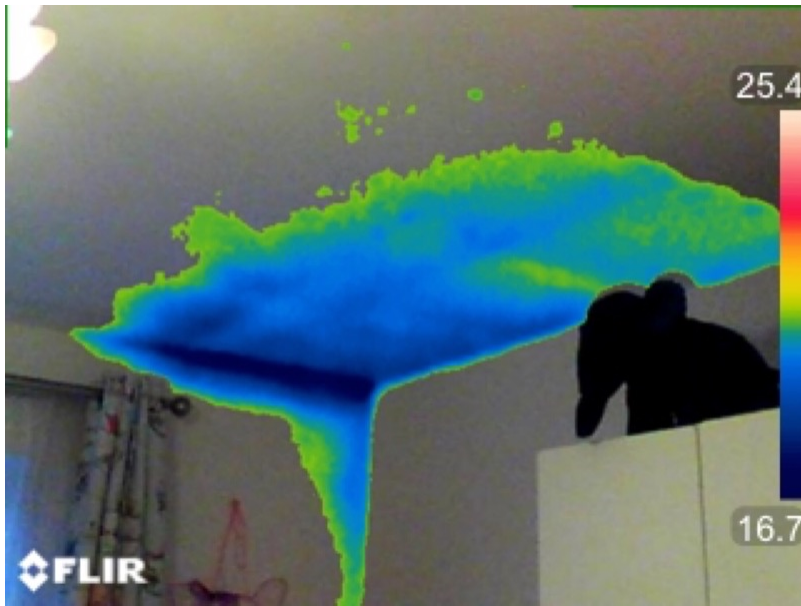
### Bedroom 2

As above, location

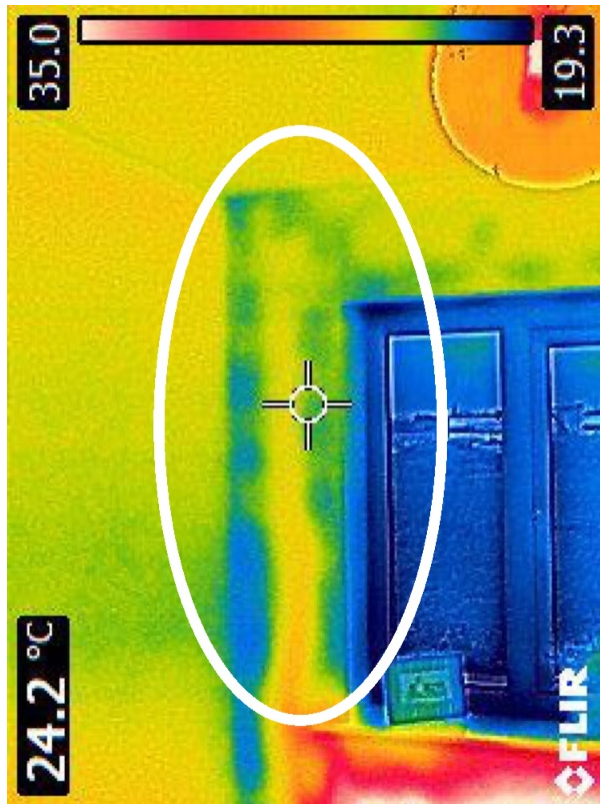
### Bedroom 3

The external perimeter of the plasterboard does not appear to be well sealed in bedroom 3, heat is escaping up behind the plasterboard in to the eaves void

- Foam fill all penetrations/ gaps before drylining
- Stagger ceiling boards and over door openings to minimise future cracking
- Mark continuous ribbon of adhesive to be applied around all openings, along the top and bottom and at internal and external corners of walls, and over service chasers

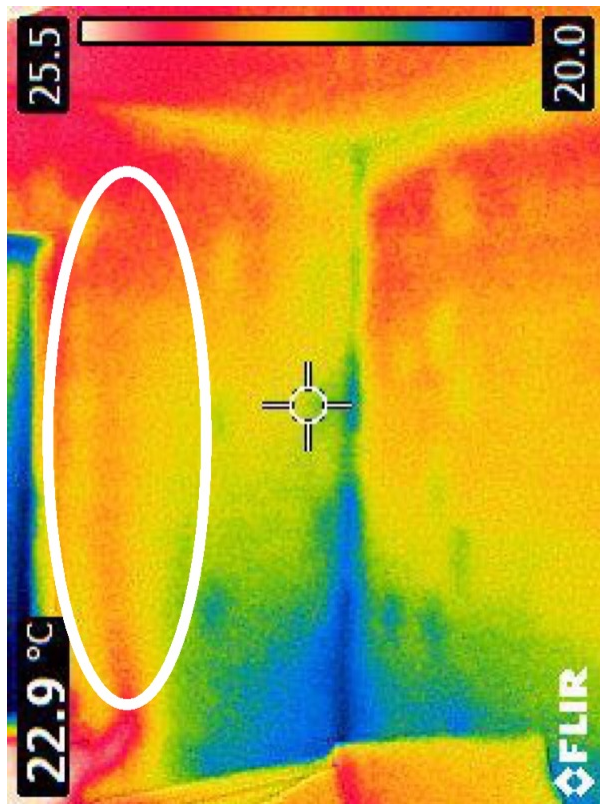
### Bedroom 3

As above

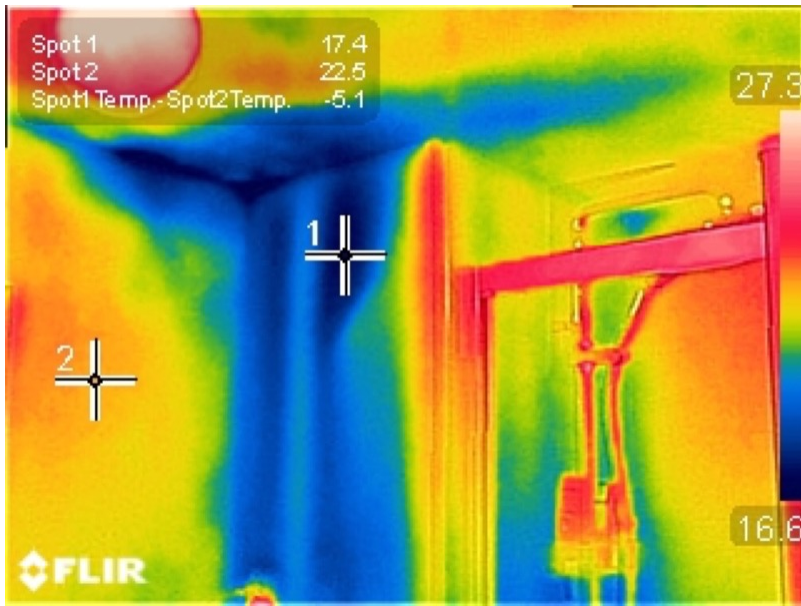
### En suite

Insulation appears to be missing from the void behind the shower causing significant heat loss, insulation is missing above. The gap in the thermal envelope will be heat out of the room via the thermal stack effect

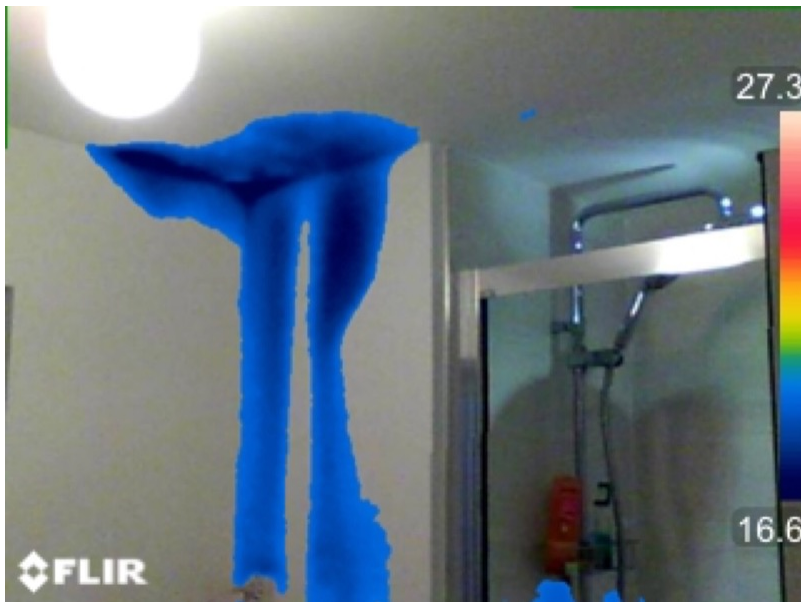
### En suite

As above location

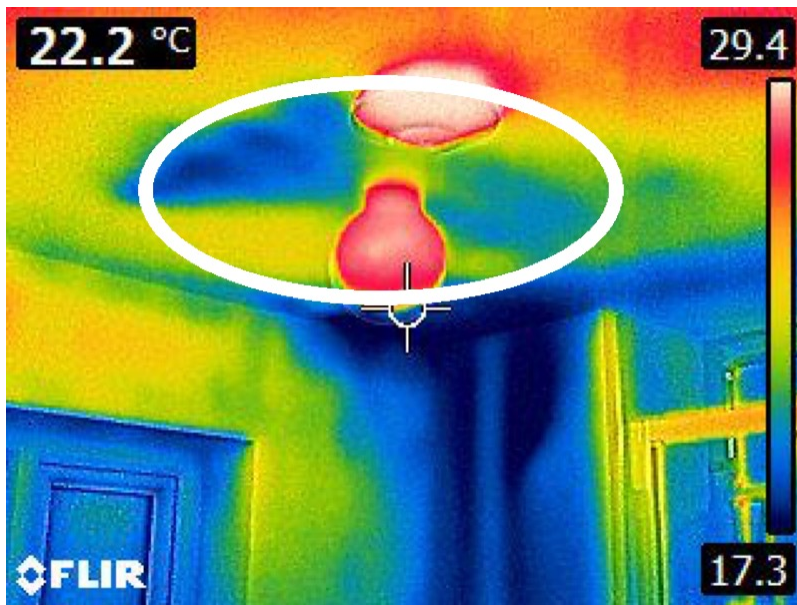
### En suite

Insulation missing in places in the eaves void above the en suite

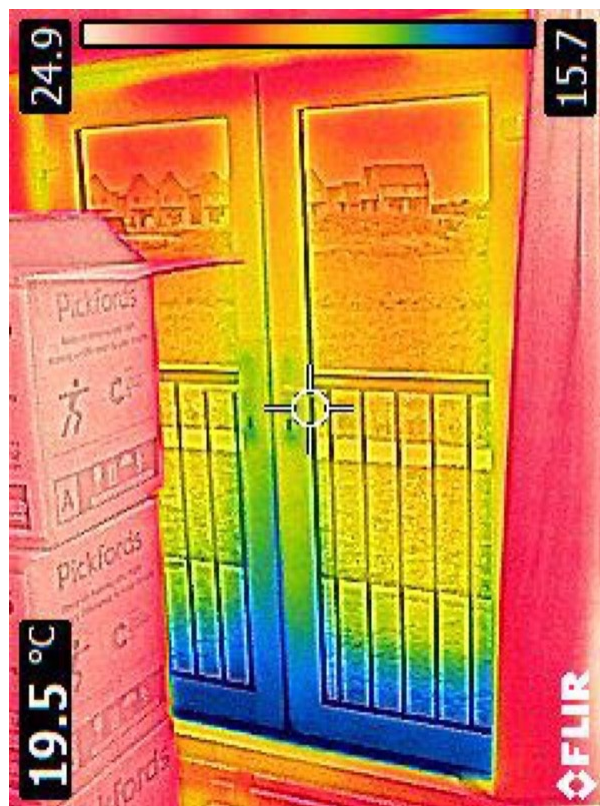
### Master Bedroom

Slightly elevated heat loss below the Juliet balcony doors

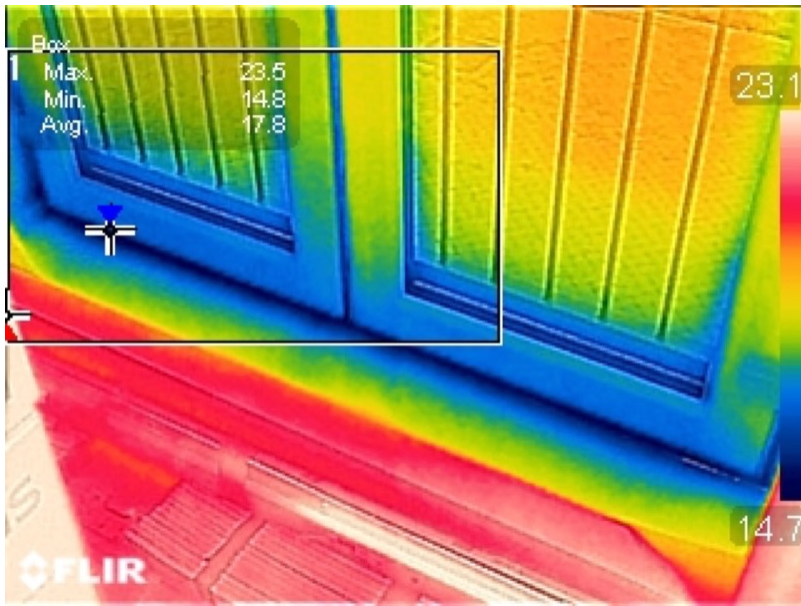
## Master Bedroom

As above, detail

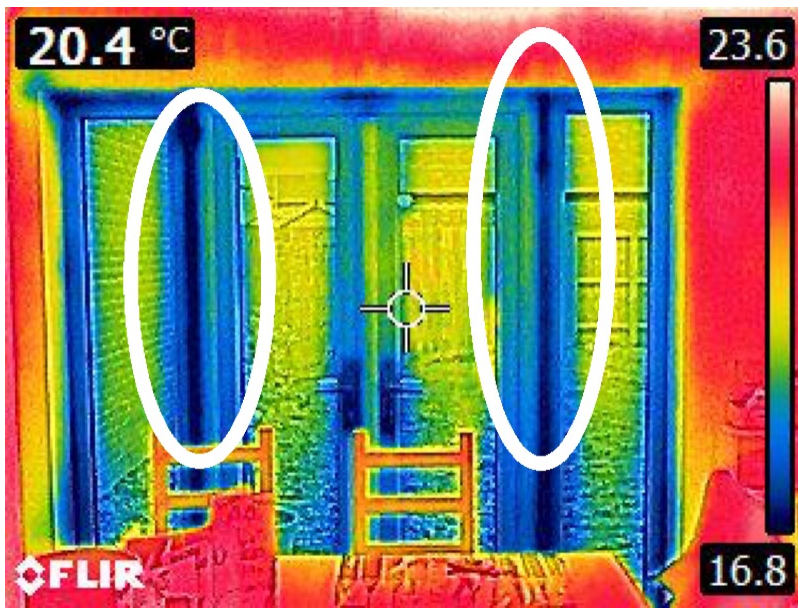
### Kitchen

Excess heat loss at the vertical joints in the patio door frame. Expanding foam likely to be missing from the joints

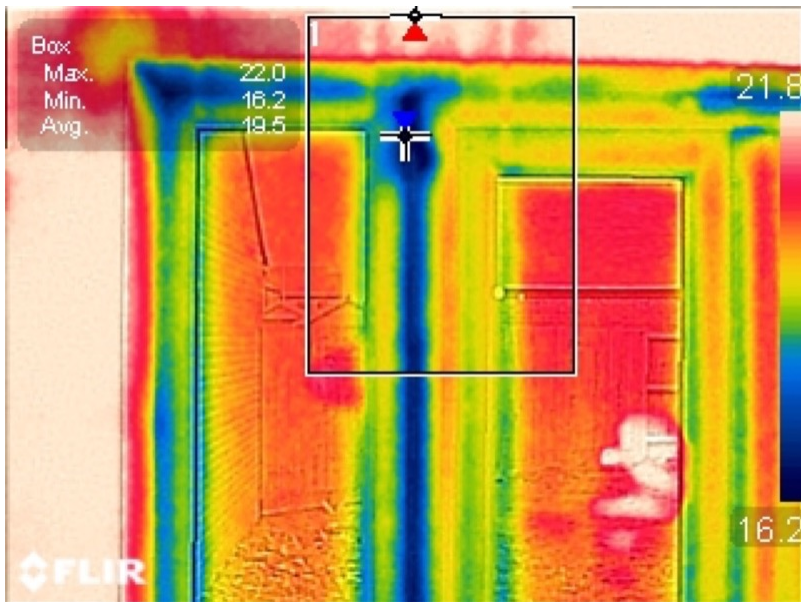
### Kitchen

As above, detail

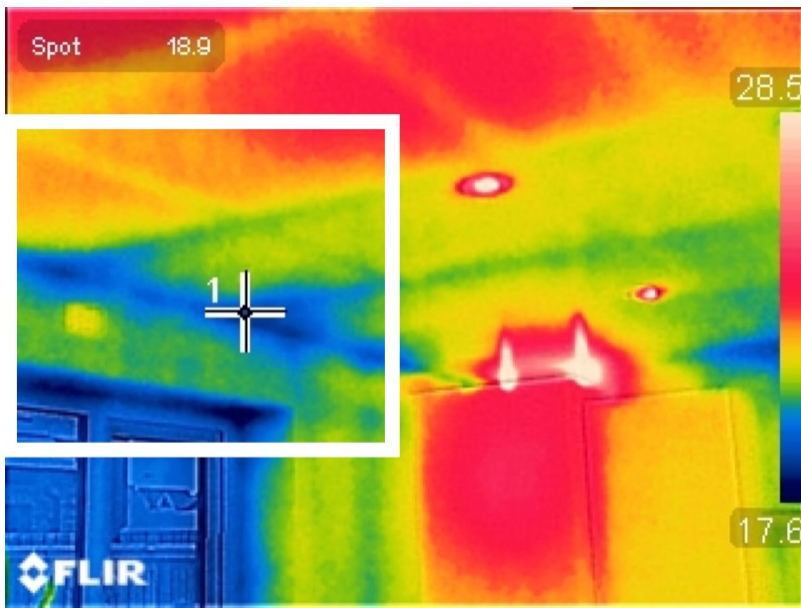
## Kitchen

Elevated heat loss where the joists are hung above the Kitchen window. Area is about 2.5 degrees colder than the rest of the ceiling

- Joists on hangers will reduce air leakage and heat loss
- Fully seal hangers with plaster to retain airtightness
- If joists need to be built in, then end caps should be used and sealed using propriety sealant

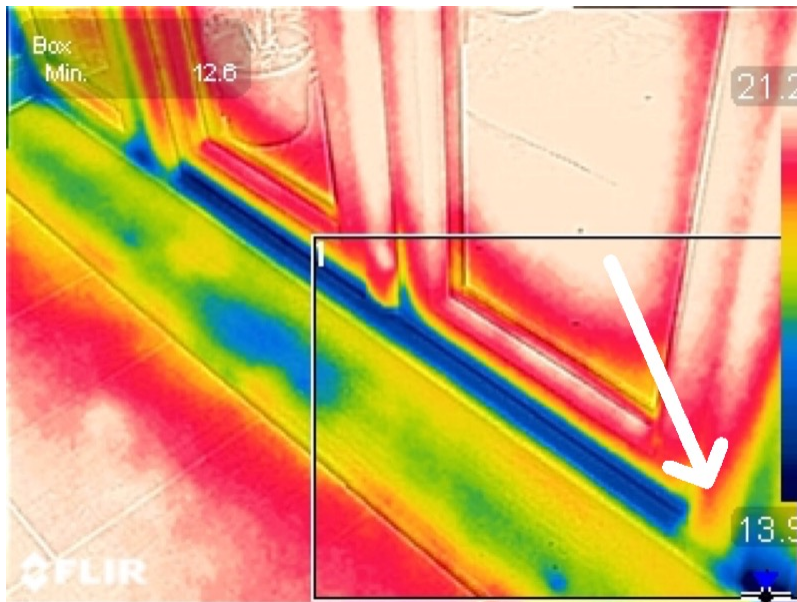
### Kitchen

There is excess heat loss below the  
glazing right of the patio doors, seal  
is likely inadequate

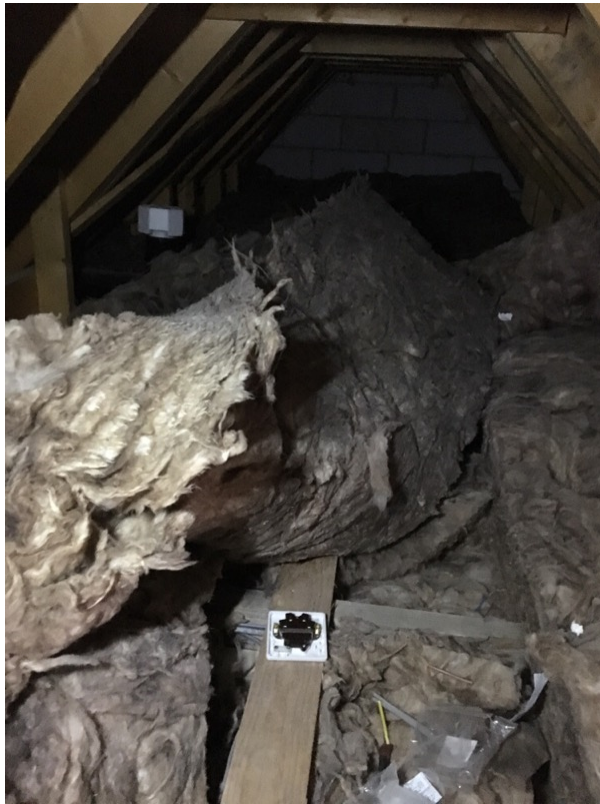
### Loft

The insulation is not neatly laid and needs adjusting throughout the loft
