Example Report

192 Issues Identified

SUMMARY - TOP ISSUES LEADING TO POOR PERFORMANCE

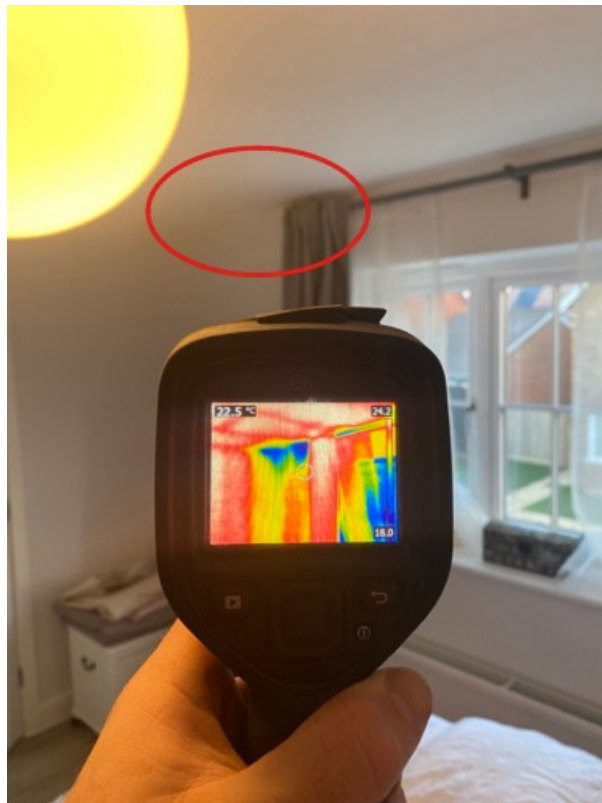
Bedroom 3
Assigned To Insulation
As above

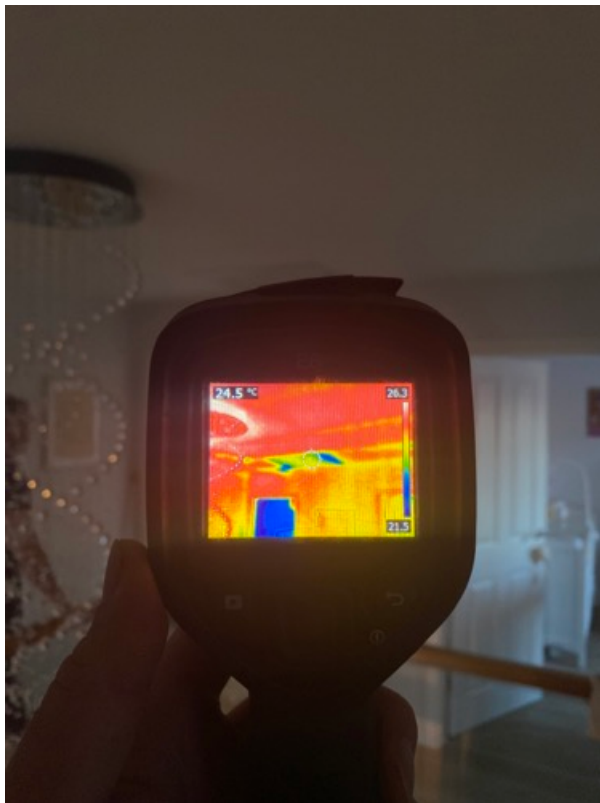
Landing

Minor cold bridging around the loft hatch

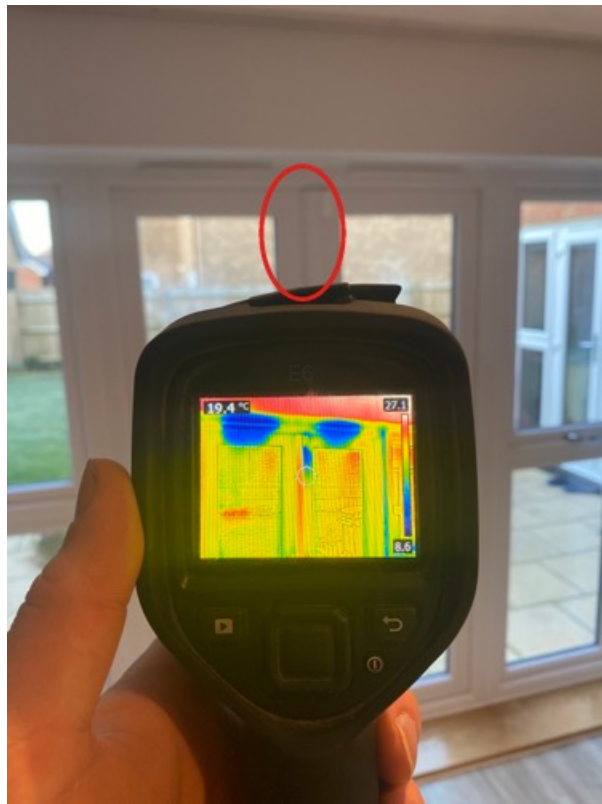
Living Room

Cold bridging noted between the doors

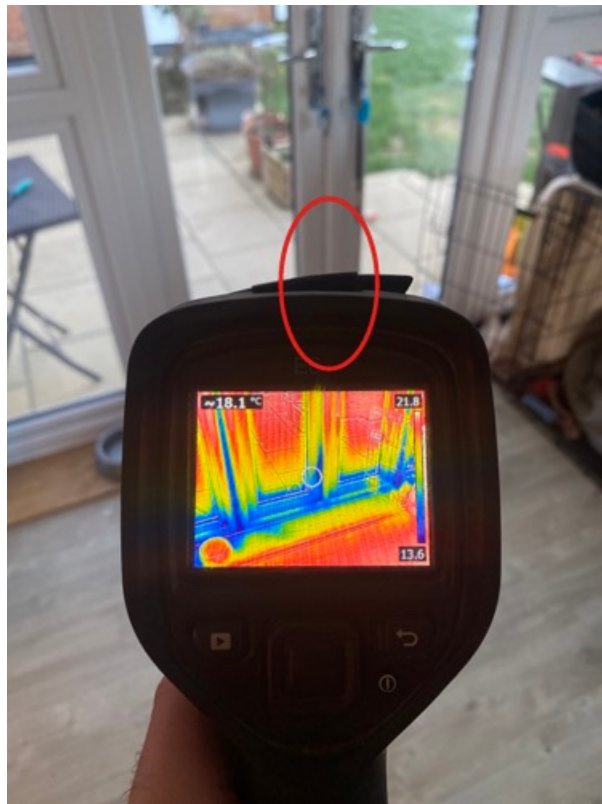
Kitchen

Cold bridging noted between the doors

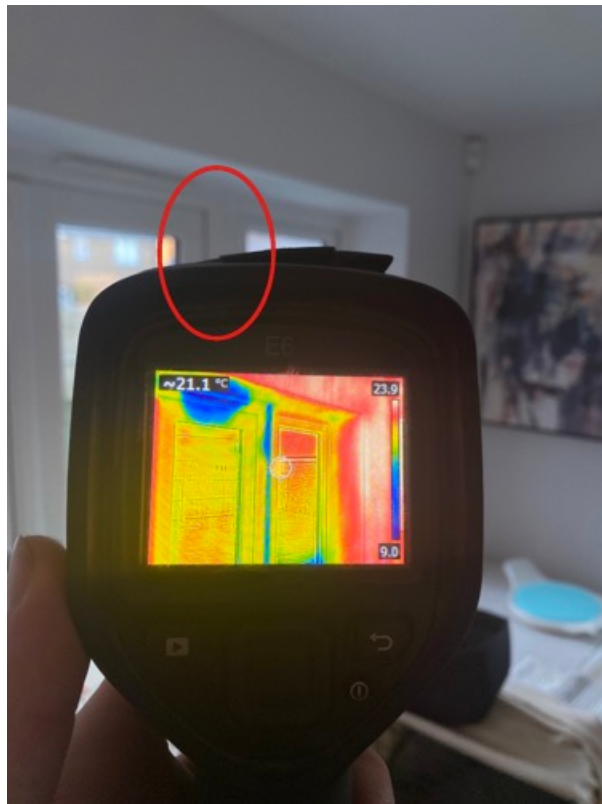
Kitchen

As above

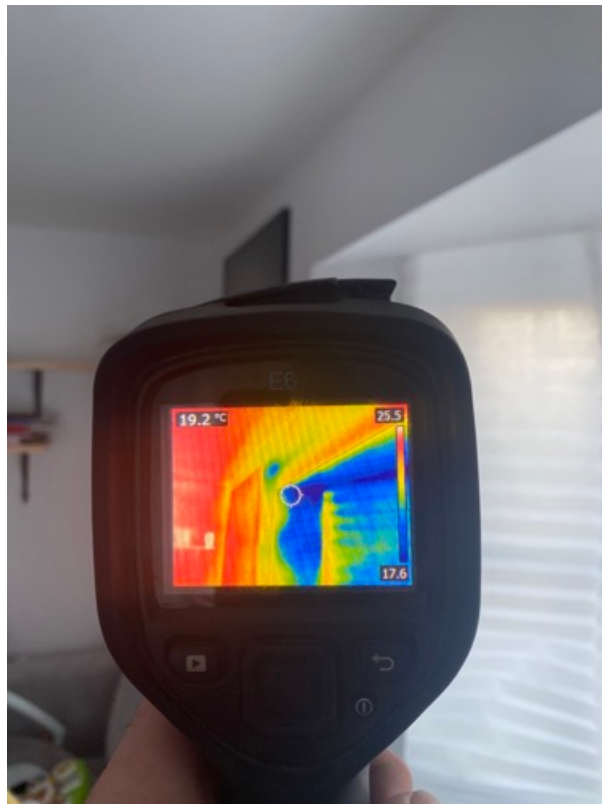
Dining Room
Assigned To Dry Liner
As above

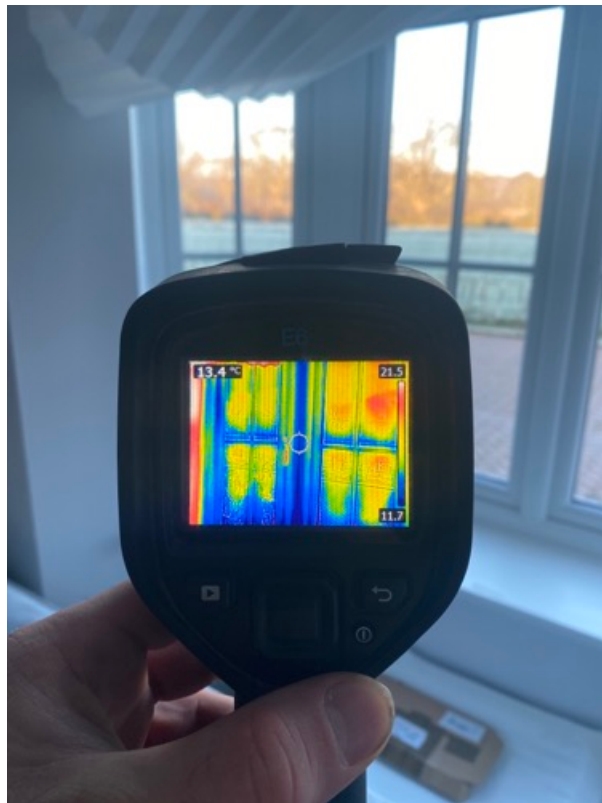
Dining Room

As above

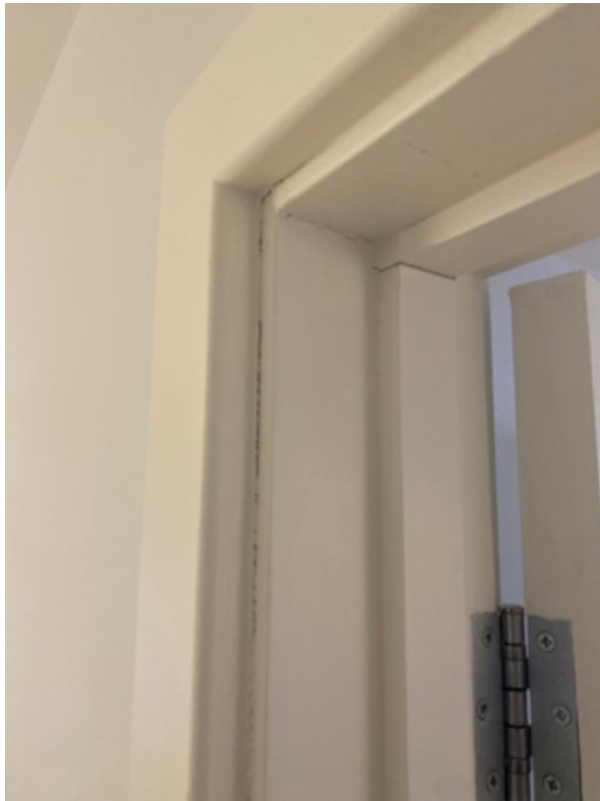
Master Bedroom

Generally throughout the entire property

Make good shrinkages to door liners/
architraves and the like

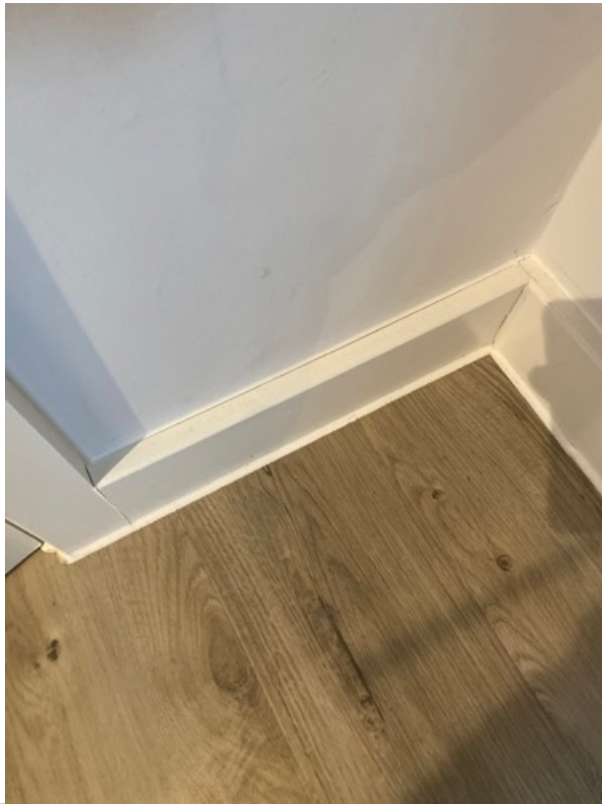
Master Bedroom

Generally throughout the entire property

Make good shrinkages around skirtings

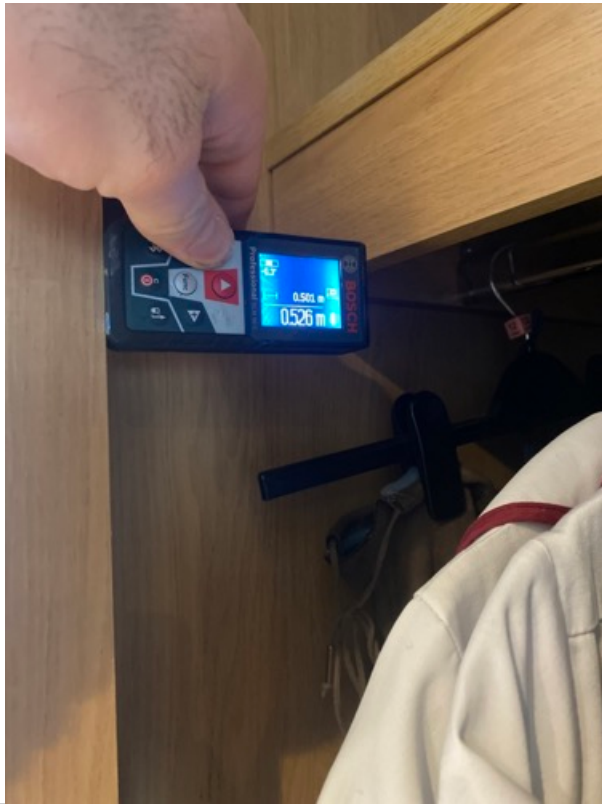
Master Bedroom

As above

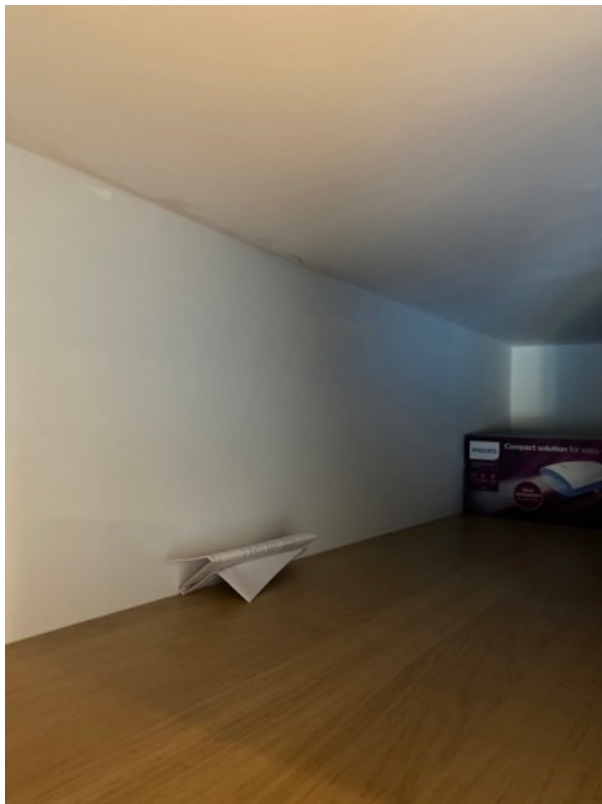
Master Bedroom

Shrinkages noted around ceiling line in wardrobe

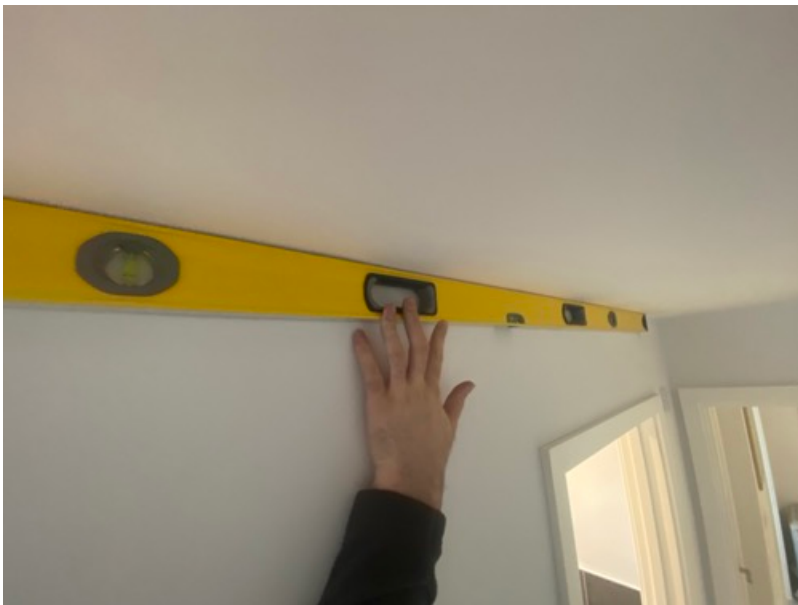
Master Bedroom

As above

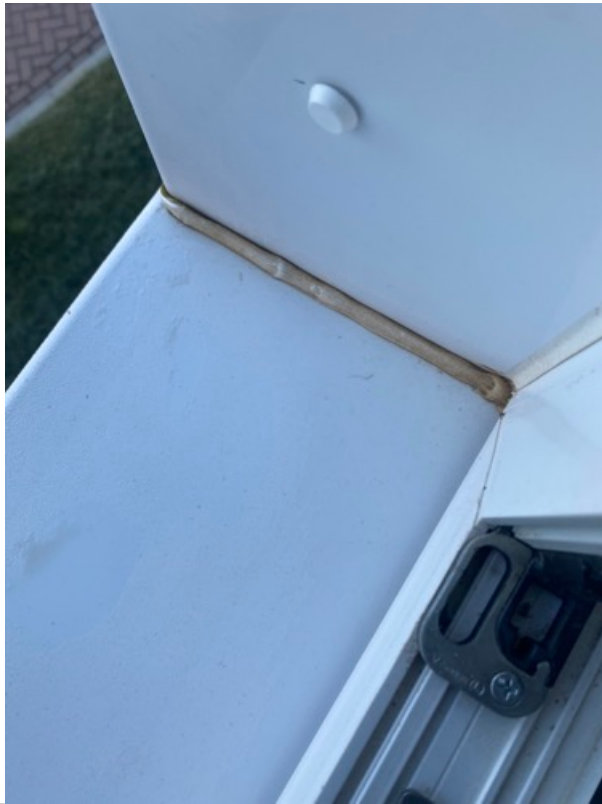
Master Bedroom

Generally - external seals splitting around external cills

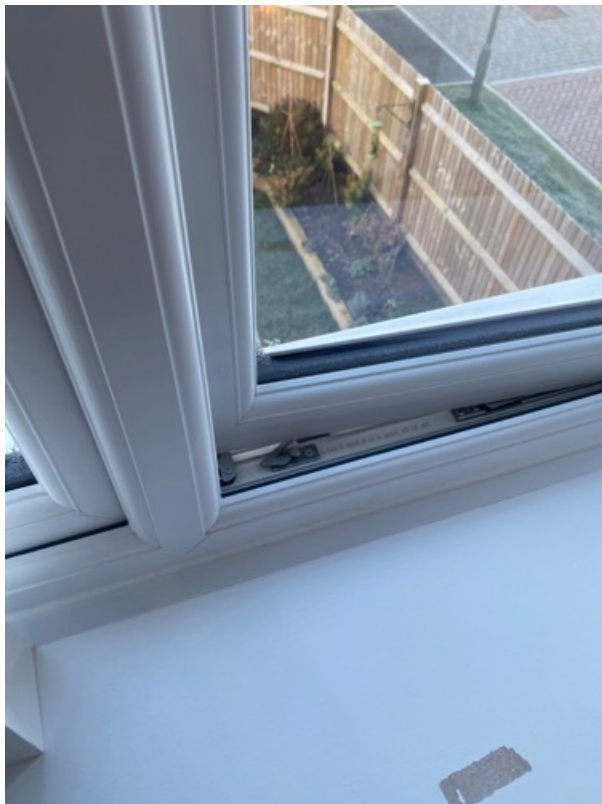
Master Bedroom

RHS window latch not catching

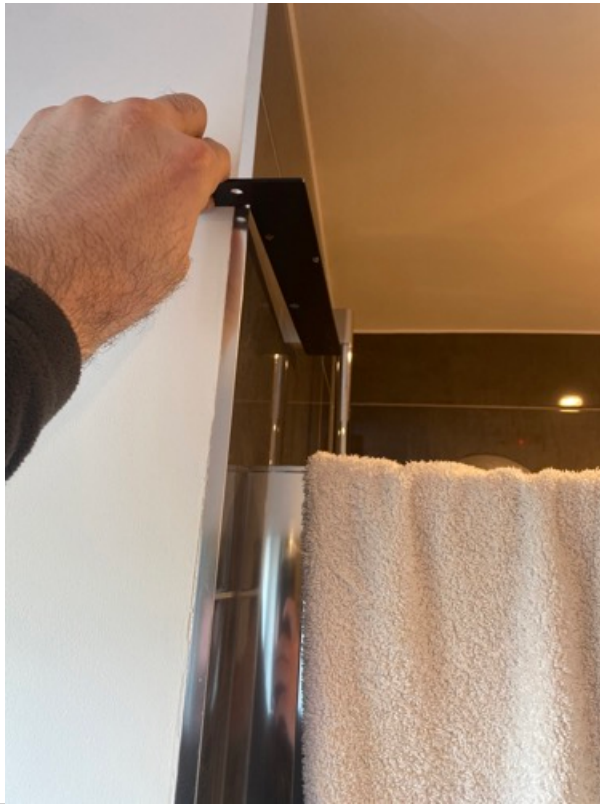
Ensuite

Dry lining not square

>10mm out over a 250mm span

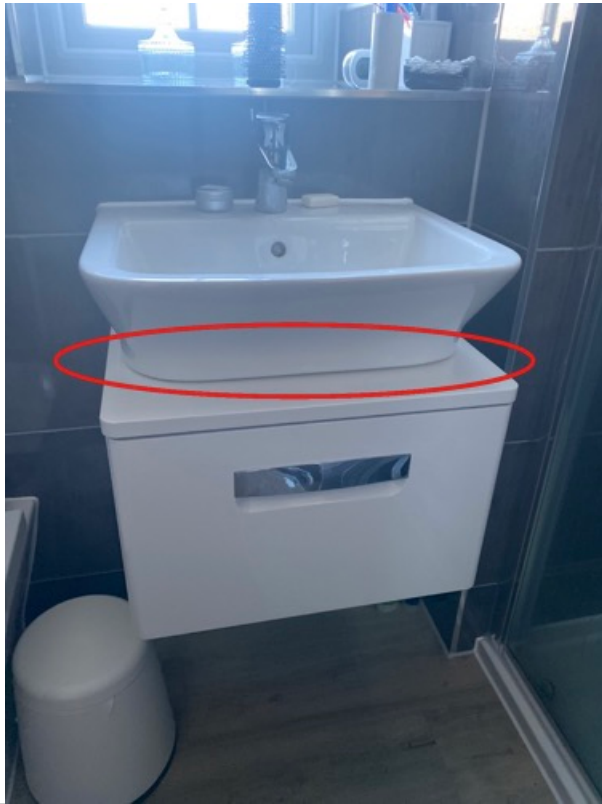
Seal around sink as per other Ensuite

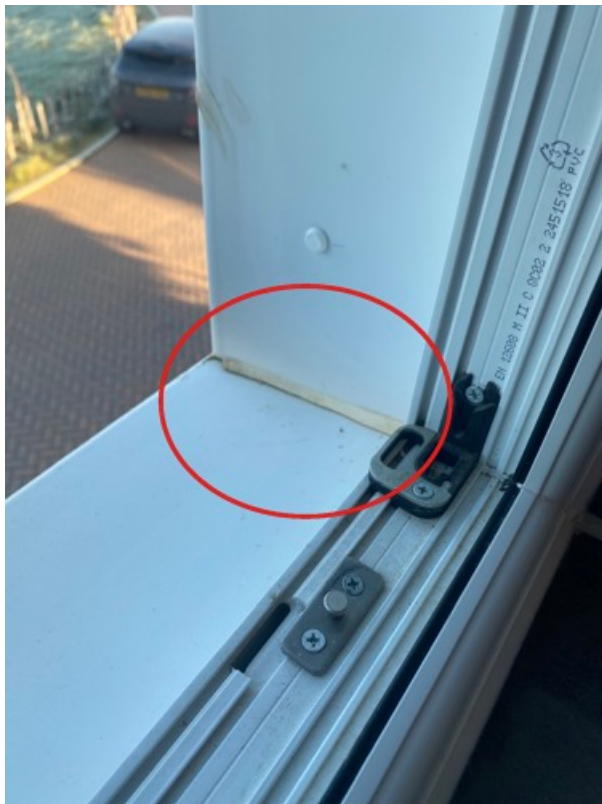
As previously noted

Mastics splitting around cills

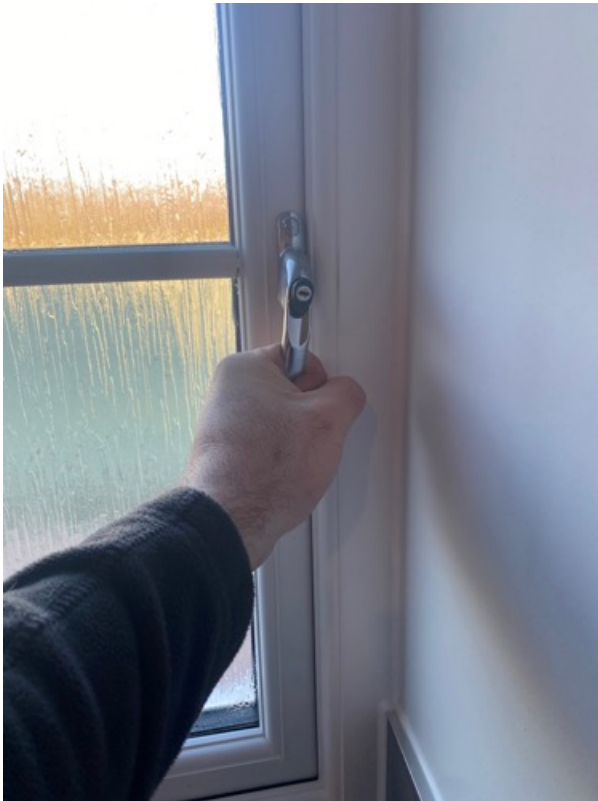
Window handle stiff to operate

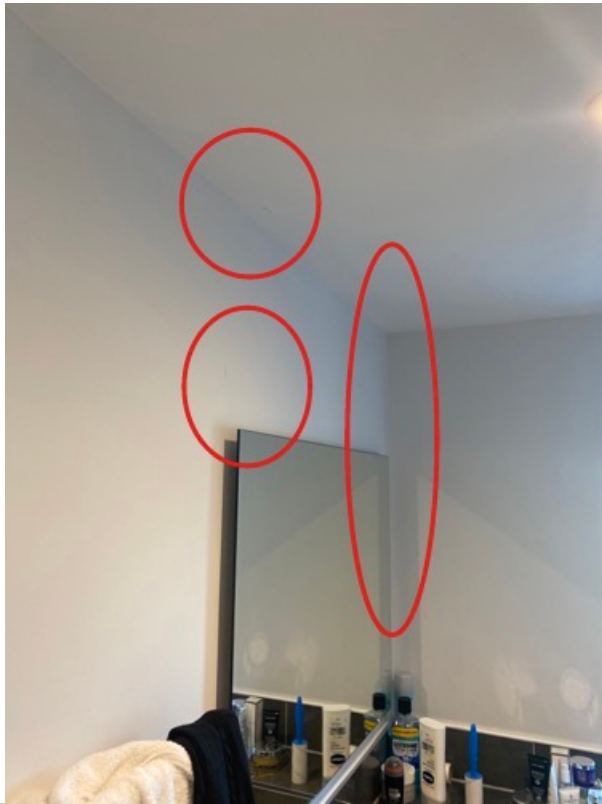
Nail pops

Shrinkages noted

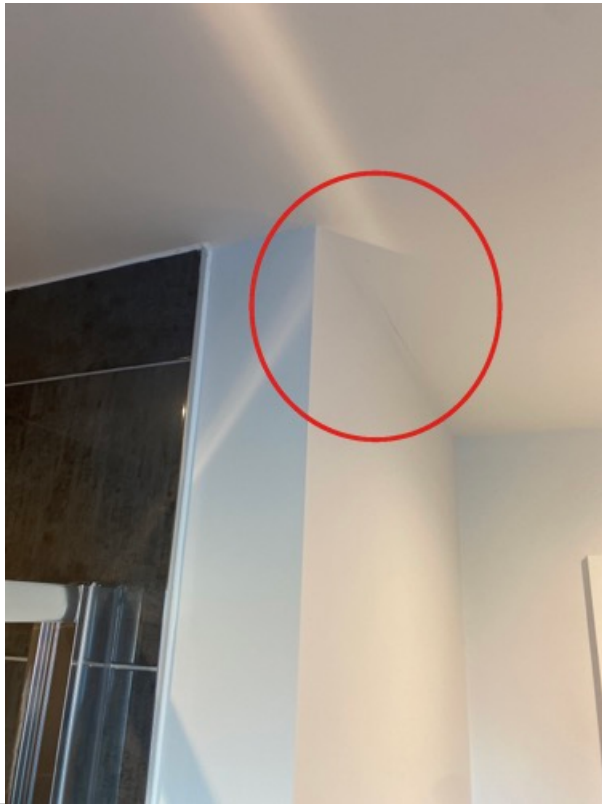
Shrinkages noted

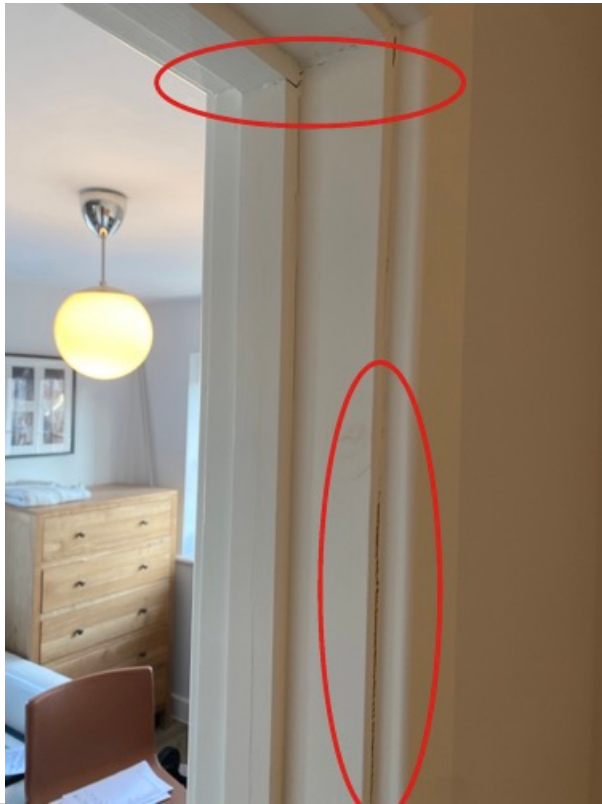
As previously noted

Make good shrinkages to door frames/
liners

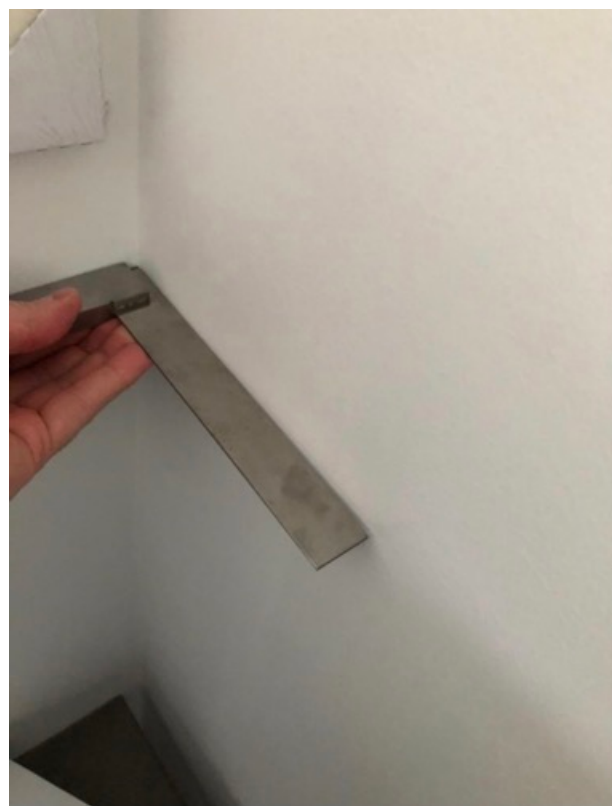
As above

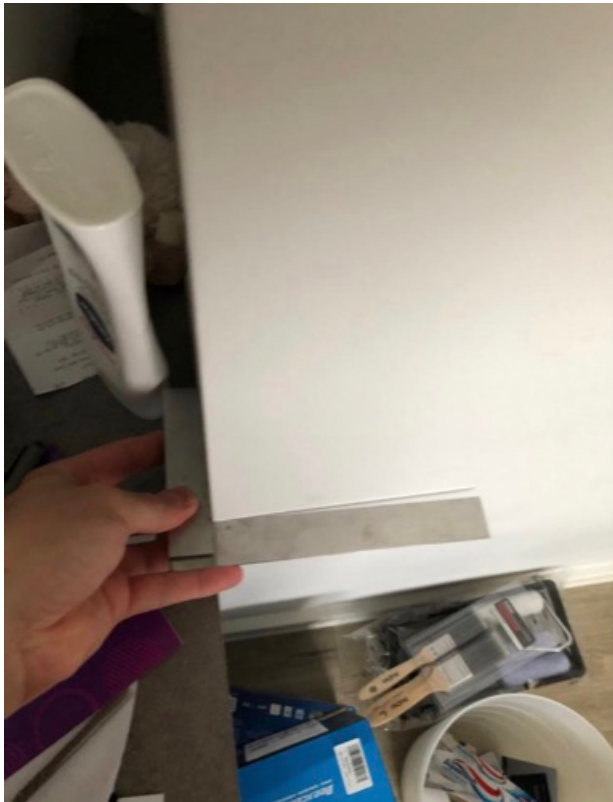
As above

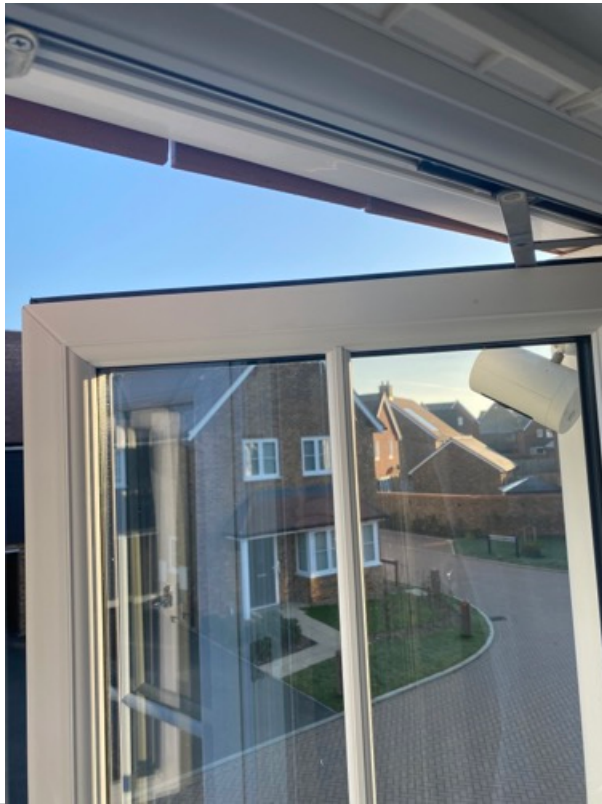
Hanging tiles/ soffit and fascia do not run parallel

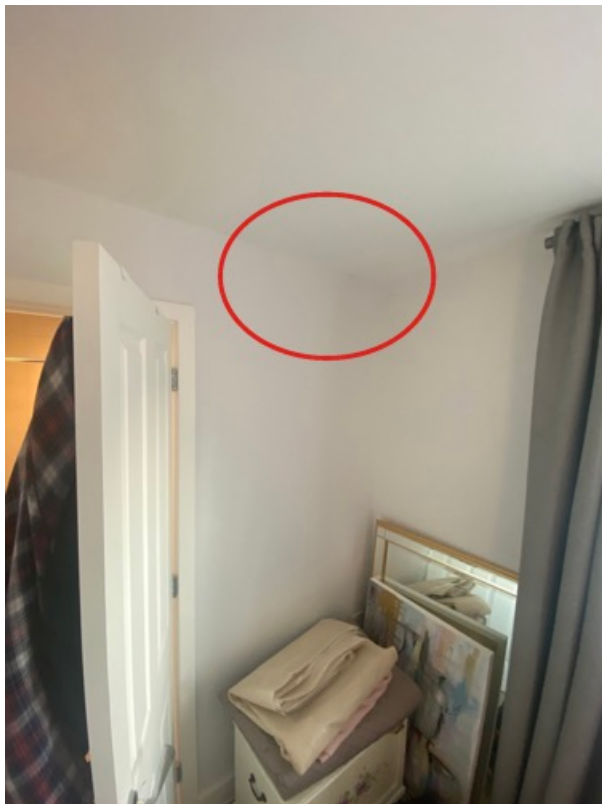
Shrinkages noted

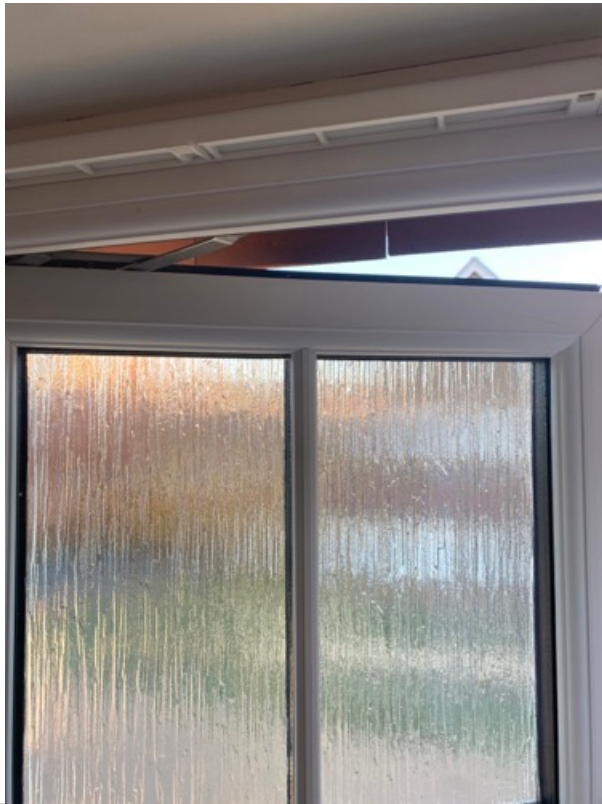
Window opens close to hanging tiles

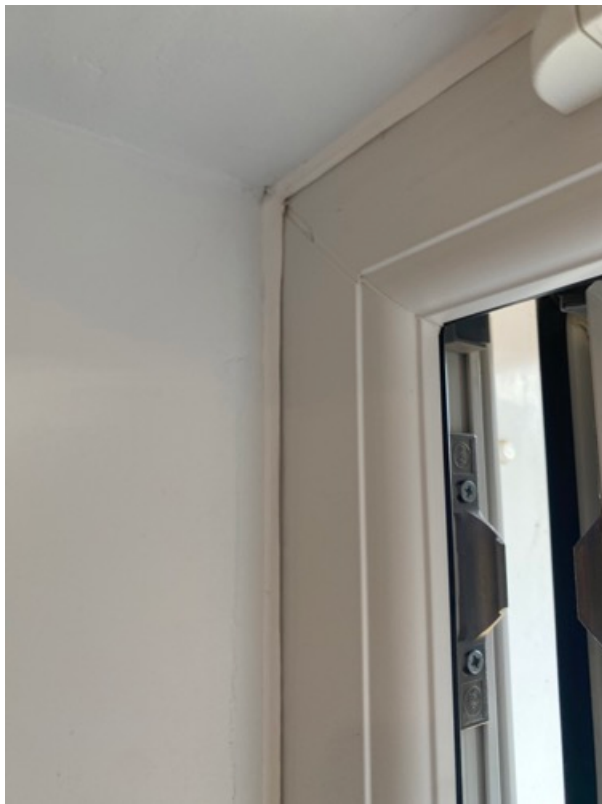
Generally throughout the entire property

Reapply split mastics around openings

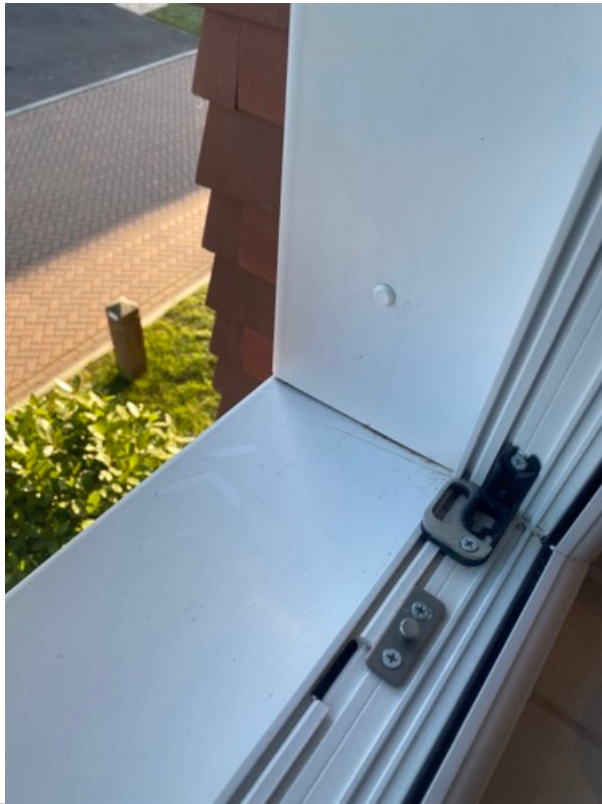
Seals missing around external cill

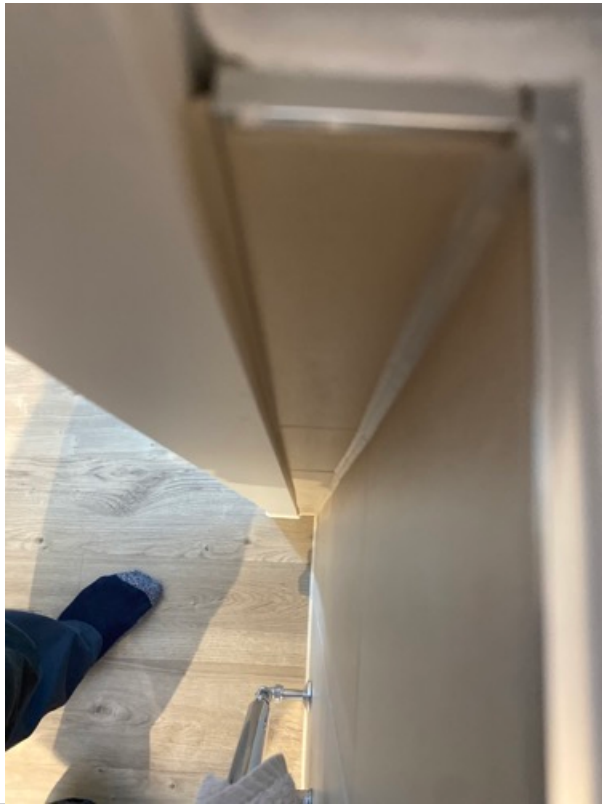
Seal down RHS architraves

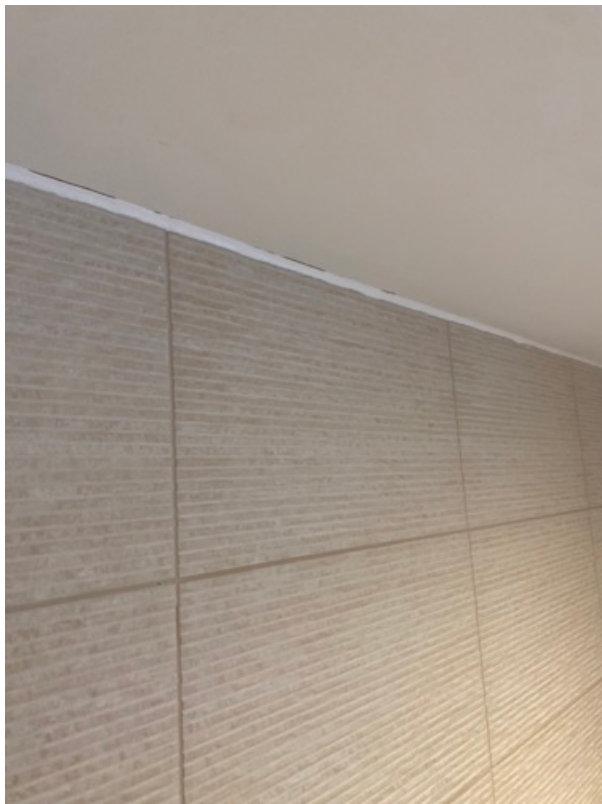
Mastics splitting around the ceiling line

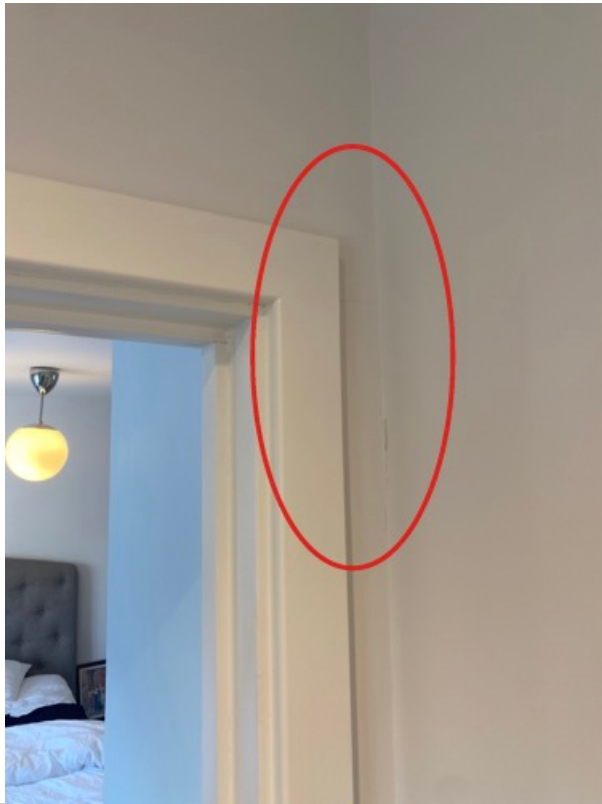
Shrinkages noted

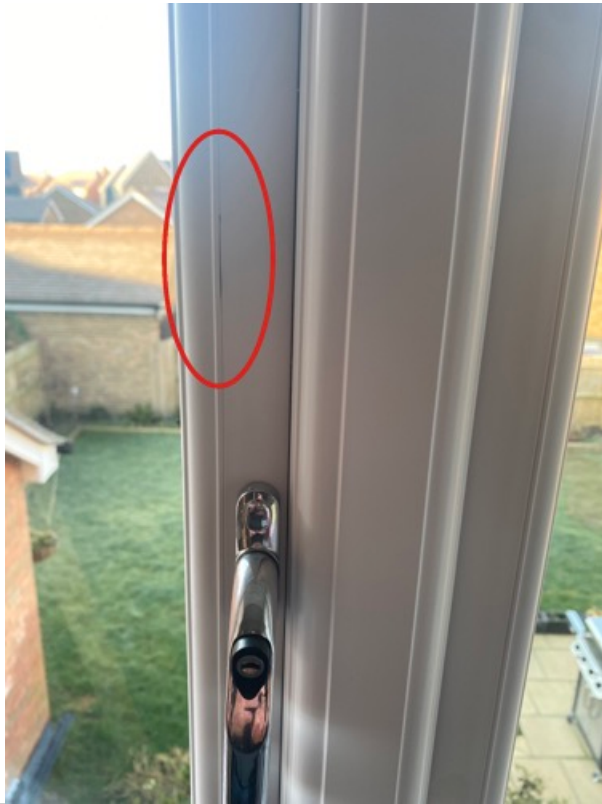
Frame damaged

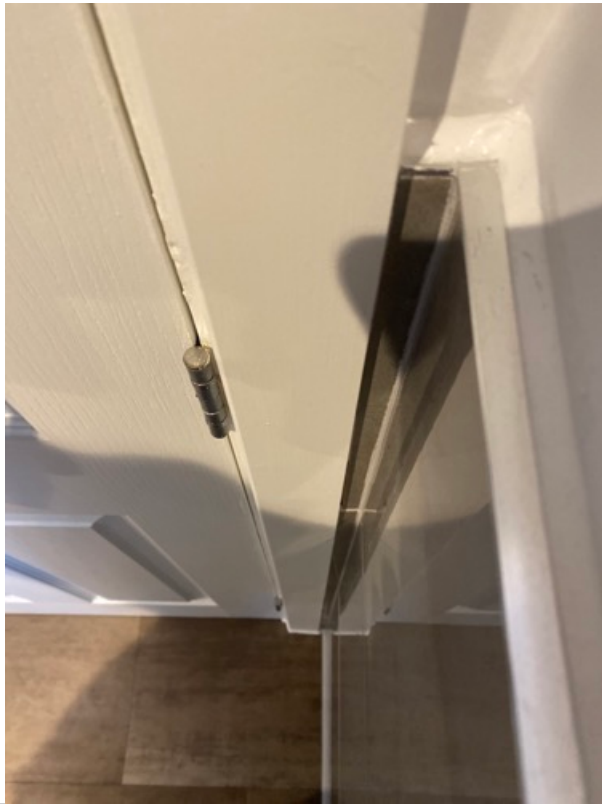
Seal down RHS architrave

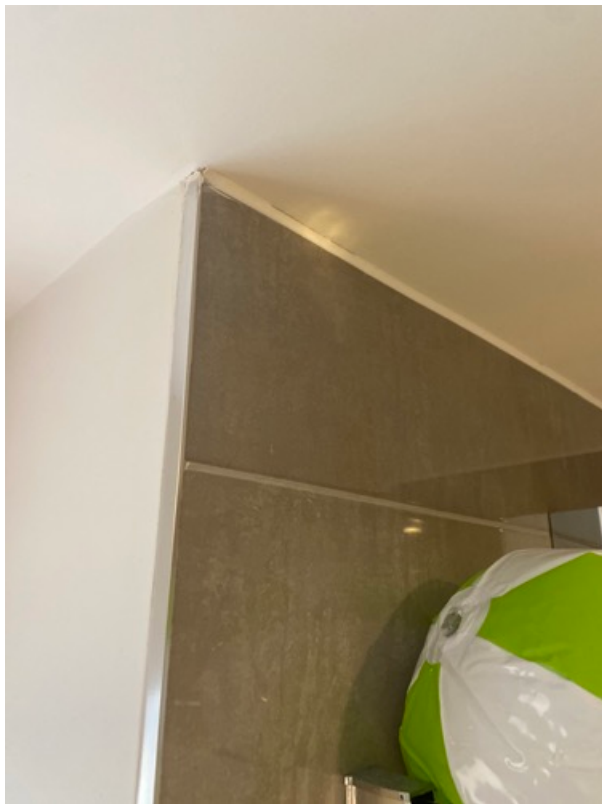
Mastics splitting around the tile line

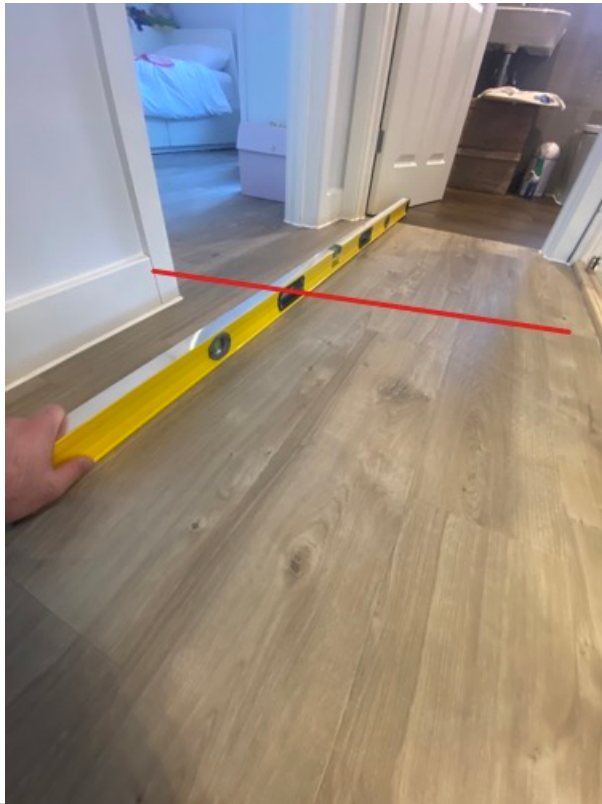
Flooring levels noticeable change and deviate as cross the landing, surrounding the staircase

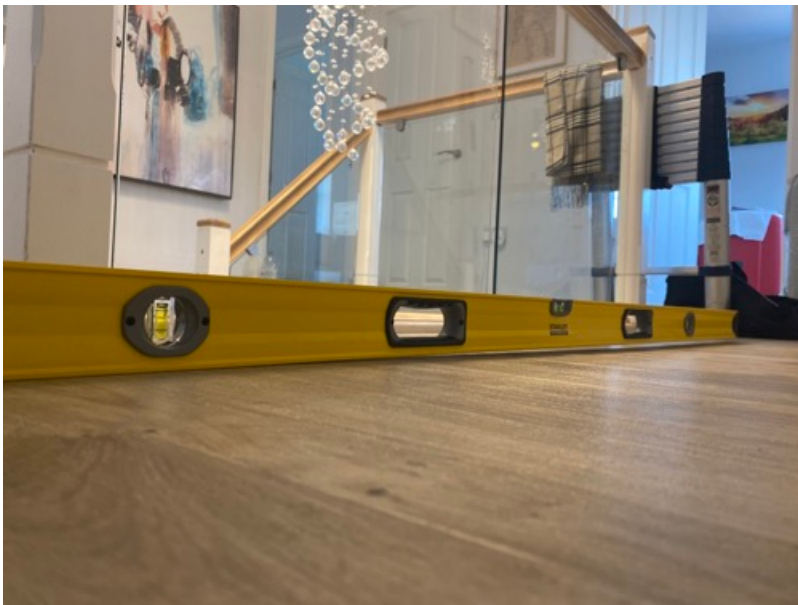
As above

>10mm over a 1.8m span referenced

- level within a 3mm deviation per 1m for floors up to 6m across (measured at the furthest points across the full width of the floor)
- a maximum of 20mm out of level for floors over 6m across
- flat within a ± 5 mm deviation, measured using a 2m straight edge with equal offsets.

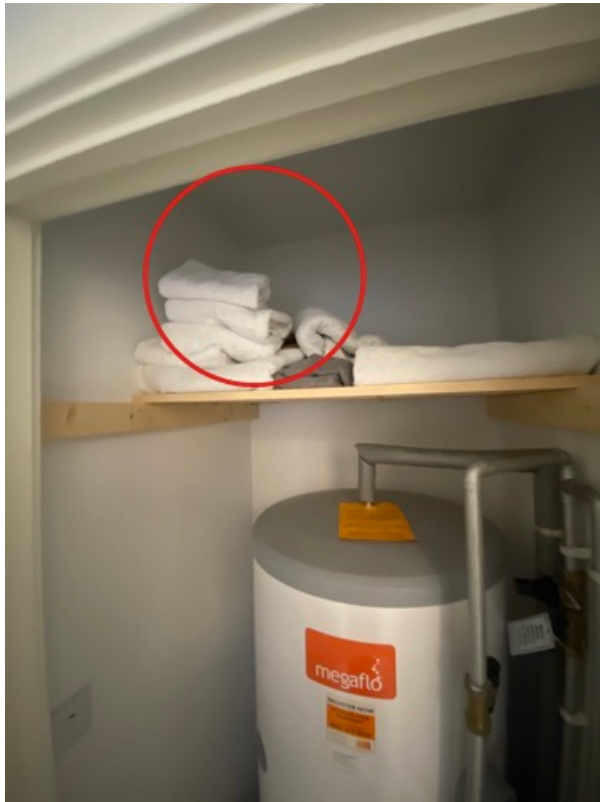
Shrinkages noted

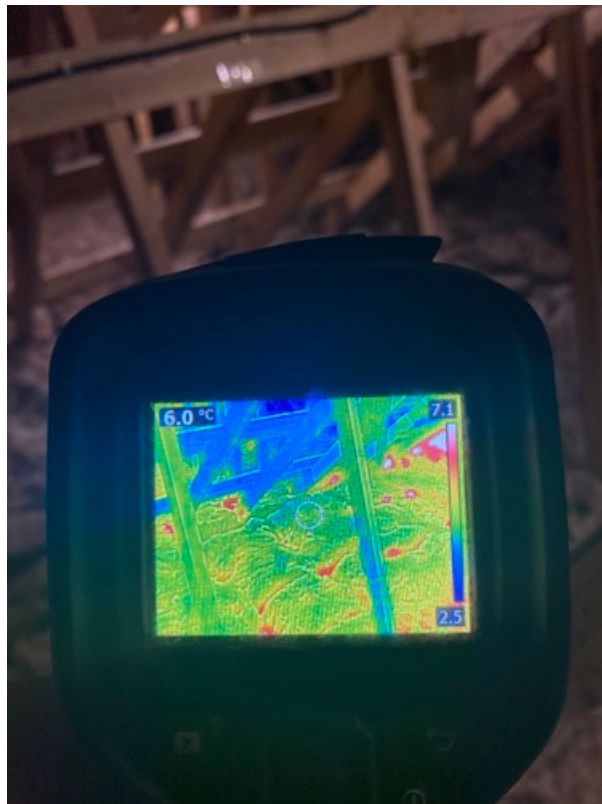
Breaks in thermal barriers where joists haven't been adequately covered by additional layers of insulation

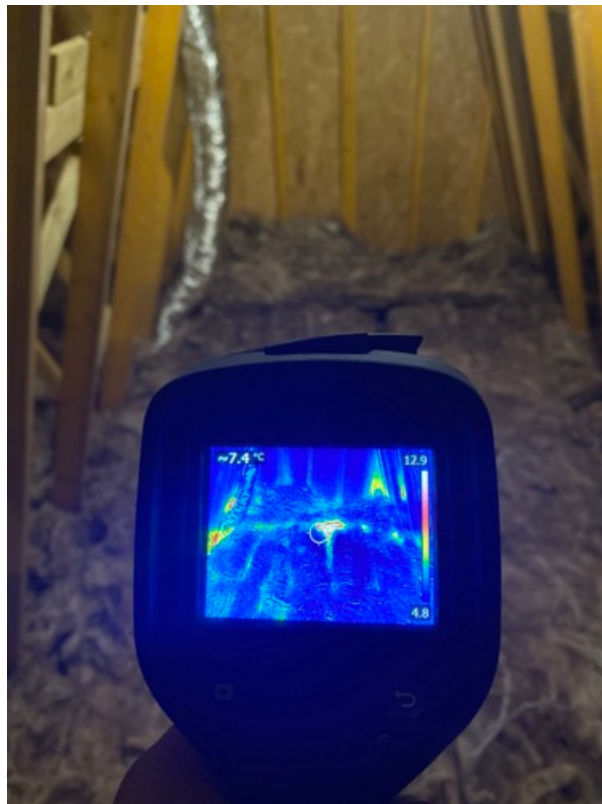
As above

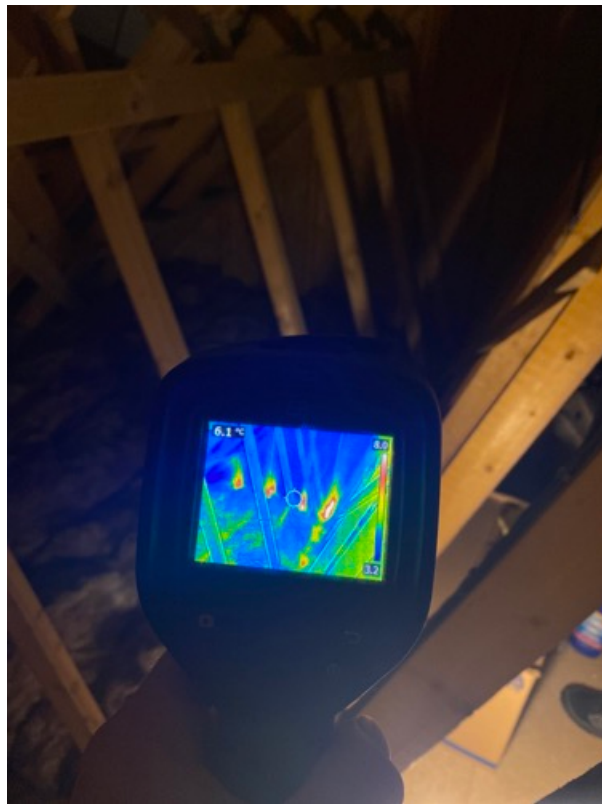
As above

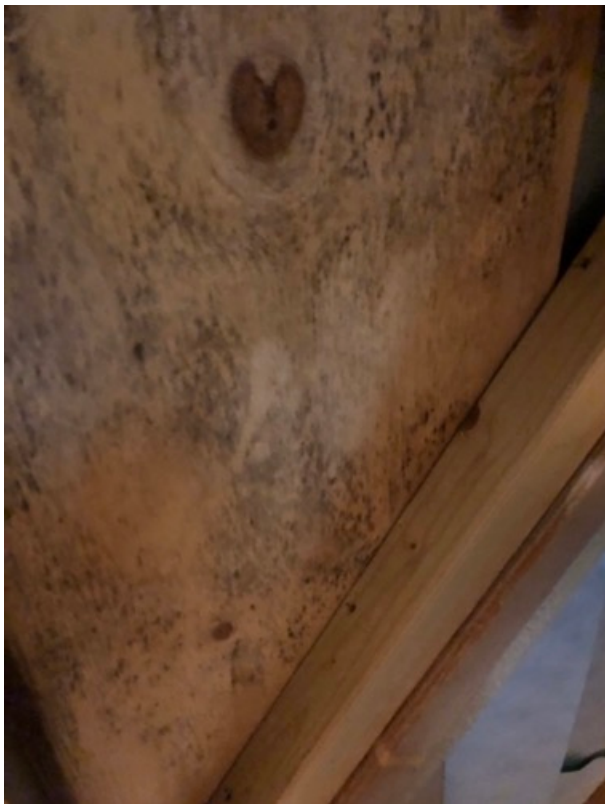
Loftspace

Condensation throughout, where eaves inadequately insulated. No visible gaps externally to allow for sufficient airflow, as later noted within this report

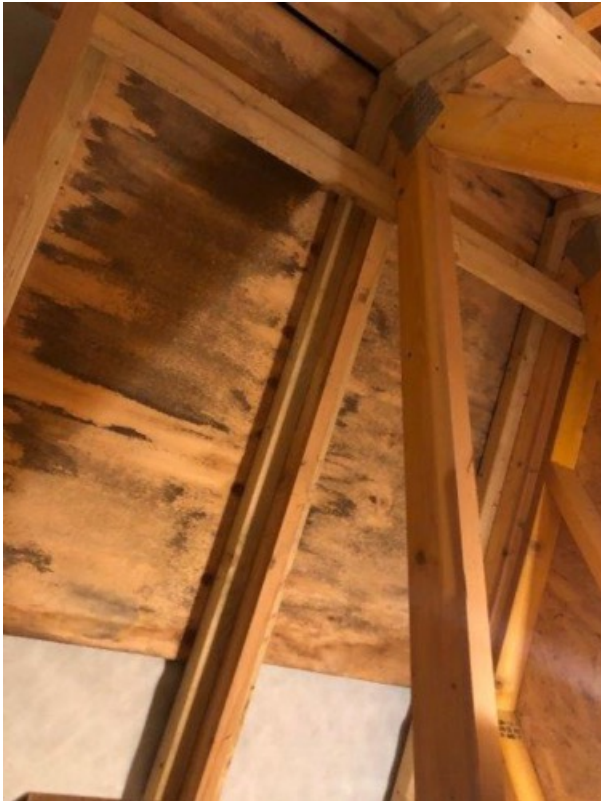
Loftspace

As above

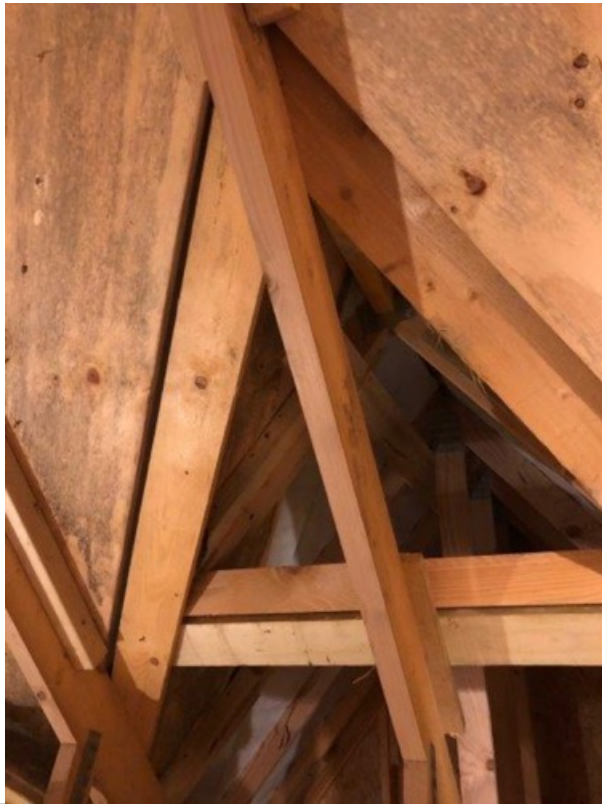
Loftspace

As above

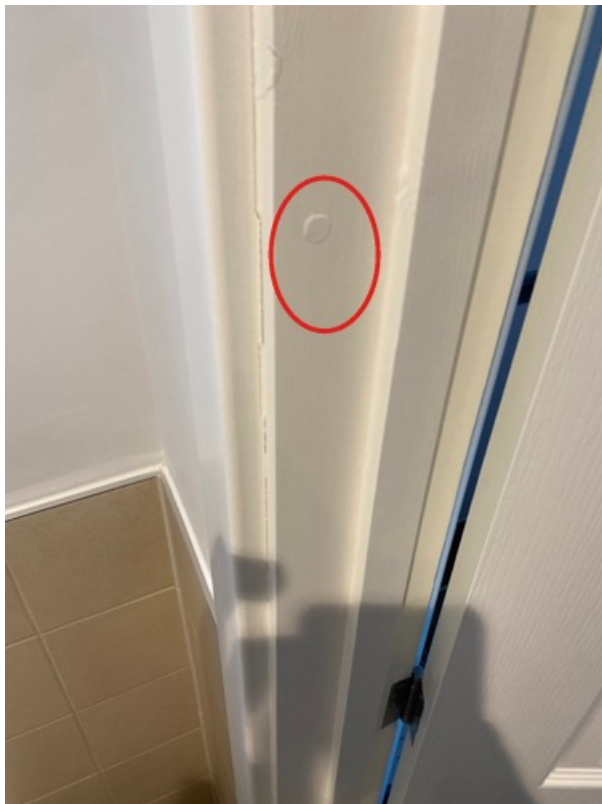
Cloakroom

Timbers throughout have been
inadequately prepped prior to decorating

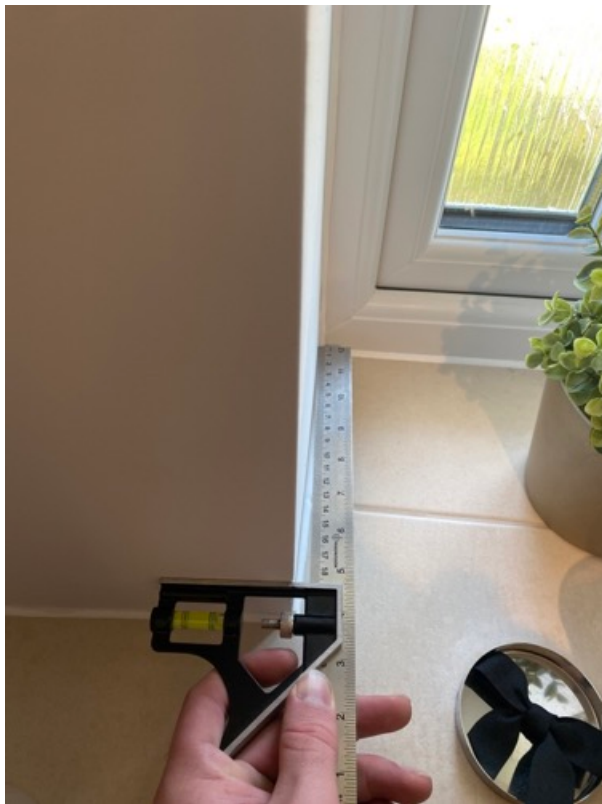
Cloakroom

Return noticeably not square

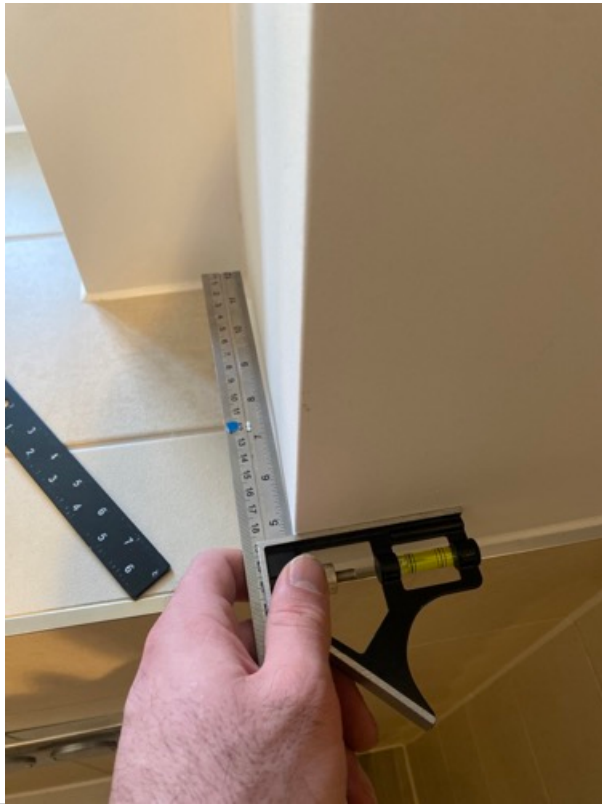
Cloakroom

As above
