Example Report

192 Issues Identified

SUMMARY - TOP ISSUES LEADING TO POOR PERFORMANCE

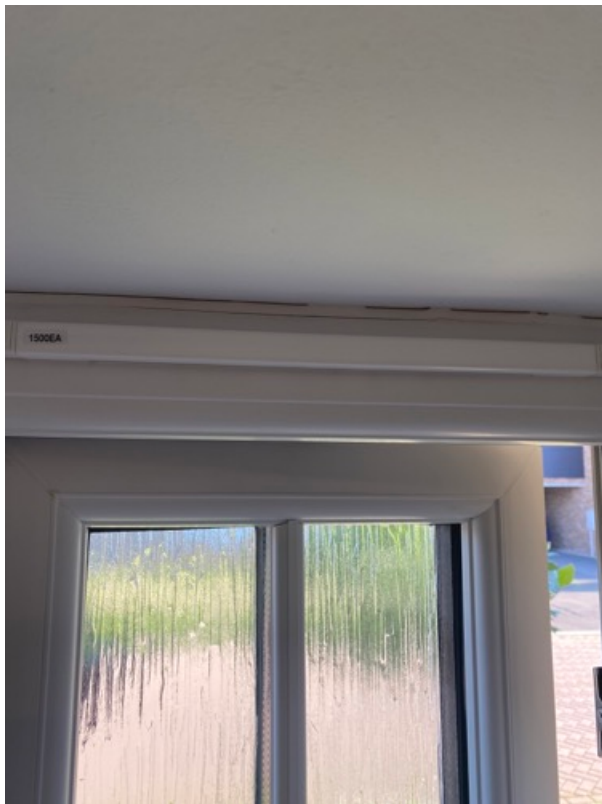
Cloakroom

Mastics splitting around opening

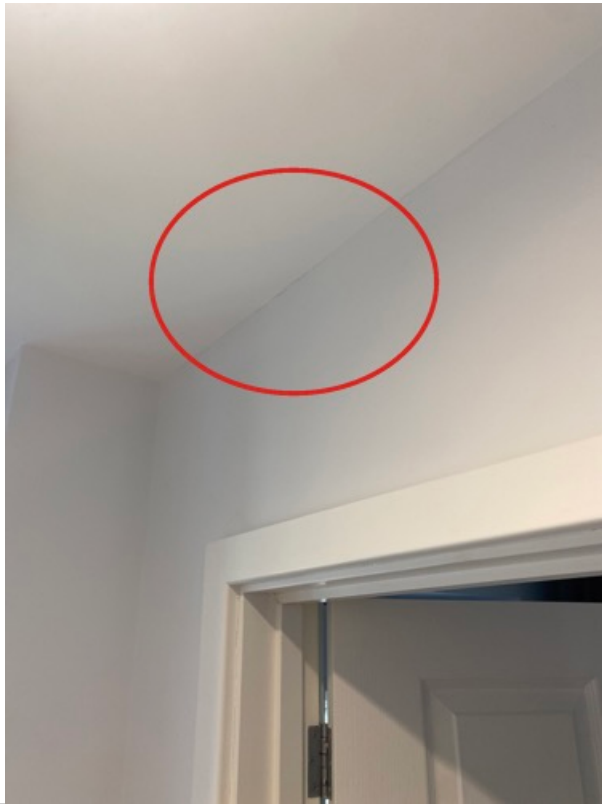
Cloakroom

Shrinkages noted

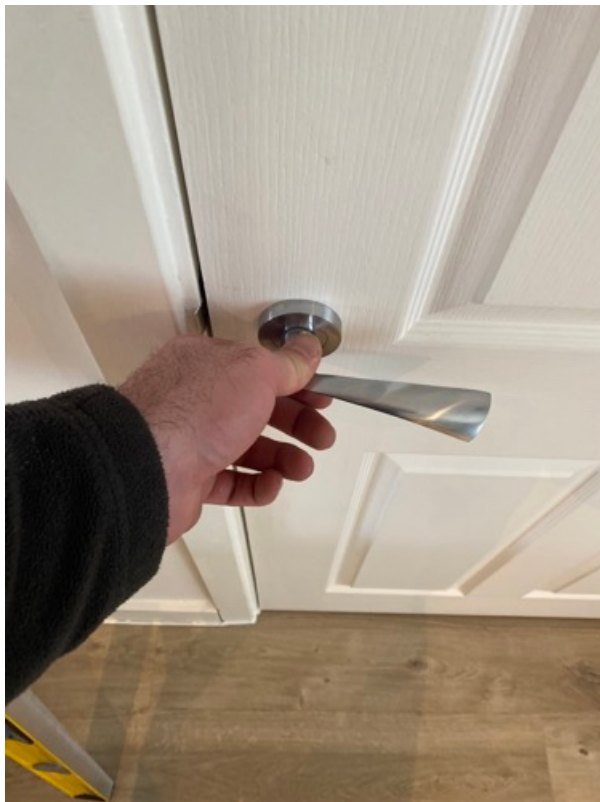
Living Room

Latch not catching

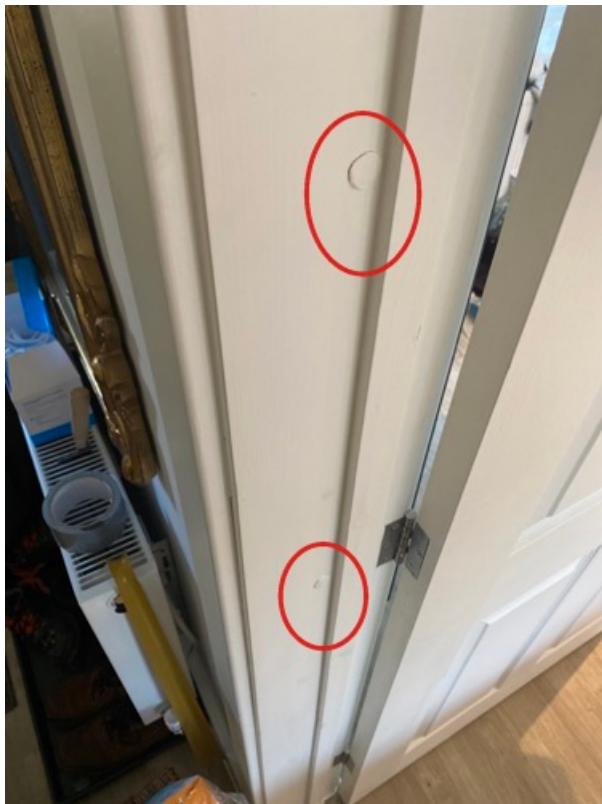
Living Room

As previously noted

Timbers not suitably prepped prior to decoration

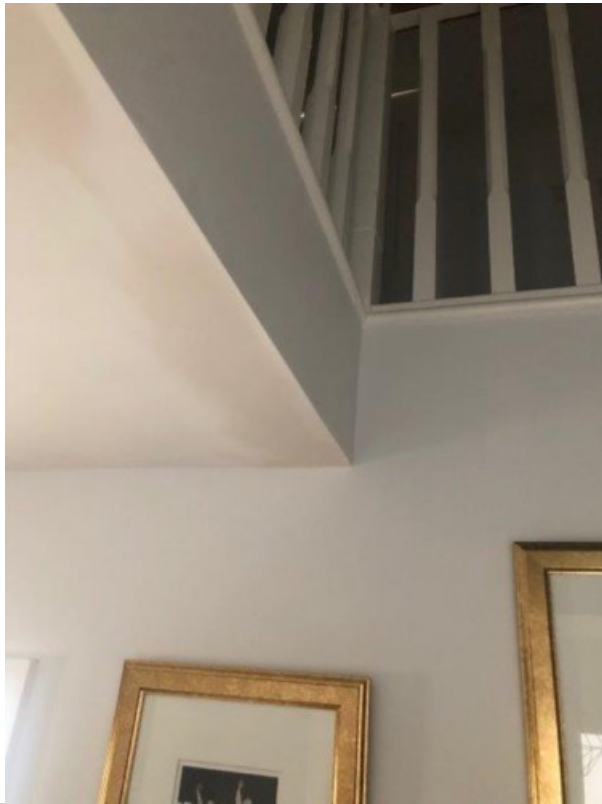
Entrance/ Hallway

Paint patchwork

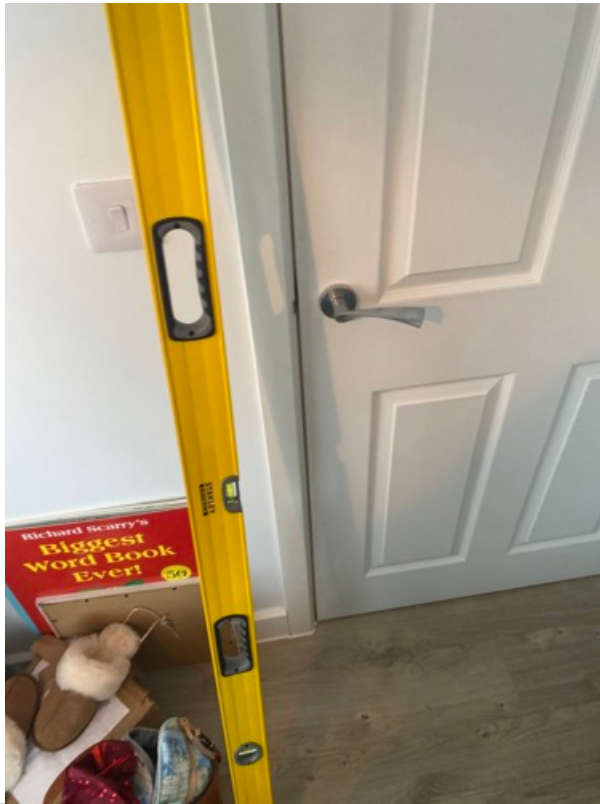
Front Room

Gaps around door to frame exceed 4mm

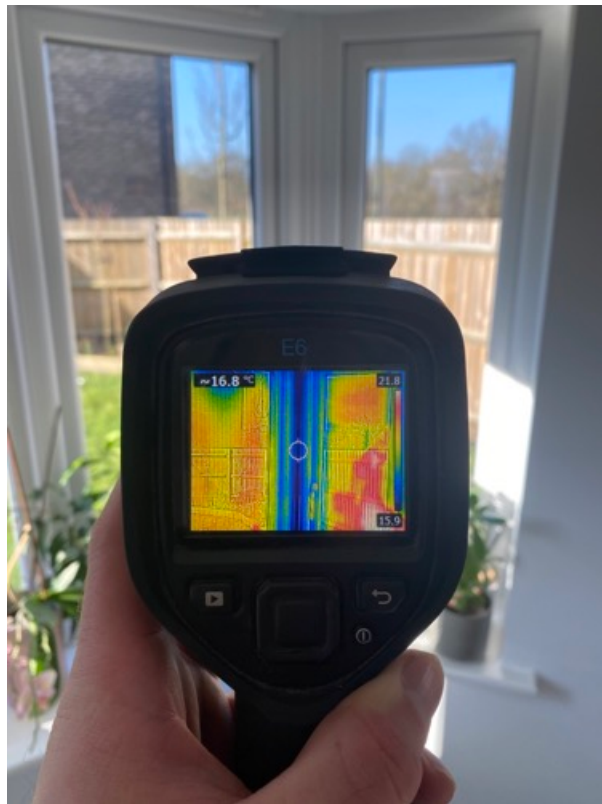
Kitchen

Cold bridging noted down the covered structural members of the opening, where assumed not suitably foam/ insulated

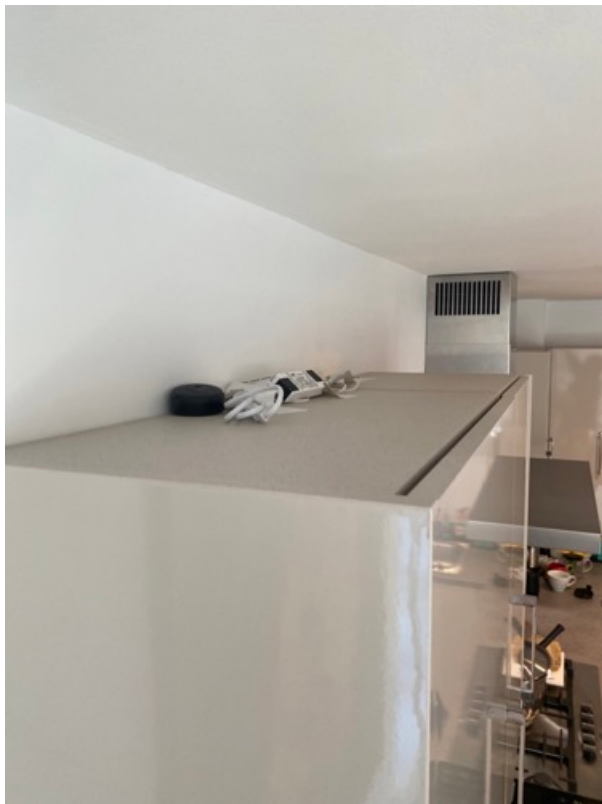
Kitchen

As above

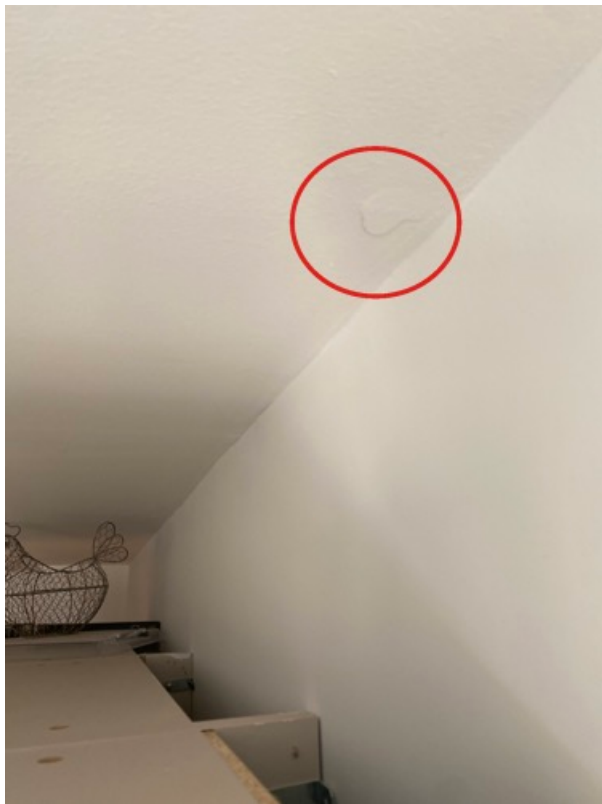
Kitchen

Example

As above

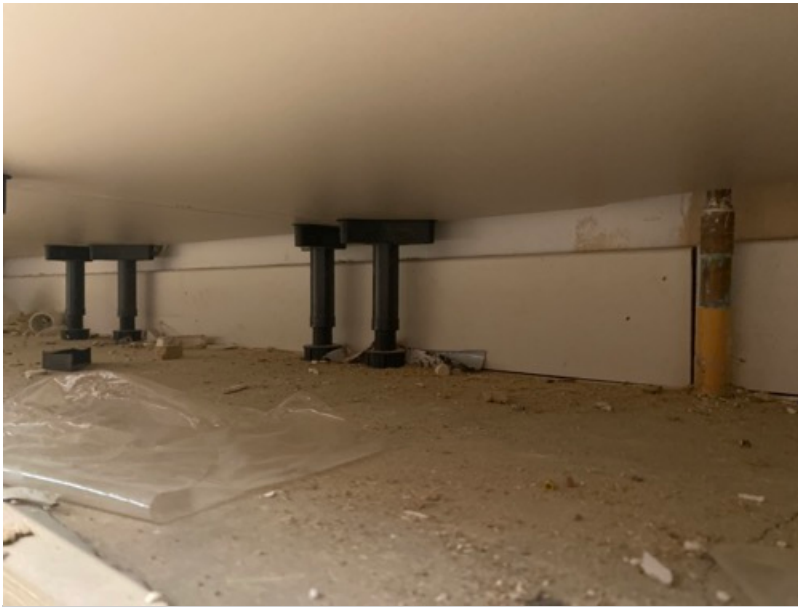
Kitchen

As above

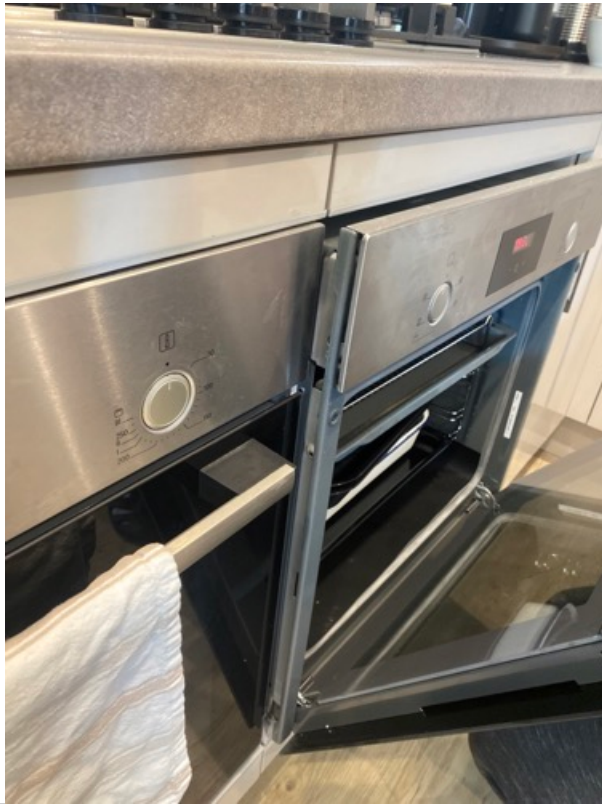
Kitchen

RHS oven not secured

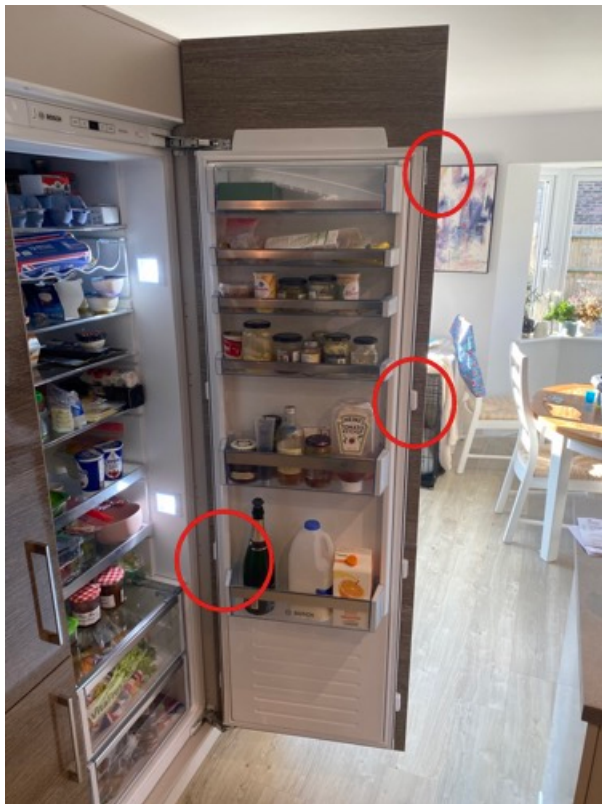
Kitchen

Generally / clips not secure

Clip missing

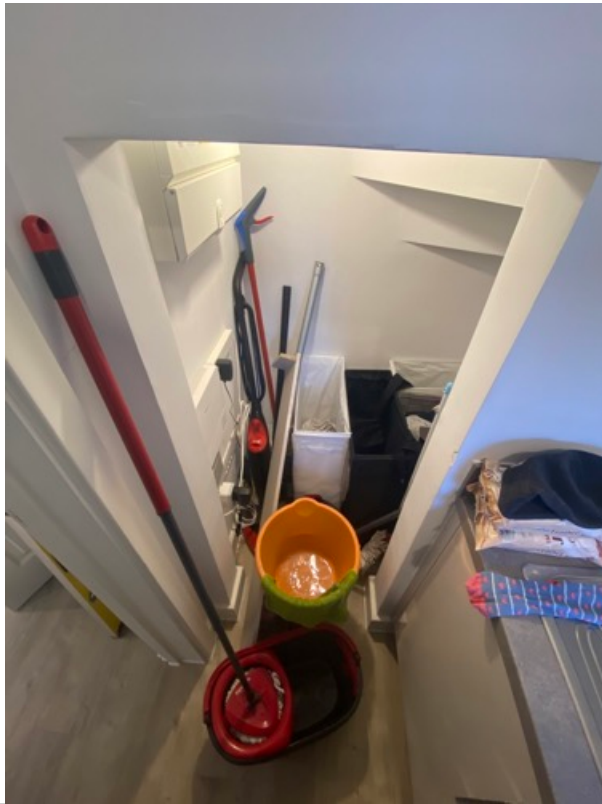
Kitchen

No apparent ending beads around opening

Plaster crumbling

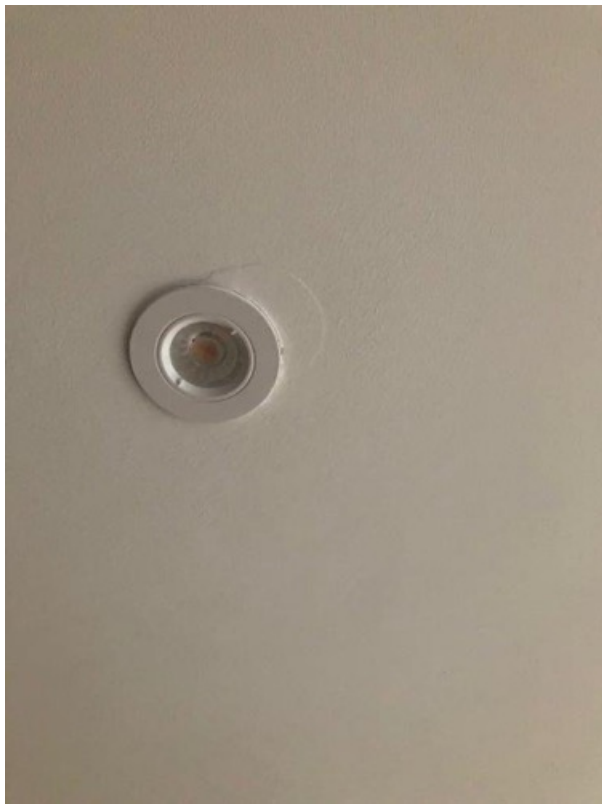
Kitchen

Previously repaired

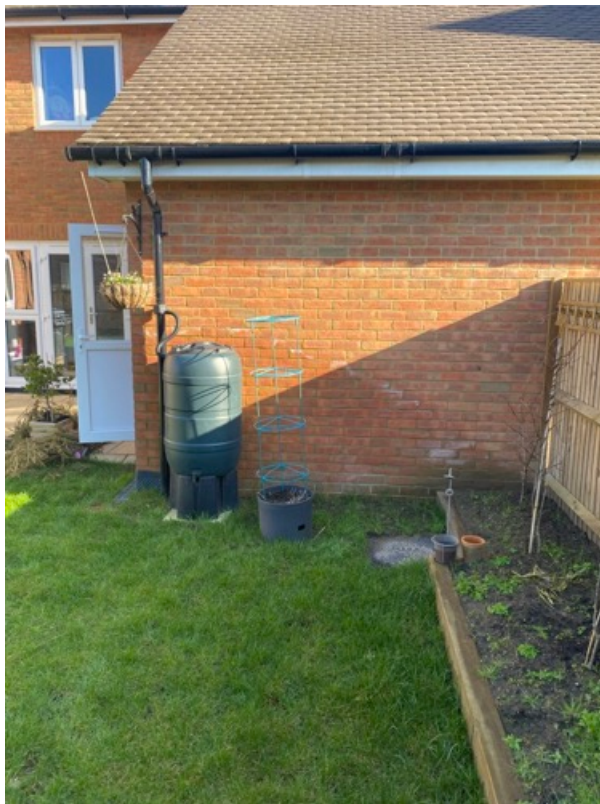
External Rear

Garage external walls saturated, ensure any DPC hasn't been damaged, or guttering

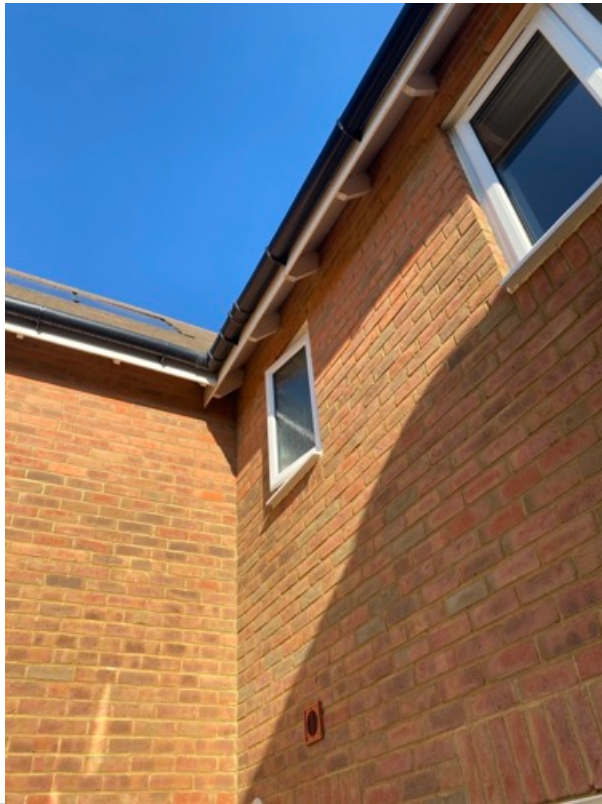
External Rear

No clear ventilation points to the eaves, noted around the property. Air circulation in the Loftspace limited which has resulted in excessive moisture and condensation build up internally

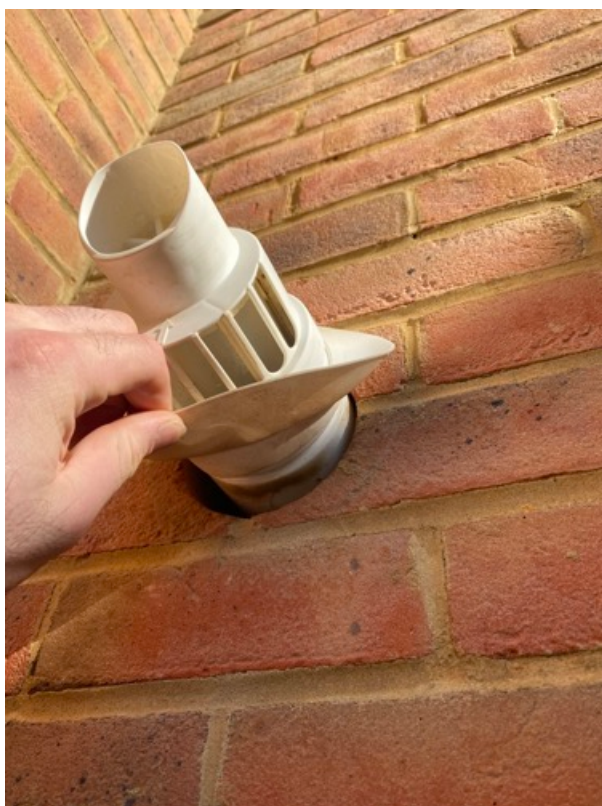
External Rear

As previously noted

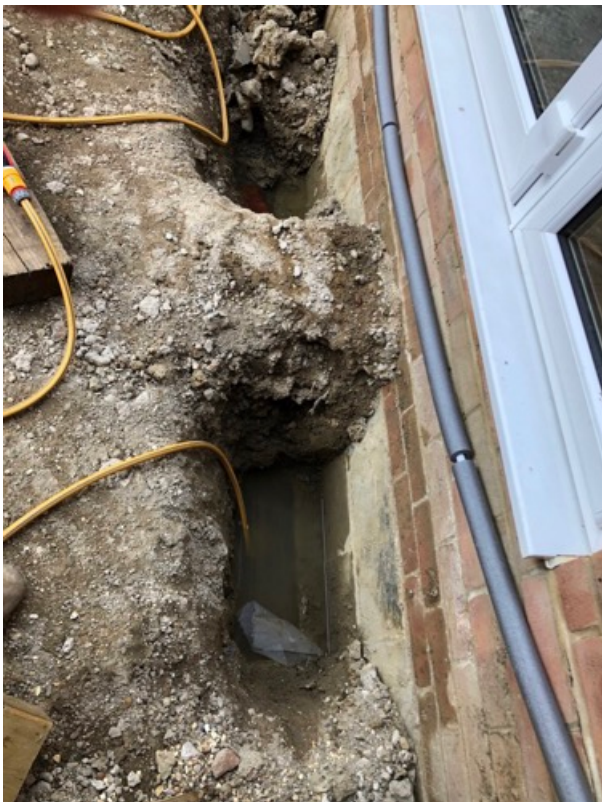
External Rear

When dig down adjacent to the property, treated water swamps the foundations highlighting a potential leak

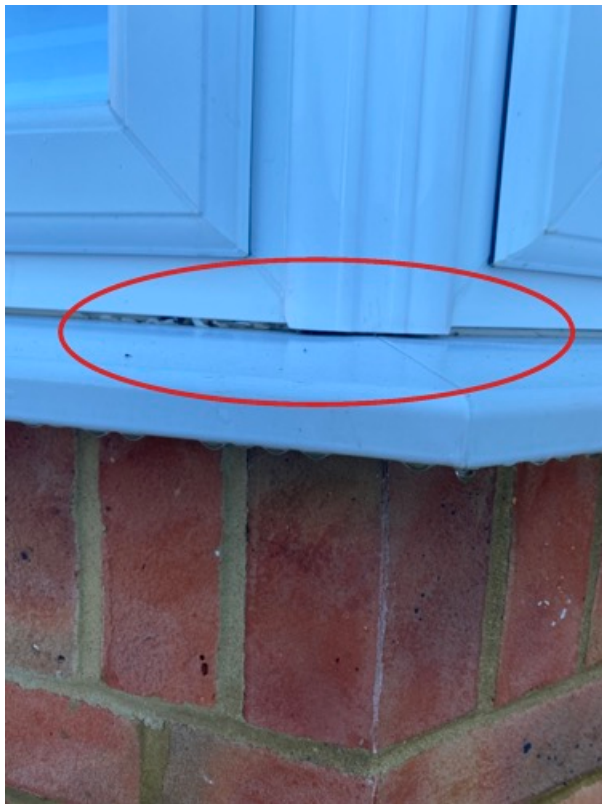
External Front

As above

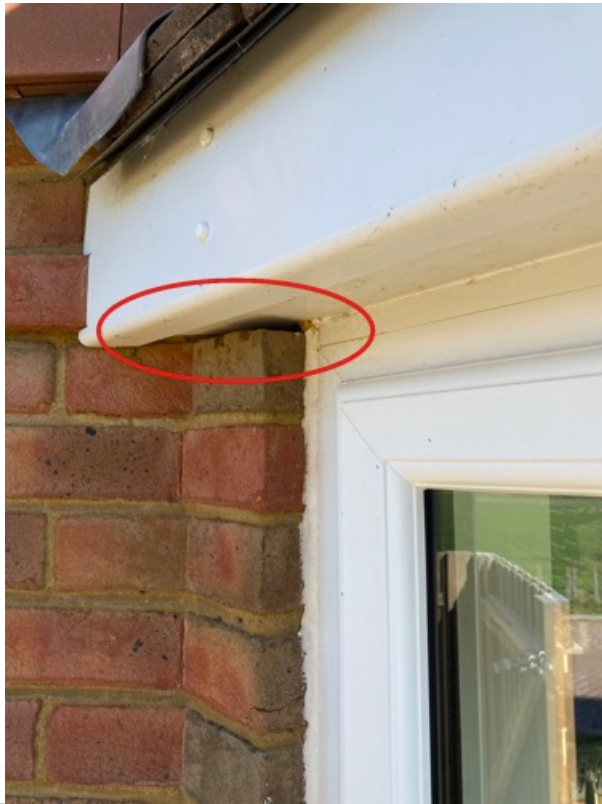
External Front

Gaps visible around bay openings

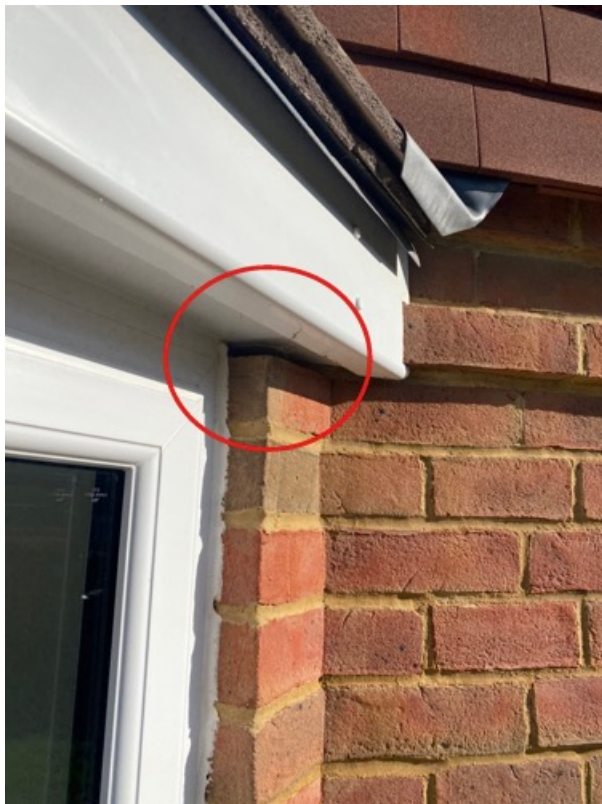
External Front

As above

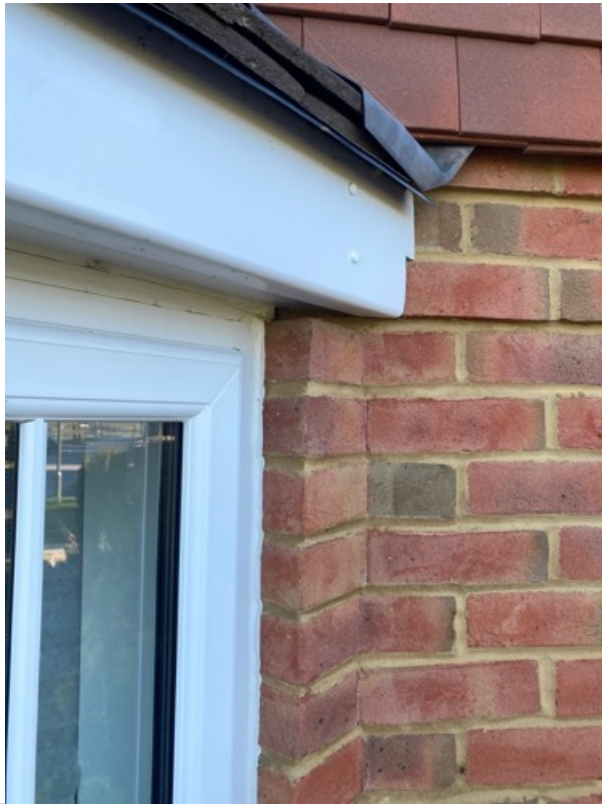
External Front

As above

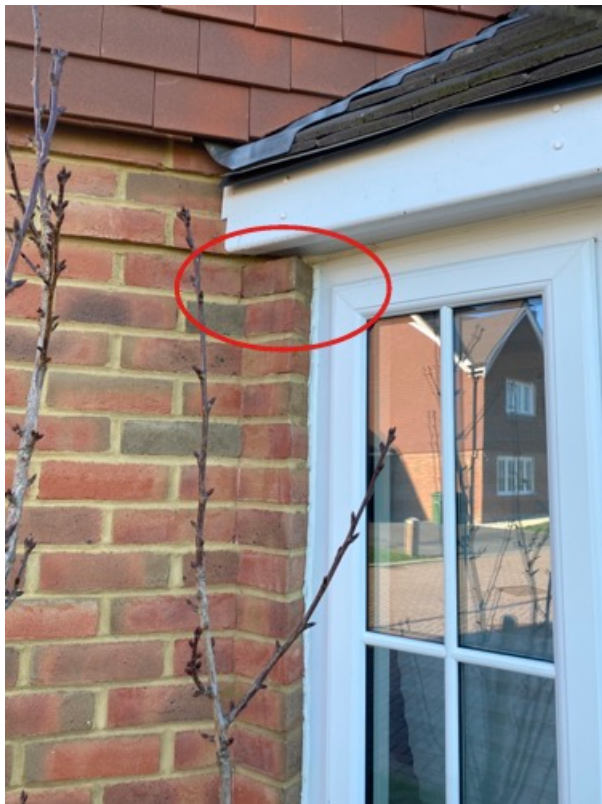
External Front

Brick loose

Rake out pointing and suitably seal around

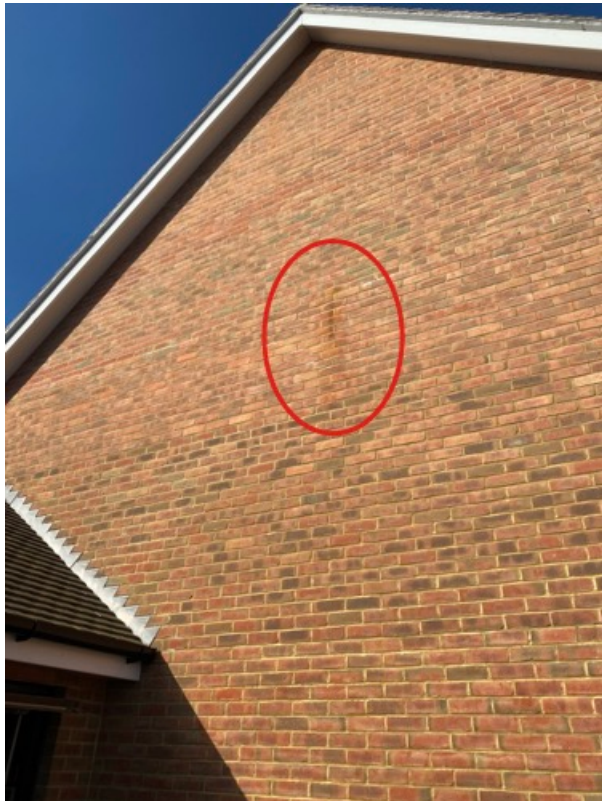
External Front

Bricks marked/ burned

Seal along stepped flashings

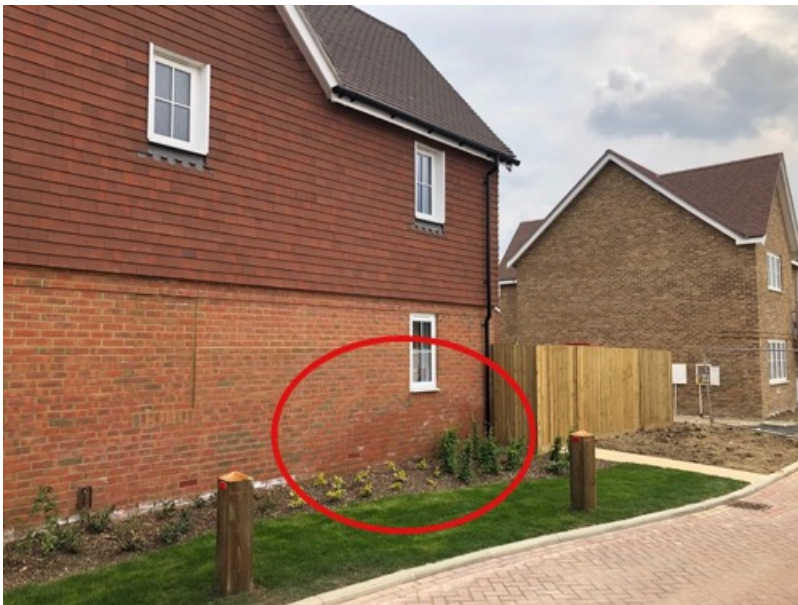
External Front

When garden was done, treated water found under the house - to avoid potential damage, drainage pipes were installed with access, to drain treated water - NHBC claim 20 / 21705
