# Example Thermal Survey

## Overview

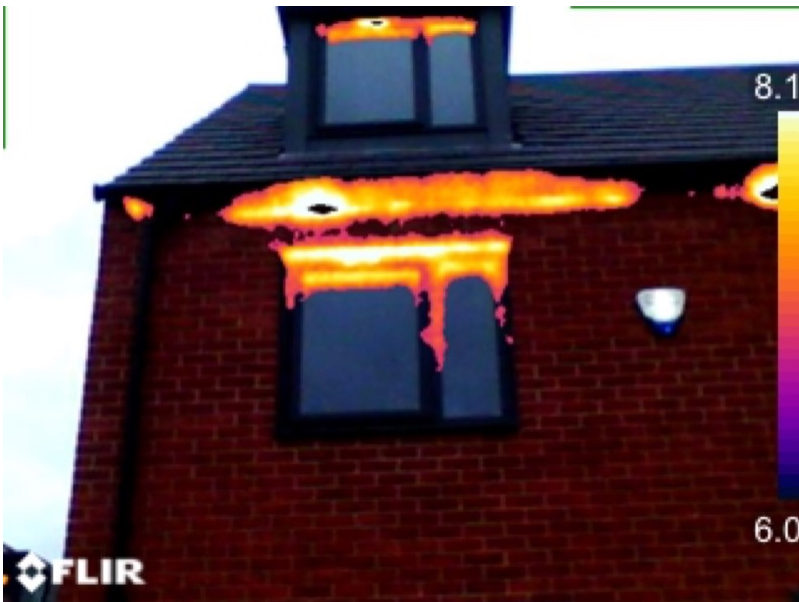
Exterior front

Heat from the windows is warming the soffit.

This could suggest the insulation is missing above the windows. Given the insulation fill is poor in other areas, recommend the insulation above the upper windows is investigated

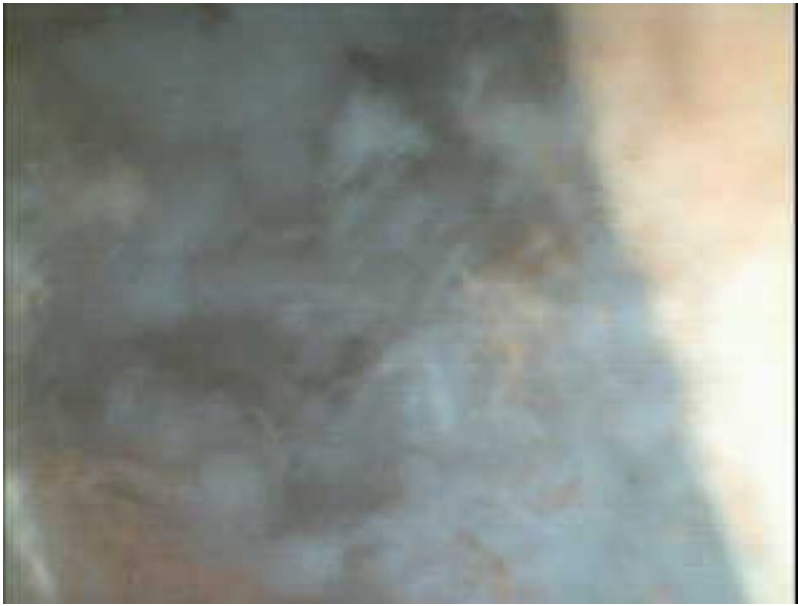
### Exterior back

Insulation fill sufficient at test location

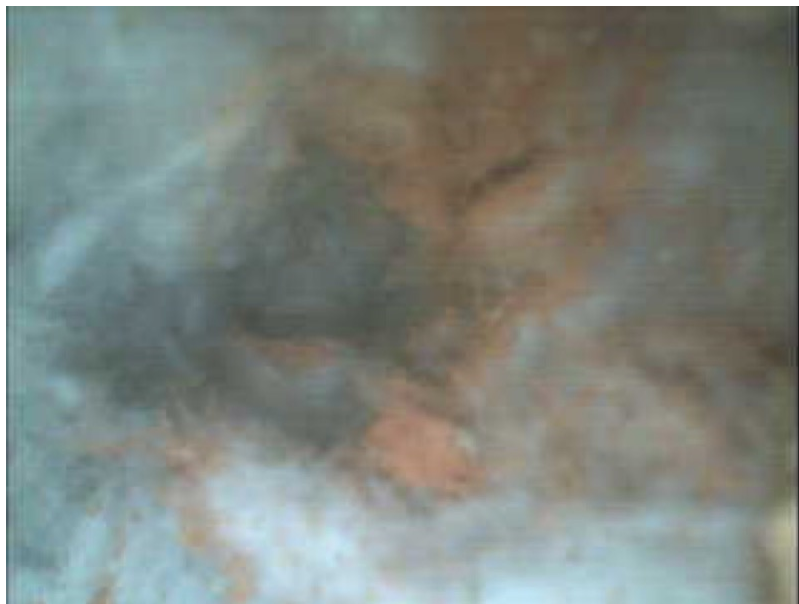
Exterior right

Insulation fill sufficient at the test location

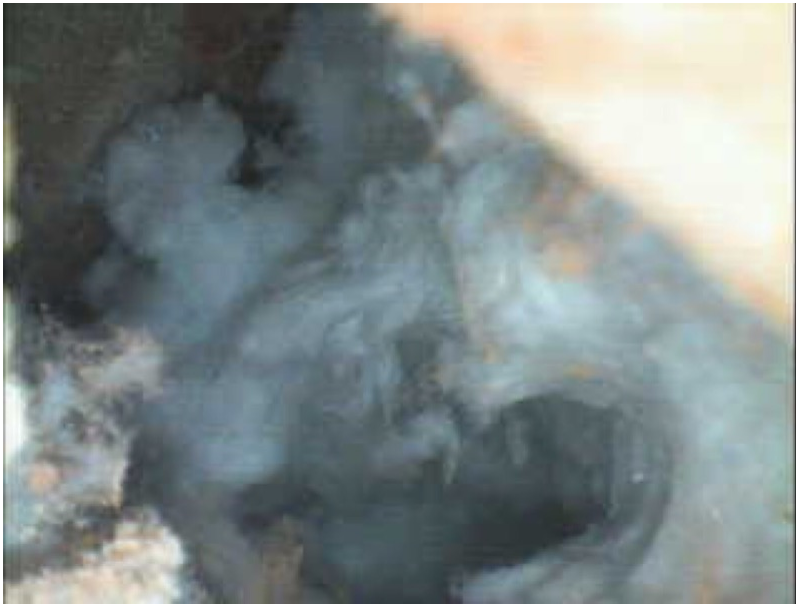
### Exterior left

As above, detail. Air pockets in the insulation

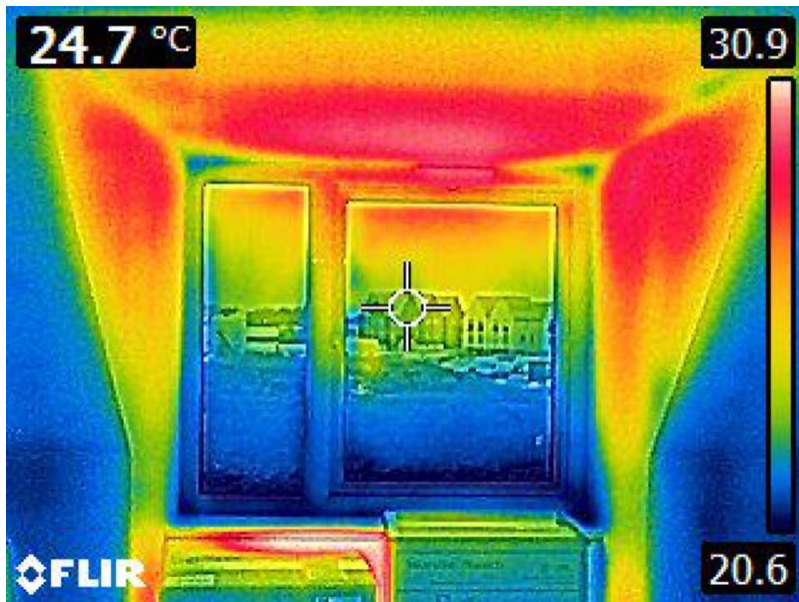
### Bedroom 5

Normal window heat loss pattern. Low emissivity coating confirmed.

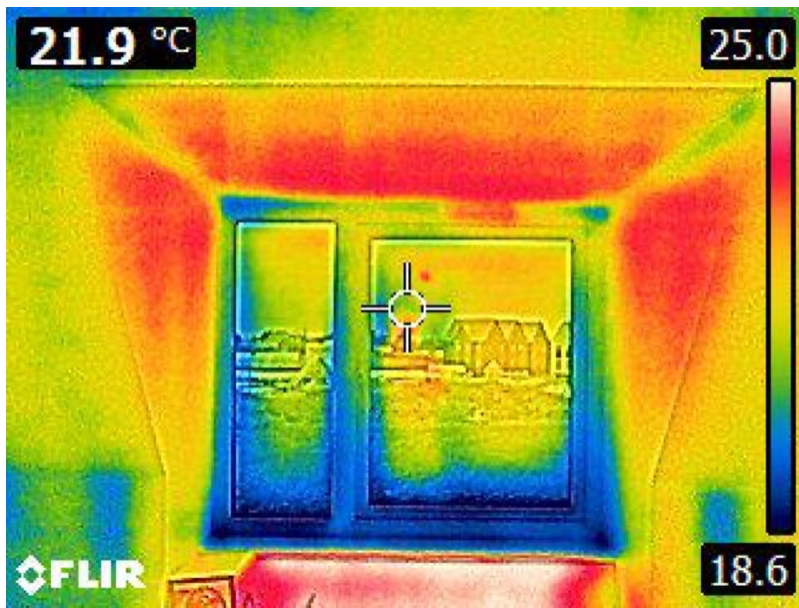
#### Bedroom 4

Normal window heat loss pattern.  
Low emissivity coating confirmed.

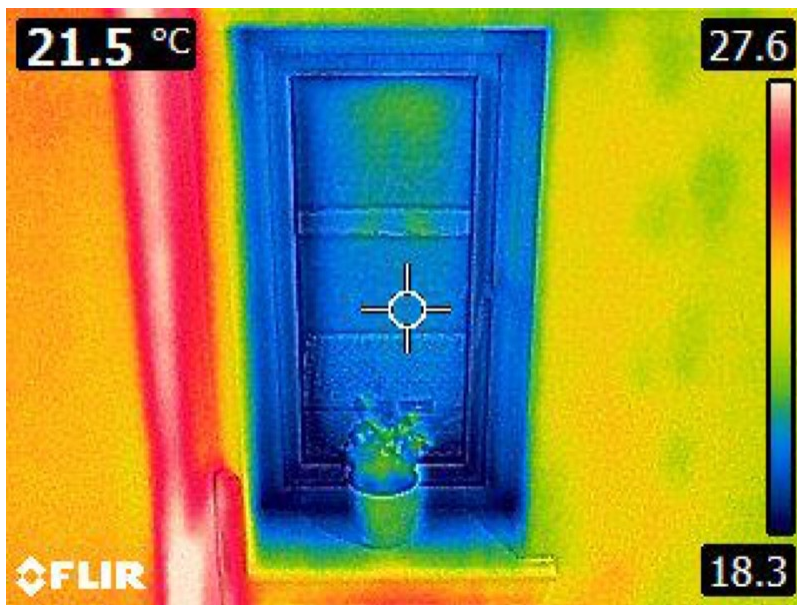
Landing

Normal window heat loss pattern.  
Low emissivity coating confirmed.

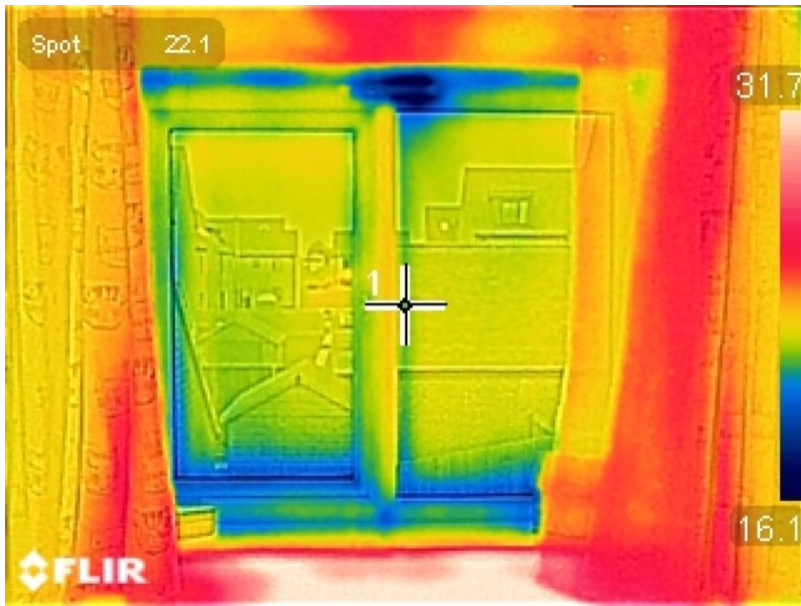
### Bedroom 2

Normal window heat loss pattern.  
Low emissivity coating confirmed.

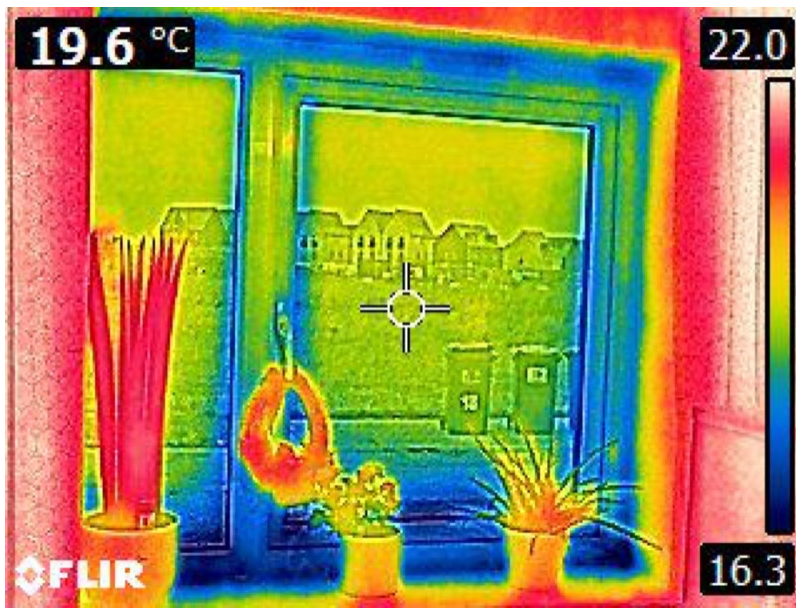
### Study

Normal window heat loss pattern.  
Low emissivity coating confirmed.

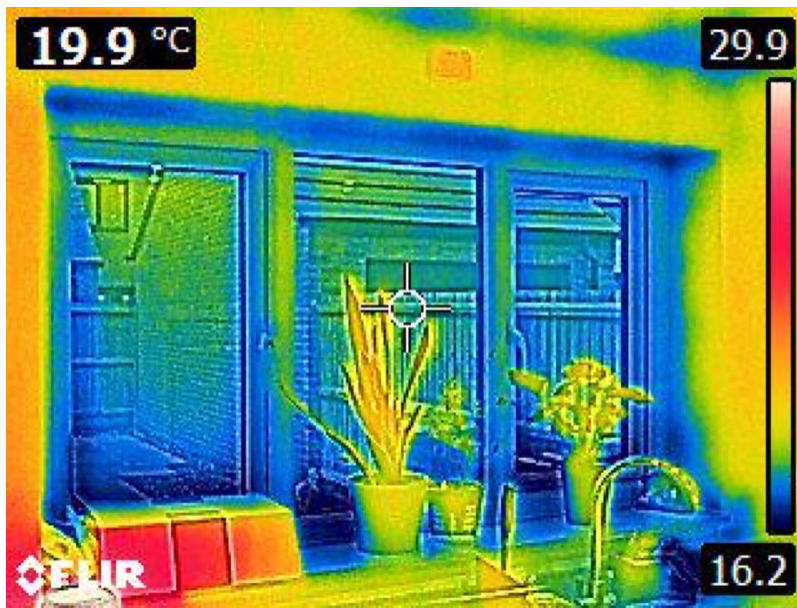
### Kitchen

Normal window heat loss pattern.  
Low emissivity coating confirmed.

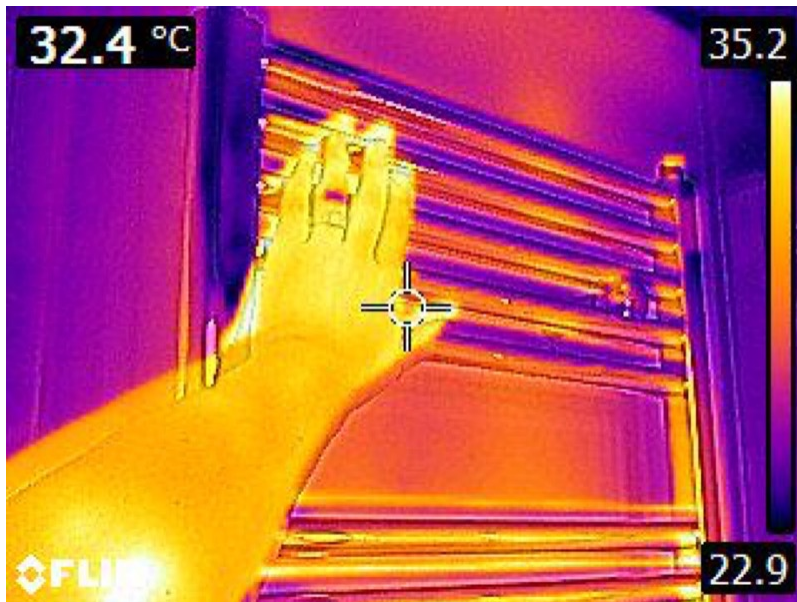
Top floor bathroom

Radiator needs bleeding
